**Clock Inoperative/Unable to Adjust Clock**

2014-2015	Camry	2014-2015	Tundra
2015	Sienna	2015	Tacoma
2014-2015	Camry HV

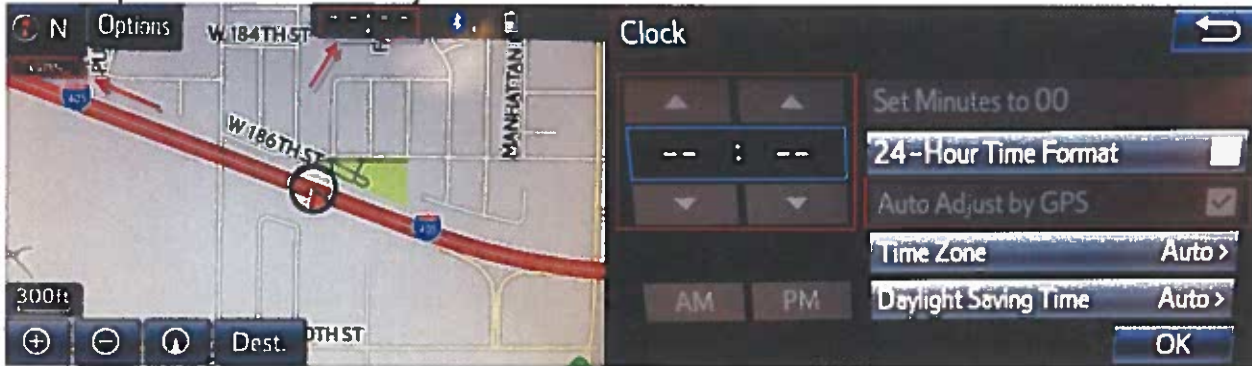
If the GPS icon on the navigation screen\* shows a red slash through it and the clock shows dashes, verify the GPS antenna and antenna connection to the radio. If an antenna issue occurs and "Auto Adjust by GPS" is checked, the clock will be inoperative and cannot be adjusted.

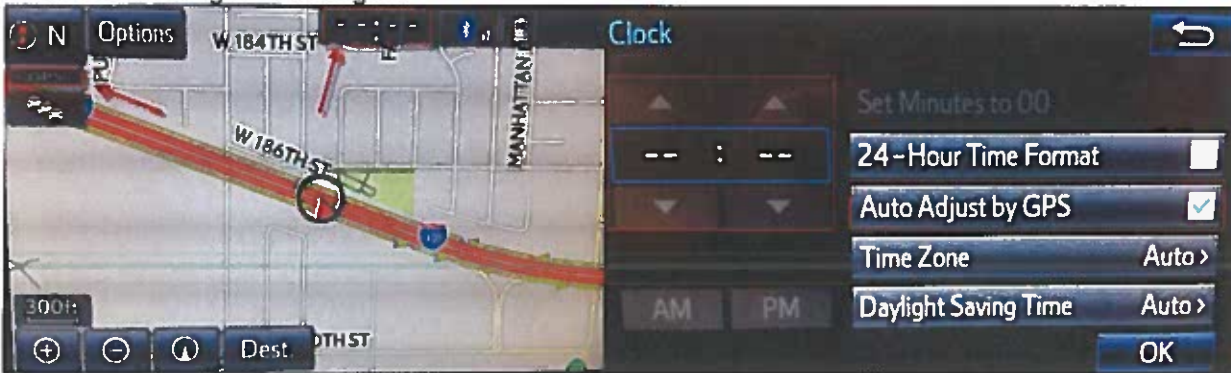
If the GPS icon on the navigation screen\* is grey but has no slash through it and the clock shows dashes, move the vehicle outside to get a GPS signal.
