# **Short Pin Installation during PDS**

YEAR(S)	MODEL(S)	ADDITIONAL INFORMATION
2016	Avalon, Avalon HV

**TOYOTA** T-SB-0097-15 October 30, 2015 Page 3 of 3

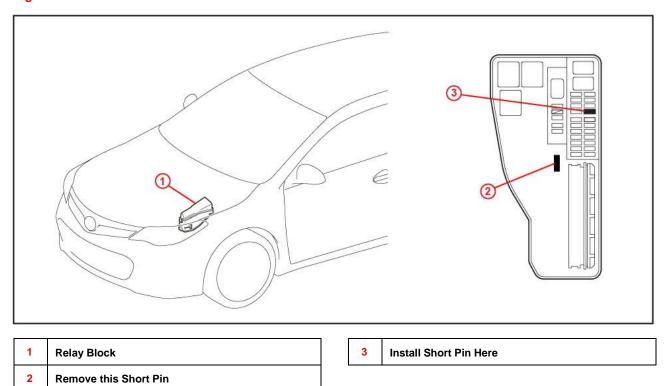
Figure 1

Remove the Short Pin from the blank space of the Relay Block in the engine compartment and install the Short Pin in the Relay Block as shown.

- The Short Pin does NOT function as a fuse, so install it only in the position shown.
- If the vehicle is stored after PDS, disconnect the negative (–) battery terminal to prevent battery discharge. Refer to Service Bulletin No. <a href="PG001-06">PG001-06</a>, "Battery Maintenance for In-Stock Vehicles and Pre-Delivery."
