Service Bulletin

Subject: Removal of Transit Blocks During Pre-Delivery Inspection (PDI)

Models: 2014-2015 Chevrolet SS

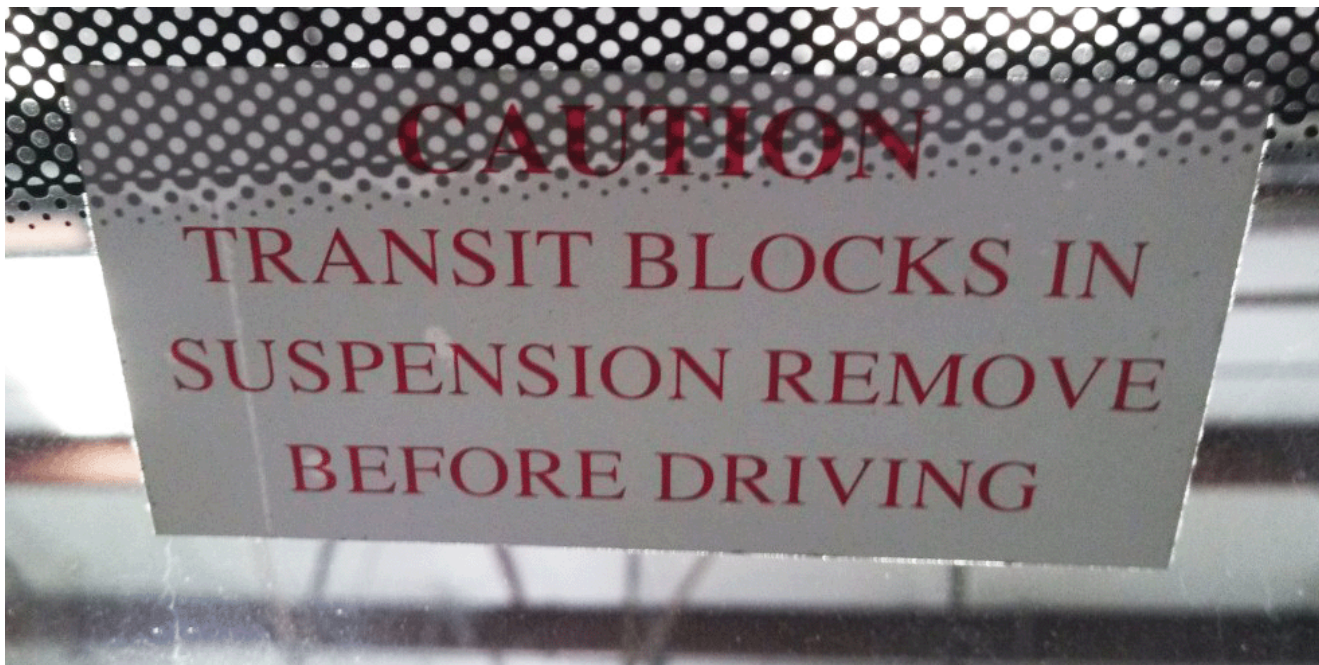
Removal of Transit Block Window Sticker

A reminder sticker to remove the transit blocks is applied to the vehicle windshield during assembly. This sticker should be removed only AFTER the transit blocks are removed.

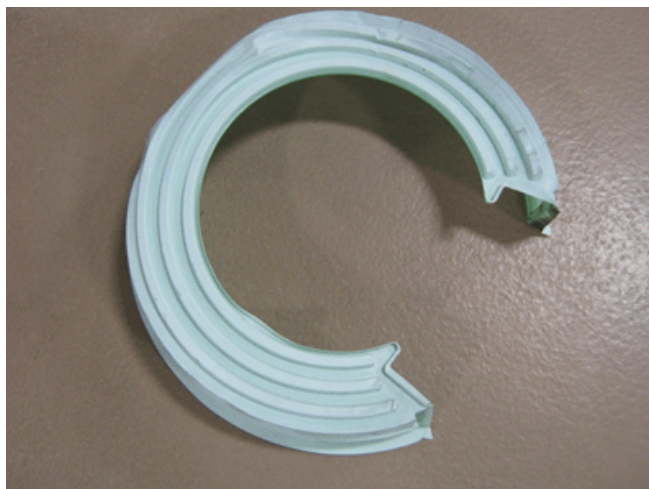
Rear Disc Brake Rotor Protection Covers (2014 MY Only)

- The factory installs rear disc brake rotor protection covers during vehicle manufacture. These covers MUST be removed from the rear rotors when performing the PDI.
