Service Bulletin

Subject: Information on Missing A/C Refrigerant Charge Label on Replacement Front Compartment Front Sight Shield

Models: 2013-2014 XTS
Equipped with RPO LFX or LF3
Vehicles Built Prior to September 16, 2013

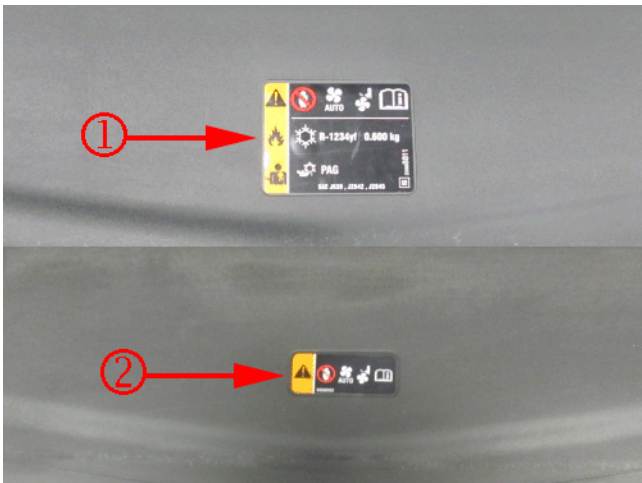
1. Old Label

2. New Label

This is due to the new service part not including the A/C Refrigerant Charge Label as shown above.

If replacing the front compartment front sight shield, follow the information below to obtain and relocate the correct A/C Refrigerant Charge label.

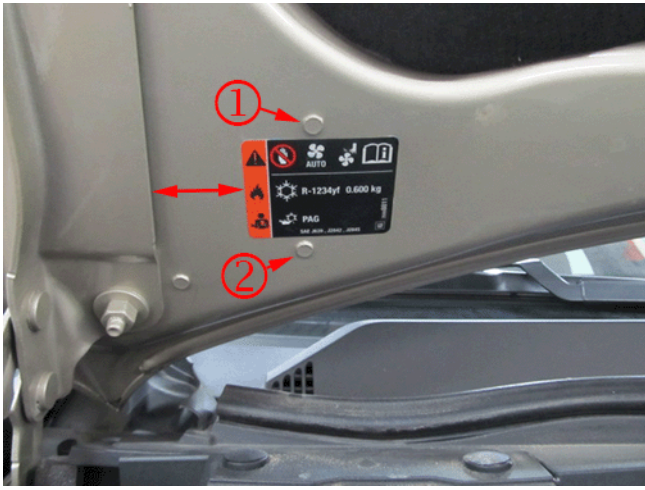
The new A/C Refrigerant Charge label will be installed on the right inner side of the hood of the vehicle.

Install the label 1½ inches (38 mm) parallel to the right hood hinge in between the two rivets like shown above.

Note: Be sure to apply the correct label per application.
