Service Bulletin

Subject: Information on Installation of Stage One and Two Rear Wicker Bills on Spoiler

Models: 2015 Chevrolet Corvette
Equipped with RPO CFV or CFZ

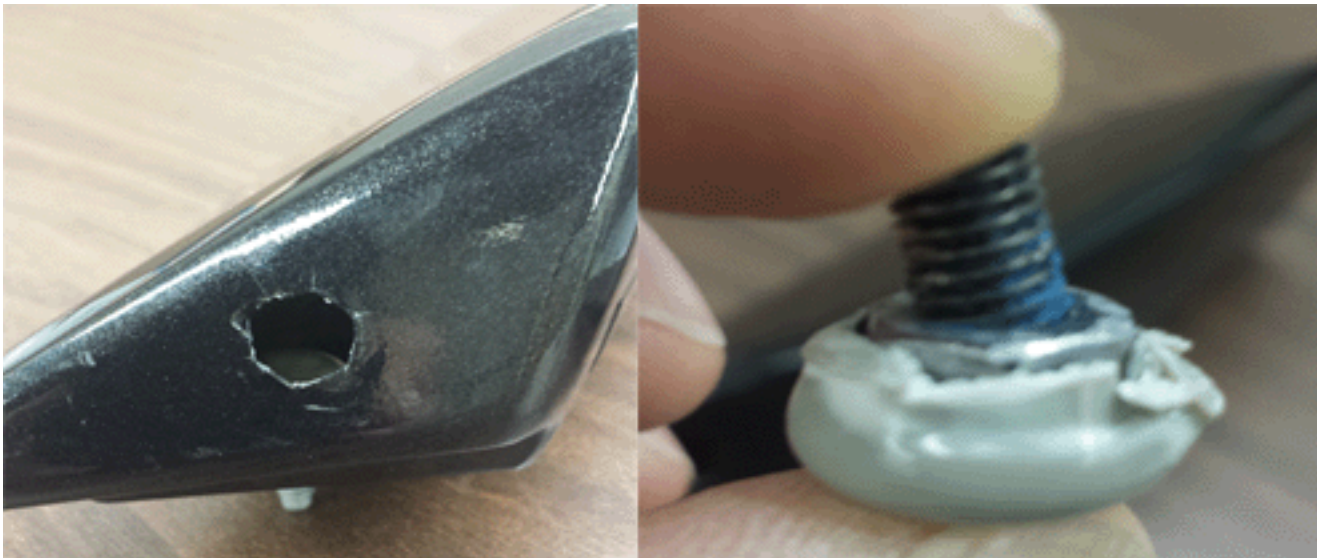
During the installation of the rear wicker bills that are fastened on the rear spoiler, some technicians may revert to the use of power tools to tighten the fasteners.

The use of power tools should not be used due to the fact that this could lead to damage to the fasteners and/or the spoiler.

When installing the wicker bills onto the vehicle, it is recommended to hand start the fasteners before using the correct hand tools to torque the fasteners to the proper torque specifications.
