Service Bulletin

Subject: Whistle Wind Noise From Drivers Side Mirror Area

Models: 2012 - 2015 Chevrolet Equinox

2012 - 2015 GMC Terrain

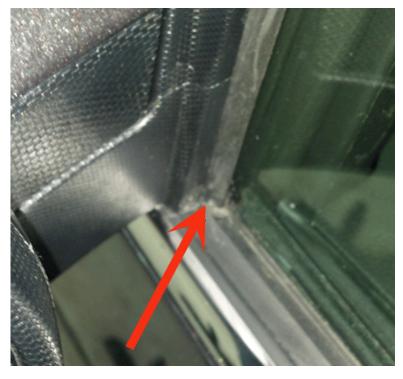
Customer may comment on a high pitched whistle or wind noise from the driver's side mirror area between speeds 25 to 52 mph. This may be caused by a gap between the belt molding and the bottom of mirror mounting patch. This may be caused by a void in the sealing area in the corner of the belt molding and the door glass frame at the front toward the A pillar. See picture below.

Suggest using a rubber mallet and lightly tapping on the belt molding - moving it toward the A pillar area. This will close the gap slightly (measure the gap between the end of the belt molding and the window a-pillar).

Next, remove the belt molding, use a suitable piece of rubber (weather strip or suitable material), and glue it to the back side of the of the belt molding to extend to fill the gap.

Reinstall the belt molding. This will fill the remaining void in the seal. Use a piece of tape to keep it in place until the glue dries
