Service Bulletin

Subject: HVAC Blower Motor Is Noisy Or Vibrates

Models: 2014 Chevrolet Silverado 1500

2015 Chevrolet Silverado, Suburban, Tahoe

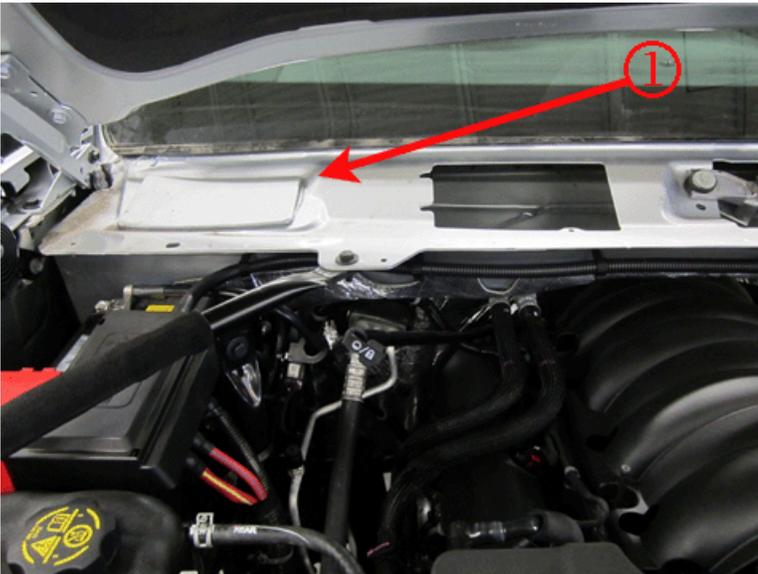
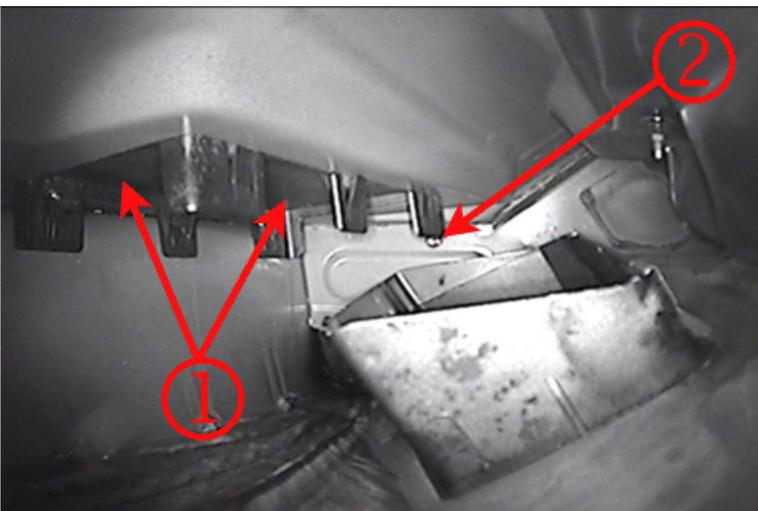
Some owners may comment that when the HVAC blower motor is running, it is noisy or may vibrate.

This concern will only occur when temperatures are below 32 deg F (0 deg C). If the blower motor is removed while it is still cold, ice may be found on the blower motor cage

If the cabin air filter is removed while still cold, snow and/or ice may be found on the filter. This concern could be caused by either a water leak into the HVAC case or snow ingestion into the HVAC case.

1. Perform normal water testing diagnostics while the HVAC is running (high blower and in fresh/outside air mode). Inspect for any water leaking past the plenum cover cap, as shown below (1). Water could drip off the bottom of the plenum cover cap (1) into the HVAC fresh air inlet, as shown below (2).

2. If water is leaking past the plenum cover cap (1) it will need to be removed and resealed. While the plenum cover cap is removed also complete the next steps to add a low pressure drop fine snow resistant screen over the fresh air inlet to prevent snow ingestion
3. Install a 12" x 12" snow resistant screen material over the HVAC fresh air inlet (2), as shown below. The water resistant screen can be ordered from Outerwears at www.outerwears.com or by calling 800-967-3450. When searching for the product on the website, use part number WR12 and then select color Black (WR12BK).
