Service Bulletin

Subject: Diagnostic Tip - Service Driver Assist Message

Models: 2015 Cadillac Escalade Models
2014 Chevrolet Silverado 1500
2015 Chevrolet Silverado, Suburban, Tahoe
2014 GMC Sierra 1500
2015 GMC Sierra, Yukon Models
With Safety Alert Seat

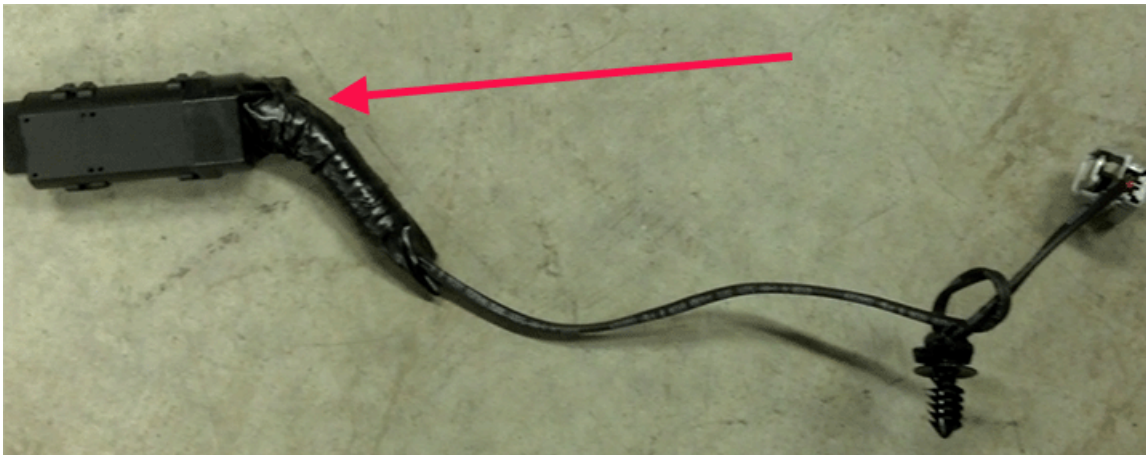
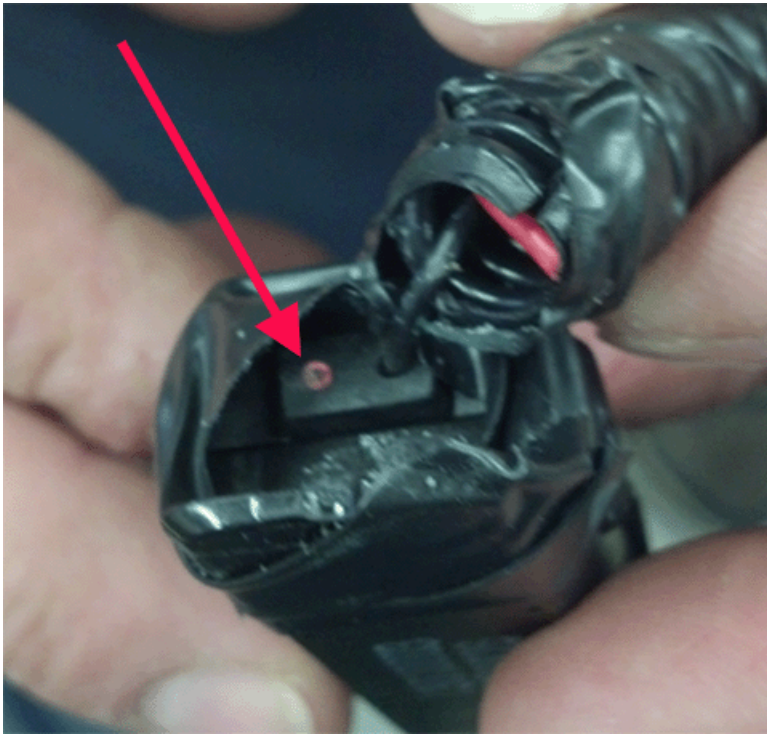
This concern could be caused by a Driver's Cushion Haptic Seat Motor circuit opened/high resistance near the motor, see pictures below.

Tip: The haptic seat motor has a pigtail lead coming off the motor. In many cases, the wiring pigtail near the haptic seat motor has broken. Do not repair the pigtail wiring, replace the haptic seat motor.
