Service Bulletin

Subject: Diagnostic Tip: EL-51578 MOST Bus Diagnostic Tool Kit

Models: 2013-2015 Cadillac ATS, SRX, XTS
2014-2015 Cadillac CTS, ELR
2015 Cadillac Escalade models
2014-2015 Buick Regal, LaCrosse
2014-2015 Chevrolet Corvette, Impala, Silverado, Suburban, Tahoe
2015 Chevrolet Colorado
2014-2015 GMC Sierra, Yukon models
2015 GMC Canyon
Equipped with RPO's IO3, IO4, IO5, IO6, RAO, or UY4

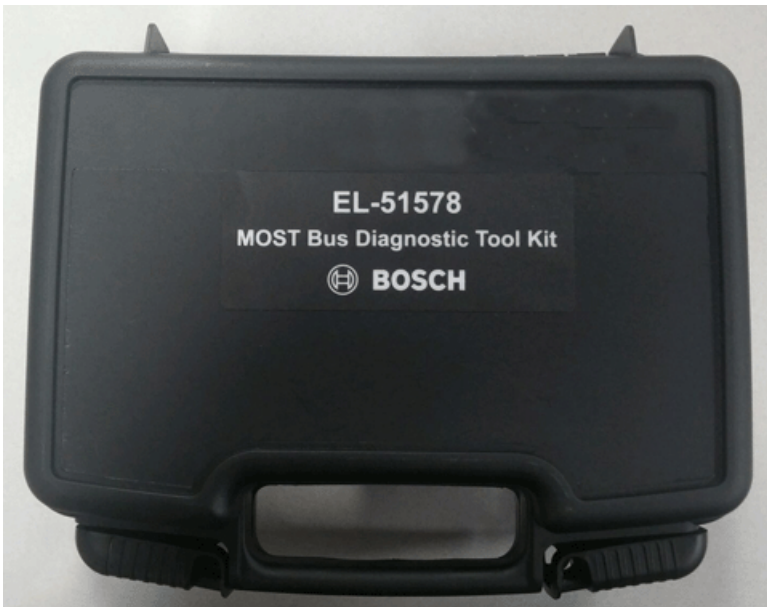
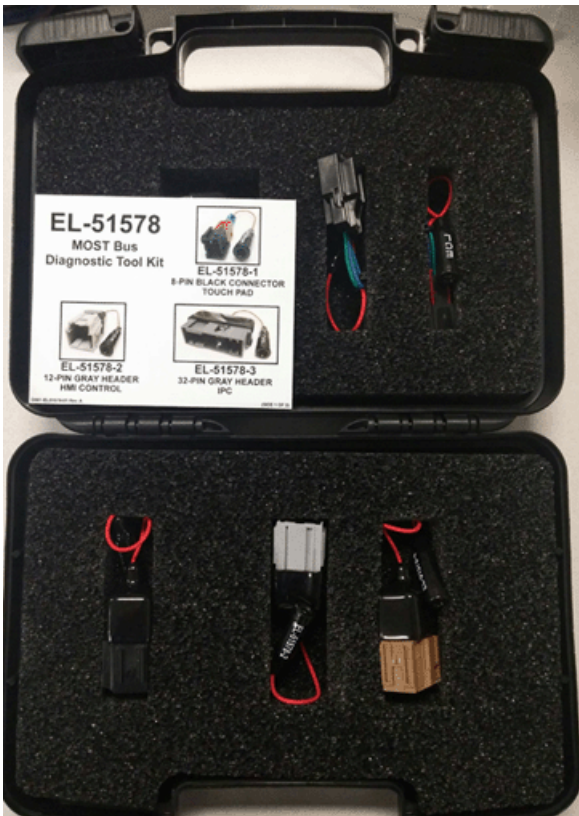
The EL-51578 MOST Bus Diagnostic Tool Kit has been released to aid in diagnosing MOST buss concerns. The kit contains header connectors that are installed to bypass MOST bus modules. The bypass connectors also contain a terminal for verifying ECL voltages (MOST control circuit). The kit does not contain a bypass for the radio, which is the master of the buss.

Usually there may be 1 of 2 modules suspect with a current Radio U0028 sym00 set depending on which Node positions are listed. If both of these 2 suspect modules are bypassed and the Radio U0028 sym00 stays current, check the MOST bus circuits and ECL for opens, shorts, high resistance, or terminal concerns.
