Bulletin No.: PIC6099

Service Bulletin

Subject: Trunk Does Not Open With Key Fob Touchpad Or Inside Release Button

Models: 2015 Cadillac ATS Coupe

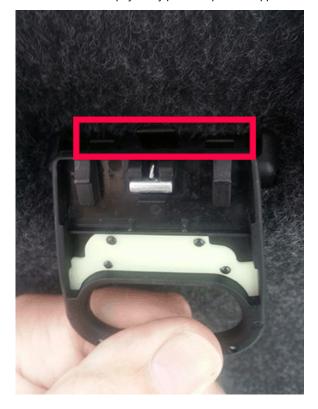
Using the photos below as reference, check the orientation of the tabs on the bezel. All 3 tabs should be visible inside the trunk

The ETR handle bezel may have been positioned incorrectly where it comes through the opening in the deck lid liner.

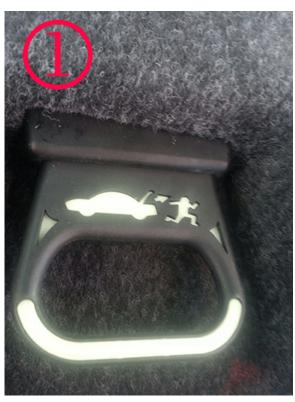
Photo # 1 shows proper positioning of the handle flat and snapped up into position.

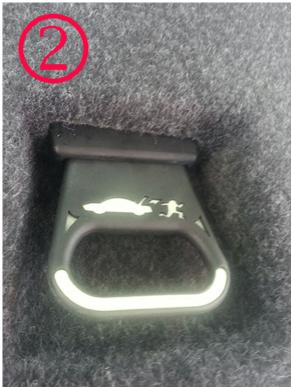
Photo #2 shows the handle pulled down. Any sort of preload on the ETR cable will not allow the latch to release when any of the electric switches are used.

The handle must be physically pushed up and snapped into the bezel.
