Service Bulletin

Subject: Diagnostic Tip - Perceived Brake Fluid Leak At Caliper Piston Boot

Models: 2015-2016 Chevrolet Colorado
2015-2016 GMC Canyon

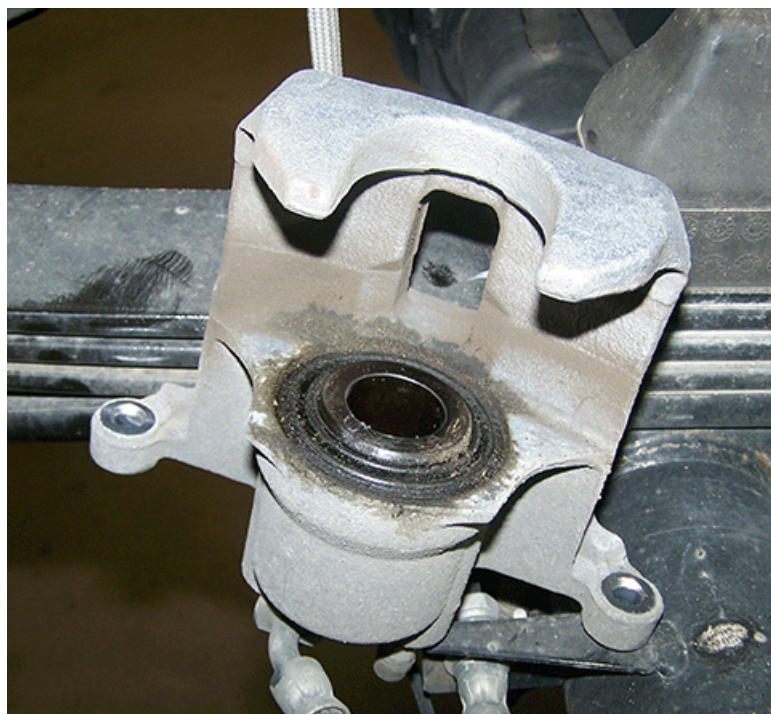
The technician may comment that, during service, it appears there is fluid leaking from the brake caliper piston area - as shown below:

The substance shown is actually excess assembly grease from the caliper boot and piston installation. This grease can be cleaned off and the rest of the service completed.
