Title: Maxxforce 11/13L, N13L and 2010+ Maxxforce 7 Cylinder Head Crack Inspection

Applies To: Maxxforce 11/13L, N13 and 2010+ Maxxforce 7 engines

MF 11/13, N13 and MF7 Cylinder Head Crack Inspection Guide

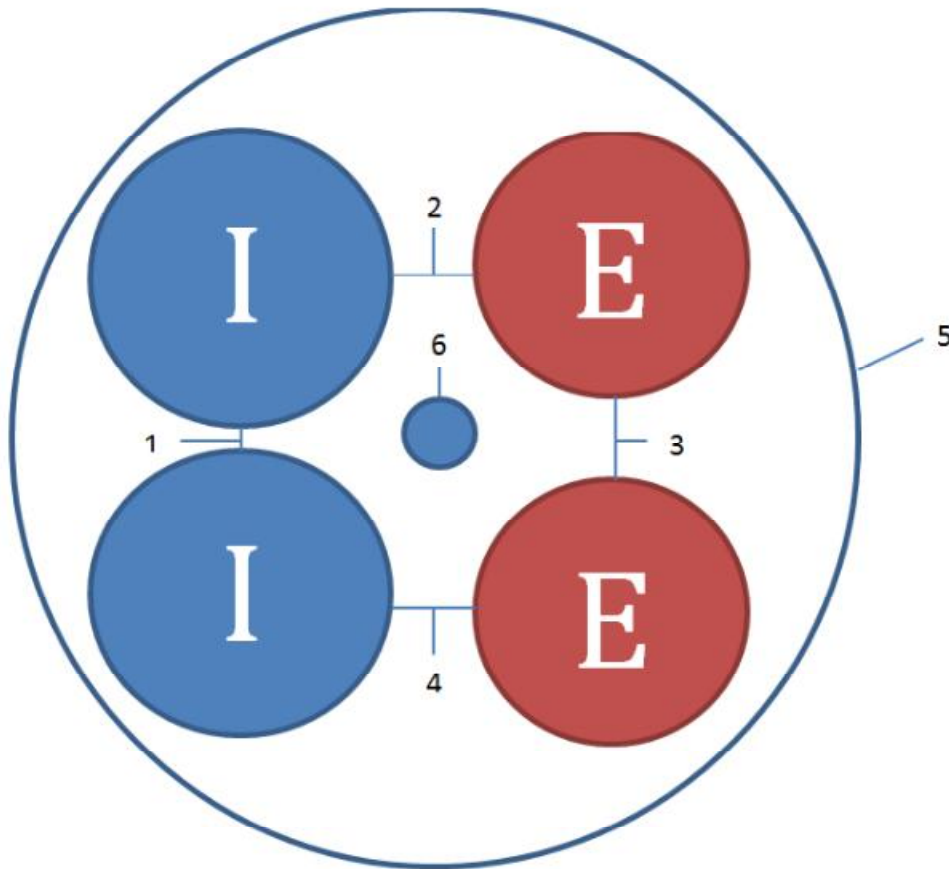
Acceptable Cracks

- Cracks of any length in location 1, between the intake ports, are acceptable
- Cracks of less than 3 mm length from location 6, Injector bore are acceptable
- Cracks between all other ports, locations 2, 3, &4 are only acceptable if they are less than 3mm in length and do not contact the valve seat
- Cracks that appear on the surface of the fire deck and are less than 3mm in length; including cracks emanating from valve seats but not between valves

Unacceptable cracks

- Any cracks that run the entire length between the ports in locations 2, 3, &4 are unacceptable and cylinder head replacement is needed
- Any cracks, regardless of length, that run along the combustion sealing surface, location 5, are unacceptable and cylinder head replacement is needed
- If there are multiple cracks propagating from a single valve seat, cylinder head replacement is needed
- If there are cracks in multiple locations 1-4, on any single cylinder, cylinder head replacement is needed
