**Document ID:** IK0800269

**Title: Proper Wire Repair**

**Applies To: All vehicles**

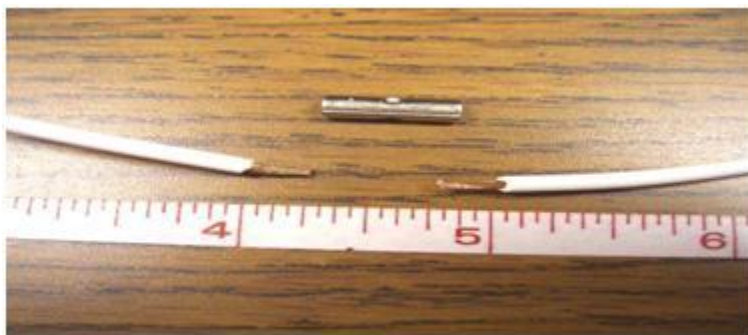
- i. Cut the conductor in the middle of the exposed conductor area.
  - ii. Strip the insulation back 1/4" from the wire ends as shown in Figure 1.
  - iii. Placed a 2" piece of double wall heat shrink tubing on one of the wires to be spliced.

If the insulation is striped as shown in Figure 1 and the exposed wires are black from moisture intrusion or green from corrosion, the technician should try to tin the wires before inserting them into the crimp splice. If the wires tin properly and solder flows smoothly on to all the individual wire strands the repair will be effective. If however, the solder does not flow properly and there is evidence that all or parts of the conductor will not take solder, the wires should be cut farther back until wires appear to be clean, the insulation stripped again, and tinned again. If the wire strands still won't take solder, the circuit should be replaced because the crimp splice will NOT be effective.

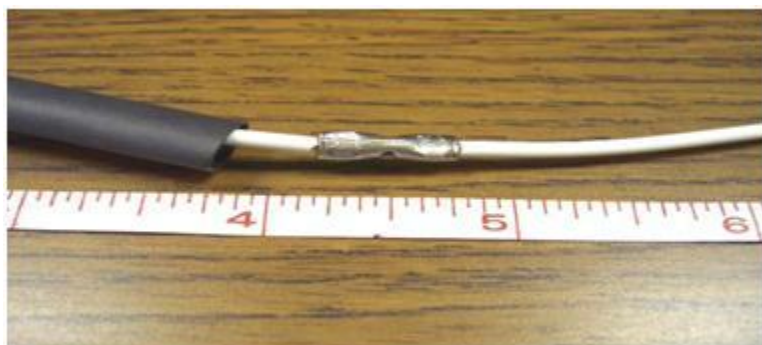
Figure 2

- iv. Crimp both wire ends into the appropriate sized crimp splice as shown in Figure 2. Make sure all the individual wire strands are inside the crimp splice.

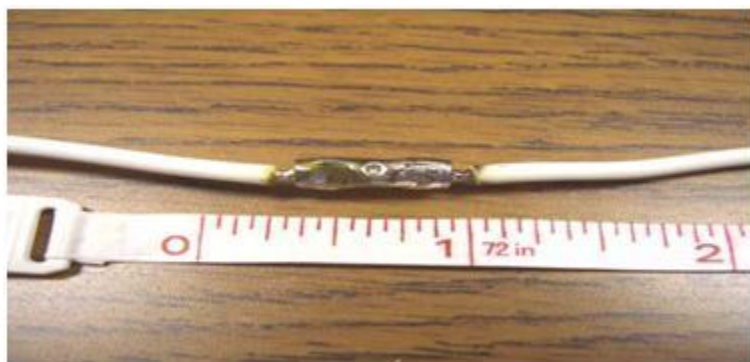
Figure 3

v. Solder (60/40 rosin core) both conductors into the crimp splice. Make certain that the solder and conductor are hot enough to allow the solder to "flow" into the individual conductors of the wire and the inside of the crimp splice as shown in Figure 3.

A good solder joint is created by applying heat to the crimp splice, not to the wire conductors or the solder. Once the splice is hot enough to melt the solder on contact, the solder will flow over and into the crimp connector as well as flow into the individual strands of the wire. If the solder joint is shiny and smooth then the proper temperature was obtained. If the solder is dull then the operation has produced a "cold solder joint" and it should be reheated until the solder flows properly.

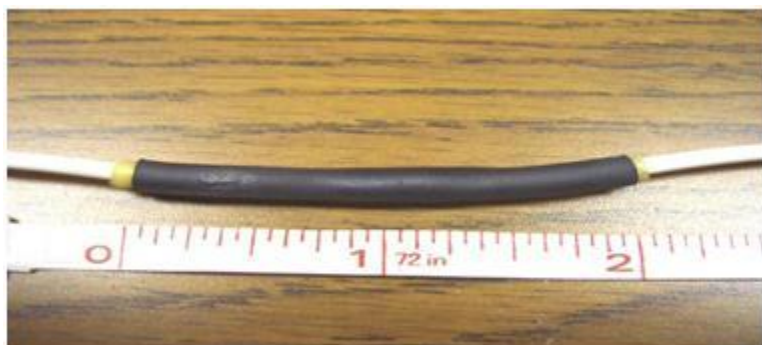
Figure 4

vi. Slide the 2" section of double wall heat shrink tubing over the crimp splice and apply sufficient heat to shrink the tubing over the connector and wires as show in Figure 4.
