**Title:** MaxxForce 7 Internal Coolant Leak Diagnostics and Repair

**Applies To:** ALL MaxxForce 7

This document will guide the user through internal coolant loss diagnostics and block repair steps for the MaxxForce 7.

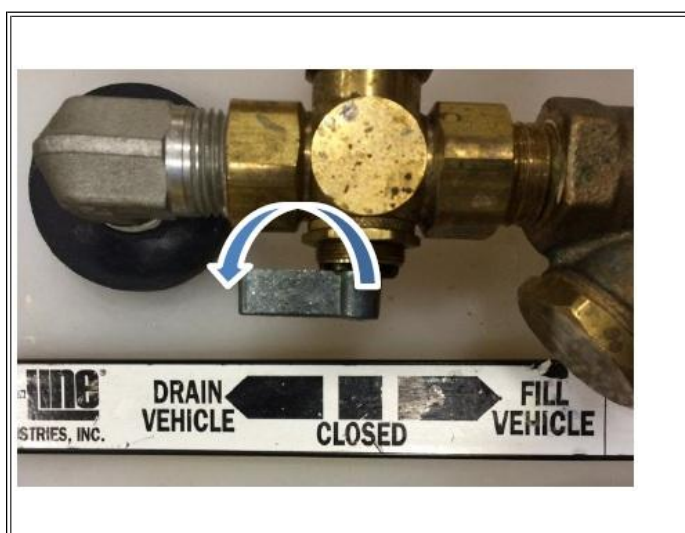
**Figure 5: Coolant Management Container Valve**

2. Position the valve to "DRAIN VEHICLE" on the coolant cart and open the valve on the Pressure Module allowing the pressure to force the coolant to fully drain, shut off the pressure, allow the pressure to finish releasing, and close the coolant cart valve. Inspect the drained coolant for heavy oil contamination, if contaminated return to diagnostic [STEP 6](#). Trace amounts of oil are ok.

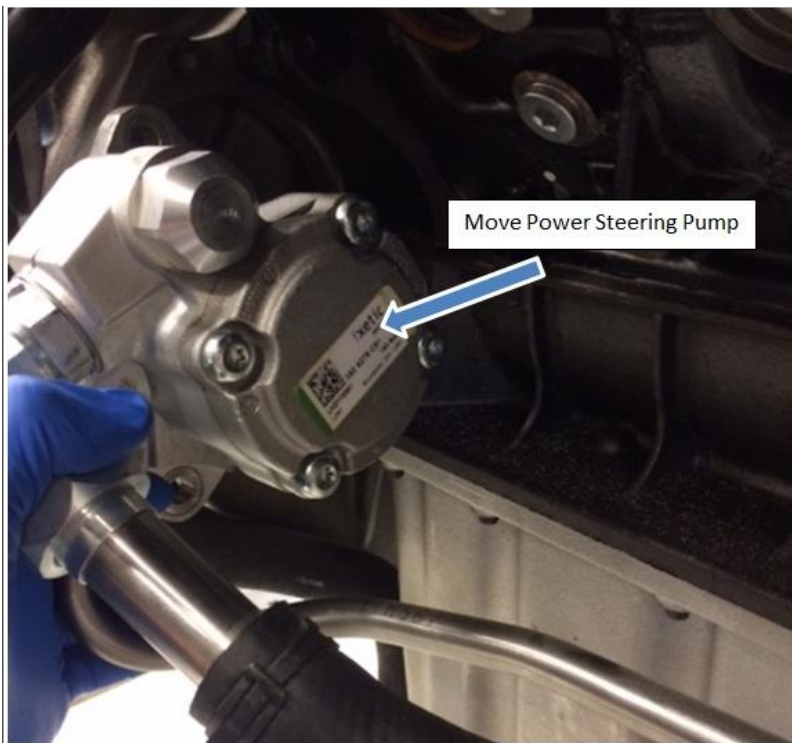
**Figure 8: Move Power Steering Pump Away from Working Area**

5. Swing the Power Steering Pump out of the repair area.

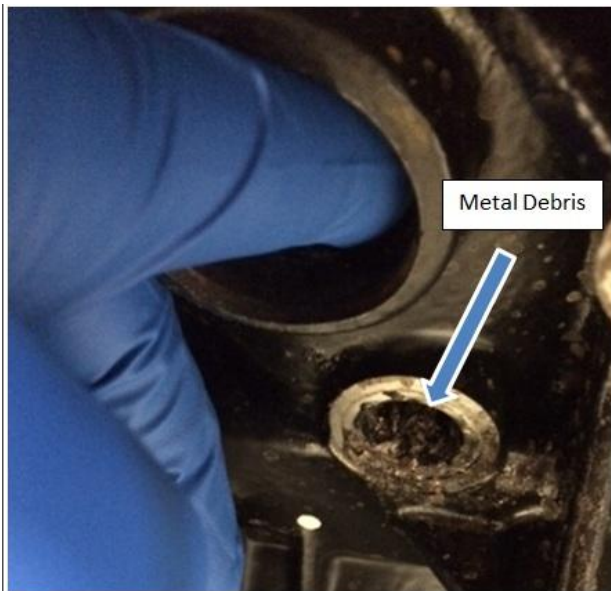
**Figure 14: Metal Debris Removal**

**10.** Going through the 38mm freeze plug opening, clear any debris in the galley by pushing, flushing, and blowing it out of the 16mm hole (Using your hand will be required to clear the area of debris).

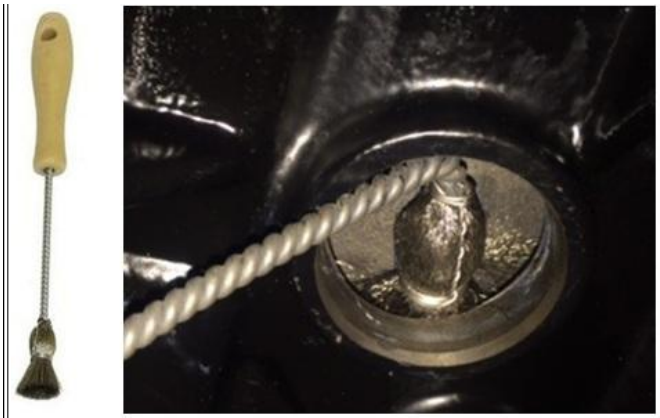
**Figure 16: Using ZTSE4391 to scrub the cavity**

**12.** Using ZTSE4391 scrub the cavity (If necessary degrease and clean the brush before using). Spray a small amount of WD-40 into the cavity to further break down the corrosion build-up and aid in the scrubbing process.

THIS AREA MUST BE COMPLETELY CLEAN, DRY AND REMAIN DRY BEFORE APPLYING THE EPOXY. ANY MOISTURE THAT COMES INTO CONTACT WITH THE EPOXY WILL INHIBIT THE CURING EFFECT. SEE FIGURE 16 ABOVE.

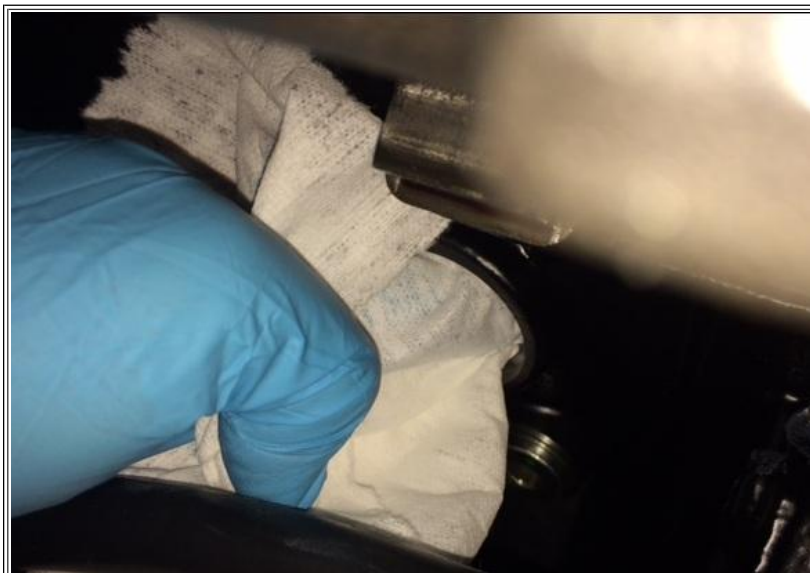
**Figure 17: Wiping the cavity clean**

**13.** Using a clean rag or a clean paper towel wipe the inside of the cavity to remove deposits that could not be flushed. Repeat steps 12 and 13 until no more debris can be removed. Once acceptable, degrease the cavity again with brake cleaner to remove the WD-40 deposits, make sure to wipe it dry several times, preferable with a non-shedding rag.

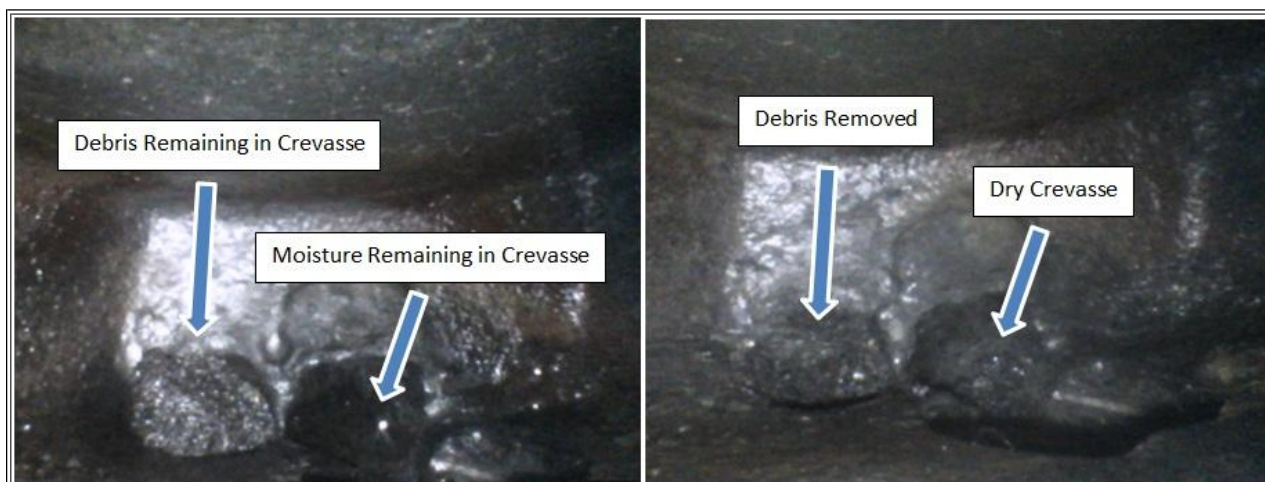
Figure 19: (LEFT) Coolant Galley with Moisture and Missed Debris (RIGHT) Coolant Galley After Cleaning and Drying

14. **REQUIRED:** Use a bore scope to visually inspect for remaining debris and fluids. If a notable amount of rust or corrosion deposits are remaining on the galley walls use a pick, or if possible an abrasive pad to clear as much as possible off the walls, rinse and inspect again. If no bore scope is available one must be borrowed or purchased for inspection of the galley. **Once the galley is acceptable please take a picture with the bore scope for documentation.** Failure to do so may result in this repair failing; causing excessive down time for the customer. This step is REQUIRED.

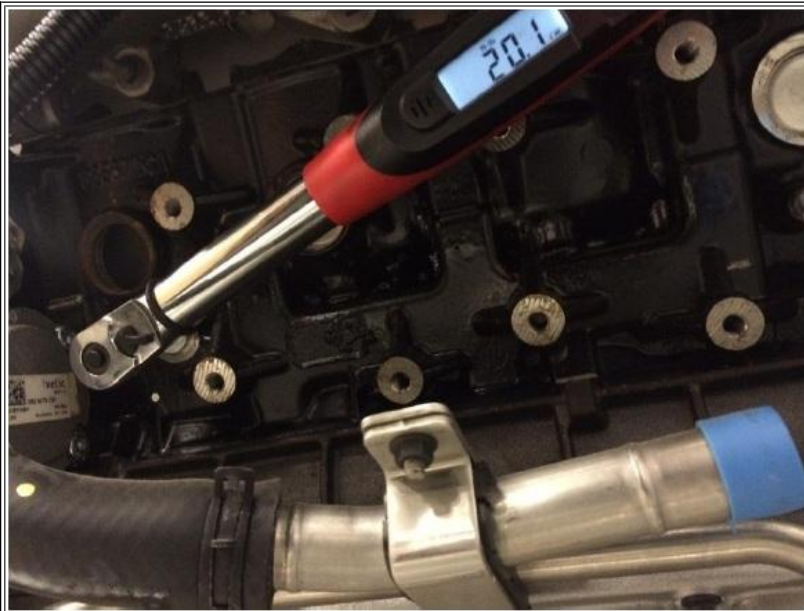
Figure 20: Install and Torque New Hex Plug

16. Install the new 16mm Hex Plug provided in the repair kit and torque to 20 ft-lb.

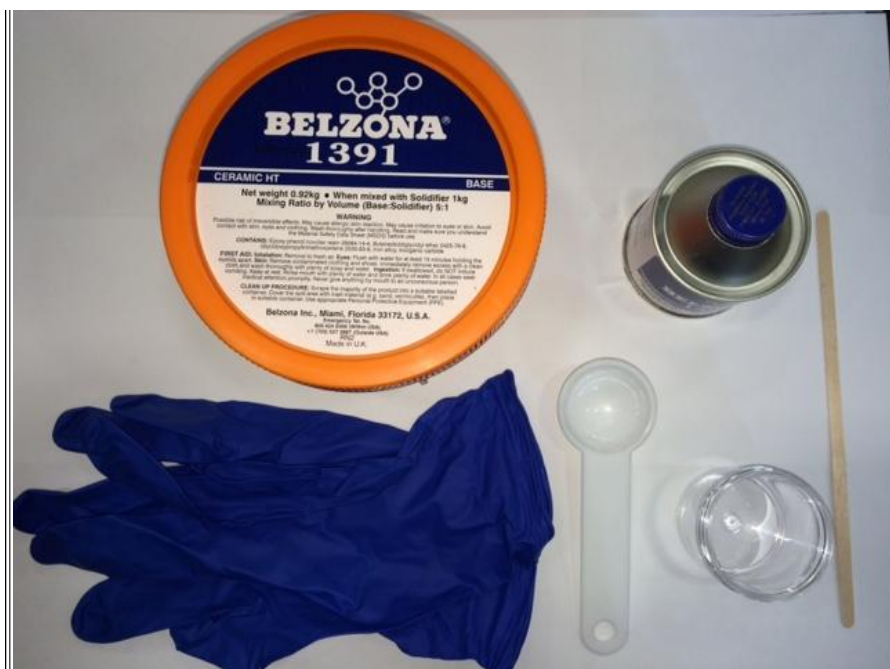
Figure 21: Belzona 1391 Epoxy Mixing Supplies

17. Gather the kit 2514509C91 for mixing the Epoxy (Belzona 1391 Base and Solidifier, Gloves, Mixing Cup, Mixing Stick, and 1 Tablespoon (Obtained Locally)).

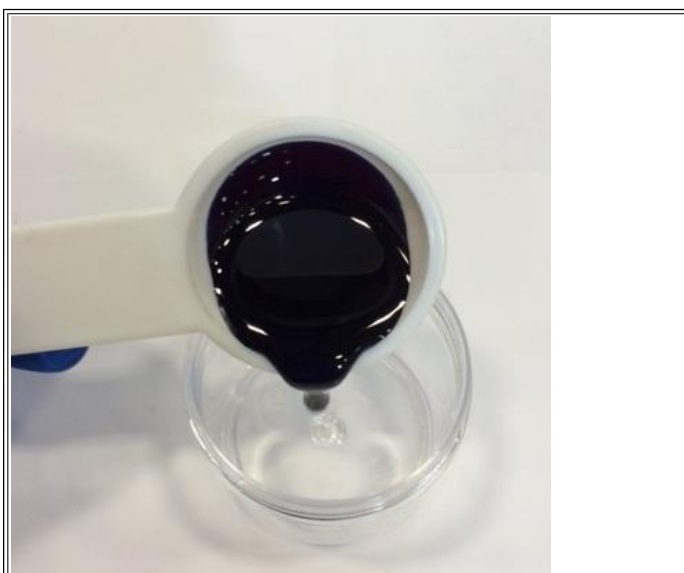
Figure 22: Belzona 1391 Solidifier (0.6 of a Tablespoon)

**18.** Measure out 0.6 of a Tablespoon (Just over half of the tablespoon) of the blue solidifier and pour it into the mixing cup. If measuring by weight this is equivalent to 9.1 grams of the solidifier.

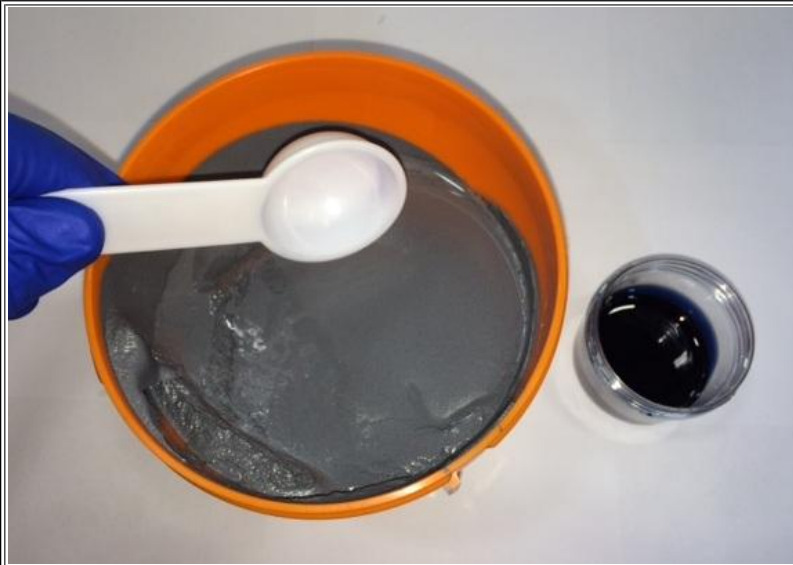
**Figure 23: Clean Tablespoon to Measure Epoxy Base (3 Tablespoons)**

**19.** Clean the tablespoon so it does not mix the Solidifier into the bulk Epoxy Base container. Failure to do so will result in curing and waste of the epoxy base.

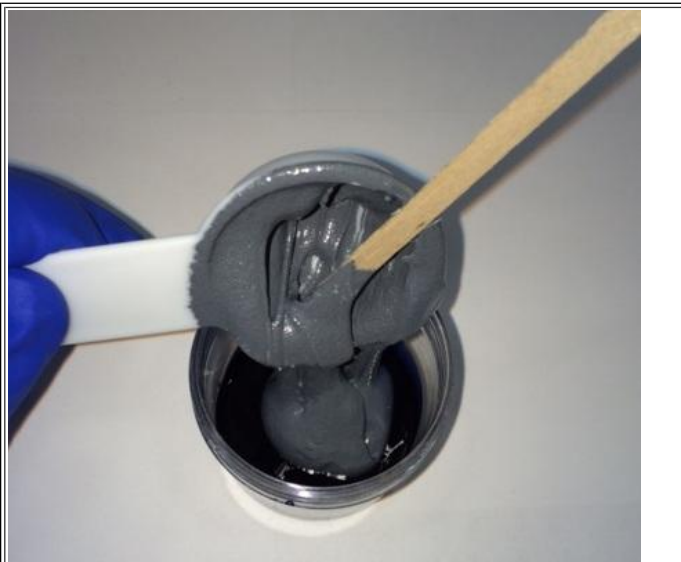
**Figure 24: Scrape Epoxy Base into Mixing Cup**

**20.** Measure out 3 tablespoons of the epoxy base and add to the cup with the solidifier, scrape out as much from the spoon as possible. If measuring by weight this is equivalent to 119 grams of the base or a combined weight of 128 grams. You must discard the measuring spoon if it cannot be fully cleaned. **DO NOT REUSE A DIRTY SPOON OR A SPOON WITH EPOXY RESIDUE.**

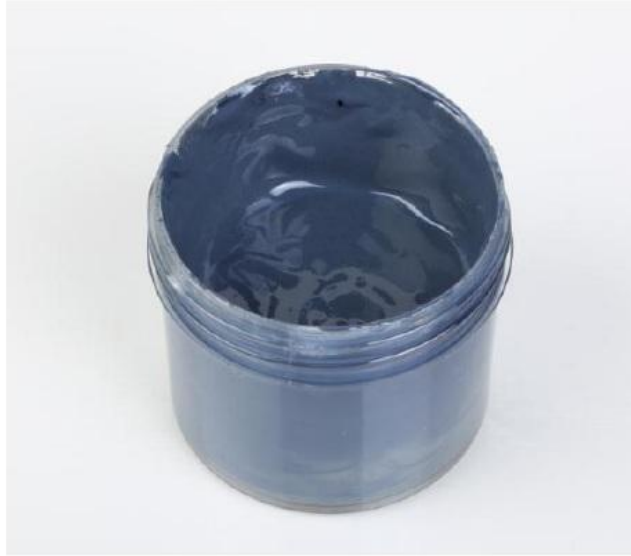
**Figure 25: Fully Mixed Belzona 1391 Ceramic Epoxy**

21. Using the provided mixing stick; thoroughly mix the epoxy until the blue solidifier is no longer visible and the epoxy has become a consistent color. Scraping the bottom and sides of the mixing cup will be required to fully mix the epoxy.

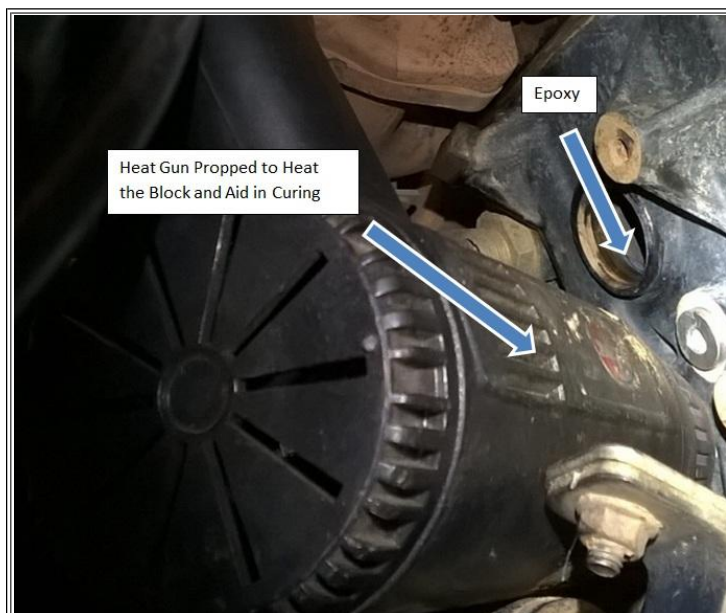
Figure 28: Use a Heat gun to Cure the Epoxy

TEMPERATURE HAS A LARGE EFFECT ON EPOXY CURING. IF ALLOWED TO DROP BELOW 50°F THE EPOXY WILL NOT CURE PROPERLY. USE A HEAT GUN TO KEEP THE AREA HOT DURING CURE TIME (PREFERABLY ABOVE 100°F). THE USE OF A HEAT GUN IS REQUIRED TO MEET THE SRT CURING TIME OF 3 HOURS. IF A HEAT GUN IS NOT USED THE EPOXY MUST CURE FOR 8 HOURS ABOVE 60°F.

25. Allow the epoxy to cure with the heat gun continuously applying heat for 3 hours (Warranty will pay for the 3 hours of bay usage), if curing is in question feel the epoxy for rigidity in the mixing container and in the block. If no heat gun is available cure time will take a minimum of 8 hours and temperatures must remain above 60°F.

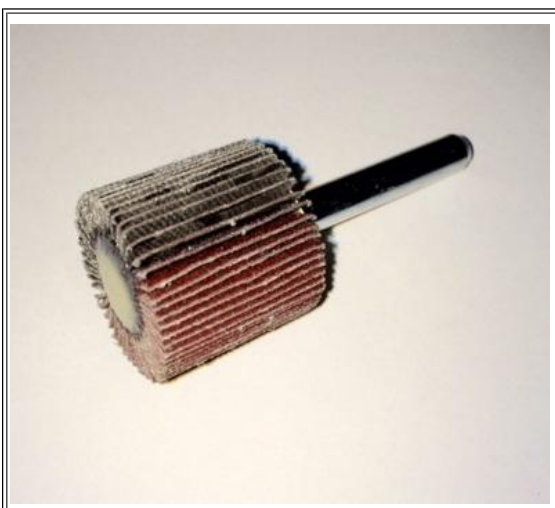
Figure 30: Flap Disc

26. Once cured, clean off the freeze plug opening with a flap disc to remove any residual epoxy and rust. Once cleaned, install the new 38mm freeze plug using ZTSE4509. A 24mm socket may be used in substitution if unavailable.
