[Less Info](#)

Hide Details

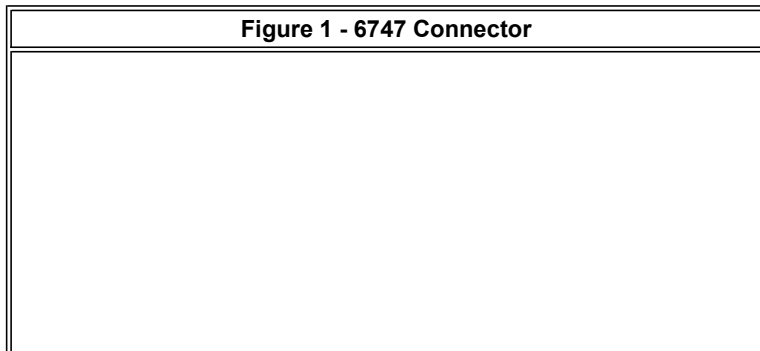
Figure 1 - 6747 Connector
