Technical Service Bulletin

Date Issued	Model Year(s) Affected	TSB #
11/09/2015	2010, 2012, 2013	429

Issue: If the exhaust tube tears, hot exhaust gas could blow against other components or material.

CONDITION: Flexible exhaust tubes may tear

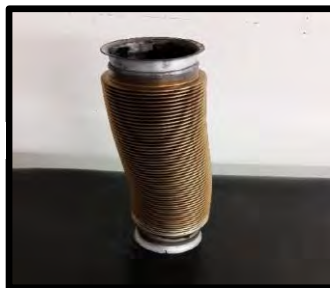
FIG. 2-1

5. The tubes joining bellows must meet the following alignment requirements stated in the installation guidelines. Voids in center of the two tubes are where the bellows are located.
6. Remove bellows and make note on the shape of the bellows that may indicate any misalignment. Refer to FIG. 2-1.

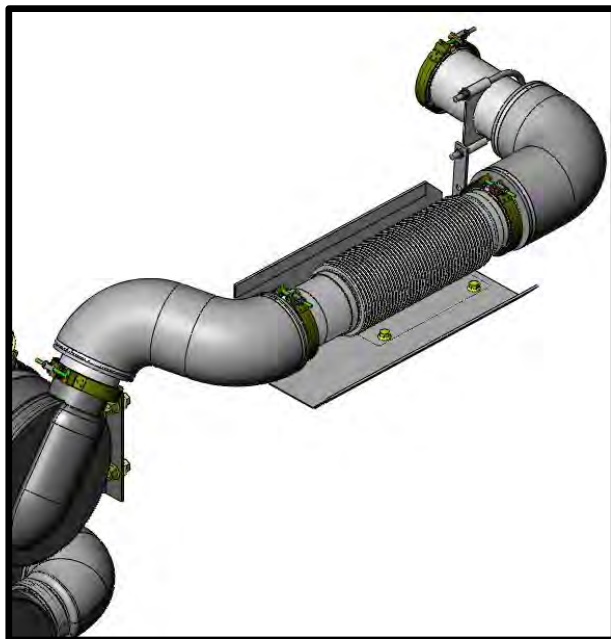
FIG. 3-1

ISL installation (shown with bellows as reference)

7. After completing alignment checks for the bellows/mating exhaust tubes and exhaust bellows has been removed: If alignment passes checks proceed to **step #9**. If alignment failed checks move to **step #8**.
8. Loosen clamps, support brackets, and v-band clamps that secure tubes to allow for adjustment of the tubes. Refer to 7th digit in VIN number for engine identification. If 7th digit is D, engine is an ISL: refer to FIG. 3-1. If 7th digit is E, engine is an ISX: refer to FIG. 3-2.

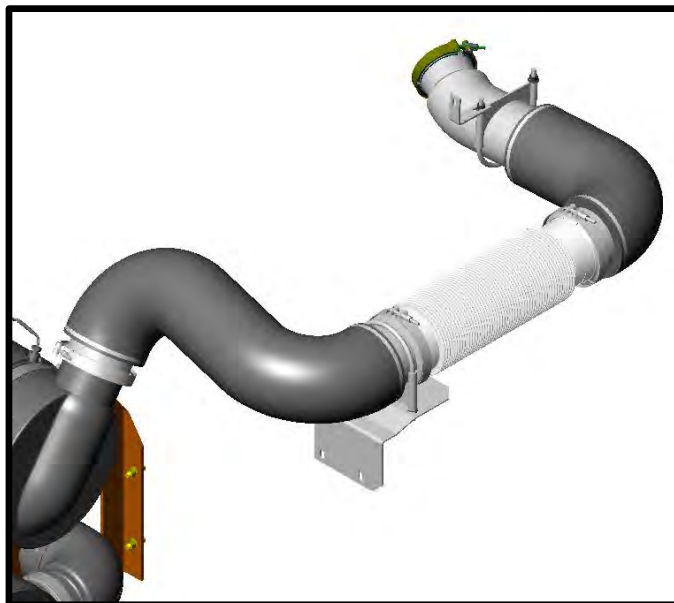
FIG. 3-2

ISX installation (shown with bellows as reference)

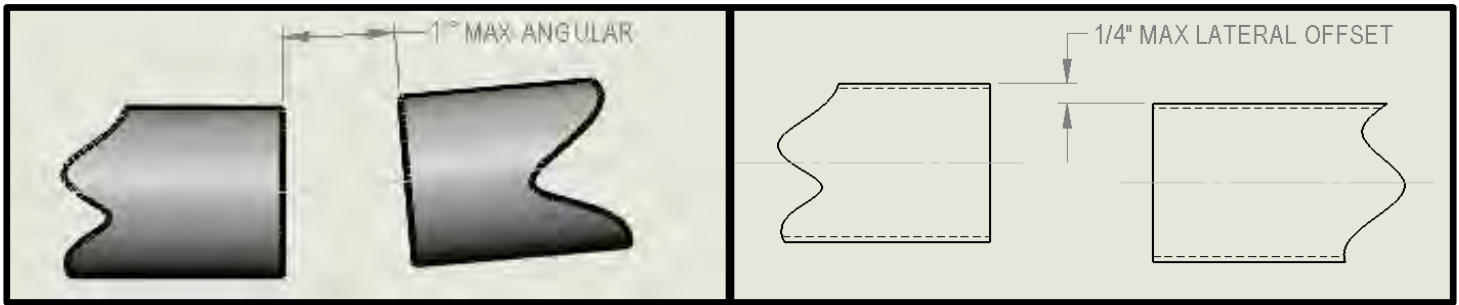
FIG. 4-1

9. Install supplied bellows using supplied v-band clamps and gaskets. Leave clamps loose enough to allow for adjustment if required.
10. Using a straight edge, align tubes and exhaust bellows so they meet requirements for both angularity and lateral offset. The alignment must be checked in (2) two quadrants that are 90° apart. If **step #8** was skipped and proper alignment cannot be achieved **step #8** will need to be completed. Refer to FIG. 4-1.

11. Once alignment requirements are met secure all clamps and brackets.
12. Torque (4) v-band clamps to 90 lbs. in.
13. Ensure all other hardware has been tightened.
14. Recheck alignment to ensure no shifting has occurred.
15. Reinstall retained heat shields (if required).
