**Document ID:** IK1201259

**Title:** MaxxFORCE 7 Fuel Dilution Diagnostics

**Applies To:** All MaxxFORCE 7

This document will guide the user through step based diagnostics for fuel in the oil.

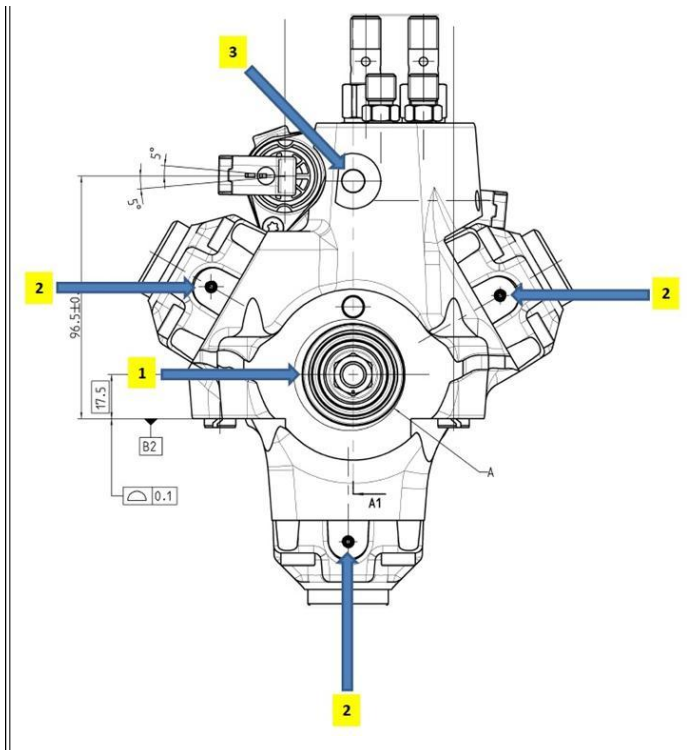
**Figure 4: Ranked High Pressure Fuel Pump Leak Locations**

- 1. HPFP Shaft Seal
- 2. Pump Cylinder Expander Screws
- 3. Pressure Relief Valve

Step	Action	Decision
10	<p><b>Inspect for fuel leaks.</b></p> <ol style="list-style-type: none"> <li>1. Remove the High Pressure Fuel Pump cover.</li> <li>2. Reassemble the fuel lines temporarily for diagnostic purposes. The steel HPFP supply lines are crush fit, meaning one time use only. They must be replaced after diagnostics are complete.</li> <li>3. Clean off the pump using brake cleaner to remove any remaining dye/fuel. Inspect the pump with a black light for remaining traces of dye and reclean if necessary.</li> <li>4. The valve cover can be left off or rested over the fuel lines.</li> <li>5. Run the Standard test in ServiceMaxx and perform a few brake stalls to raise FRP.</li> <li>6. After sufficient FRP has been built and time has gone by to cycle the dyed fuel through the system, shut the engine down and use a black light to inspect the pump for fuel/dye. See Figure 4 below for most likely leak locations. Use a small mirror to inspect hard to see locations.</li> </ol> <p style="color: red; font-size: small;">NOTE: Engine oil has a natural luminous glow to it under a black light. If unsure the glow is dye, drain a small amount of fuel from the manual drain valve on the fuel filter module and inspect with a black light. Make sure the fuel glows. A test spot of dyed fuel on the pump can help determine if it is properly illuminating under black light.</p> <p>Were any fuel leaks found?</p>	<p><b>Yes.</b> Double check with a coworker or manager. If the pump is still determined leaking, replace the HPFP and harness.</p> <p style="color: red; font-size: small;"><u>On the failed pump, please circle the leak location with a paint pen for warranty review.</u></p> <p>Reassemble the engine; return to Step 9.</p> <hr/> <p><b>No.</b> Step 11</p>
