**Document ID:** IK1201096

**Title:** ProStar+ with MaxxForce 11/13L or N13 - LT EGR Core Removal and Insertion

**Applies To:** 2010 MaxxForce 11/13, N13, ProStar+113, ProStar+122

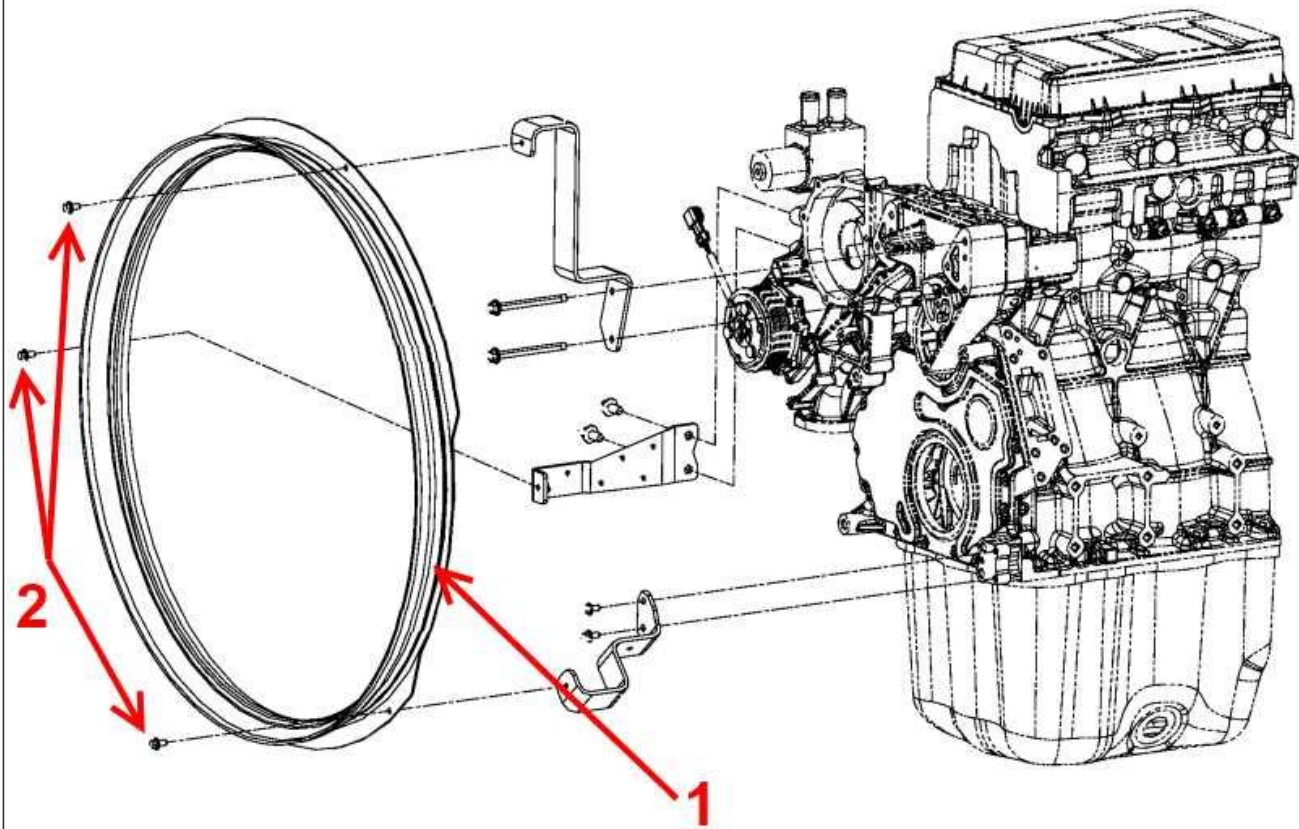
**Figure 8: Fan Shroud Ring**

Item 1: Fan Ring

Item 2: Fan Ring Bolts

19. Remove the three bolts securing the fan shroud ring to their respective brackets (**Figure 8**, Item 2).

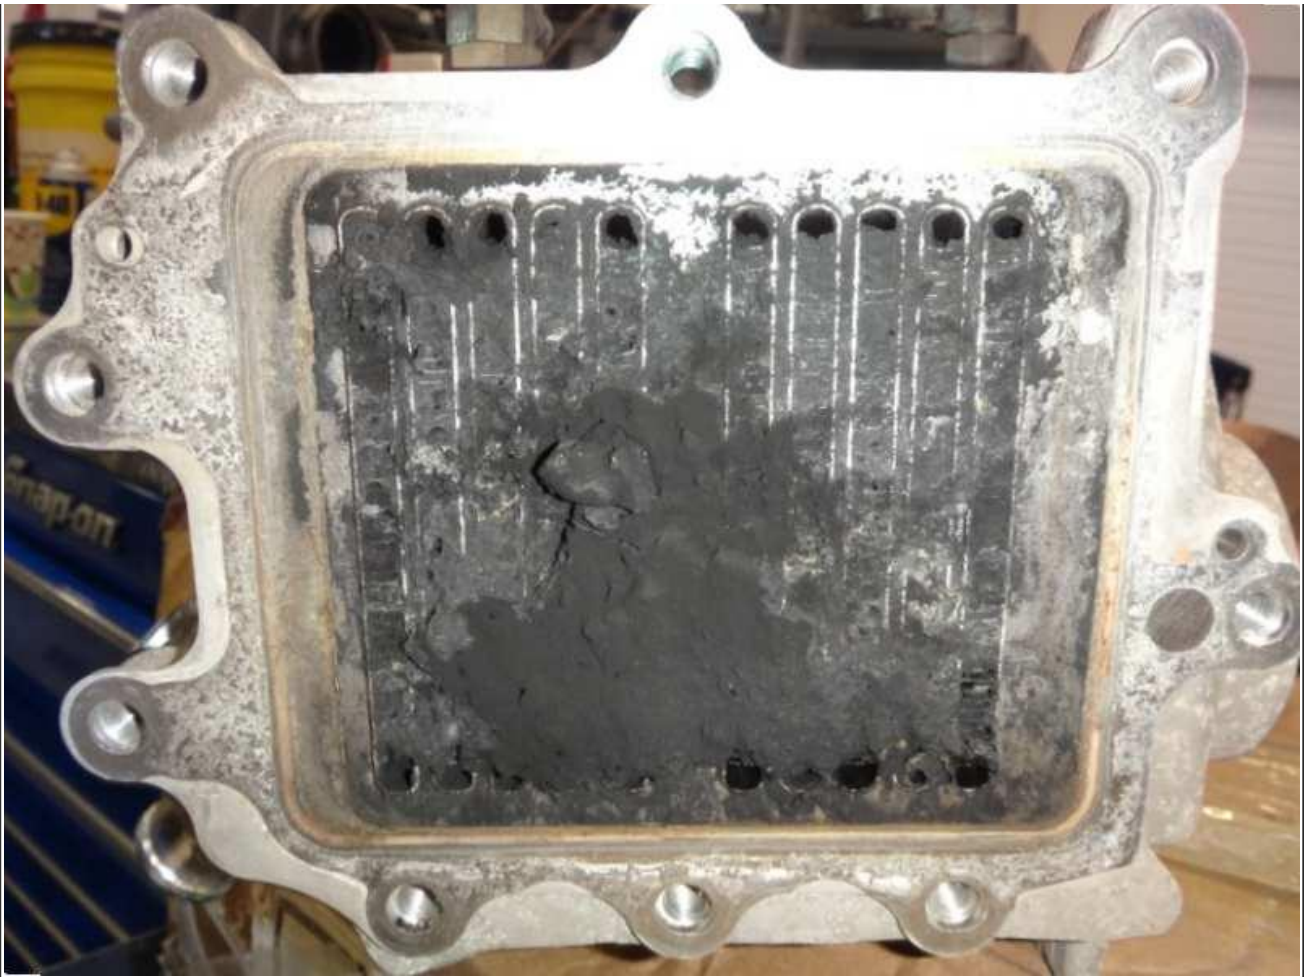
**Figure 12: Soot Build-Up on the Core Face**

Significant build-up will not allow the tool to sit against the core.

27. If necessary, scrape off soot build-up on the outlet of the core. The plate must sit flat against the face.

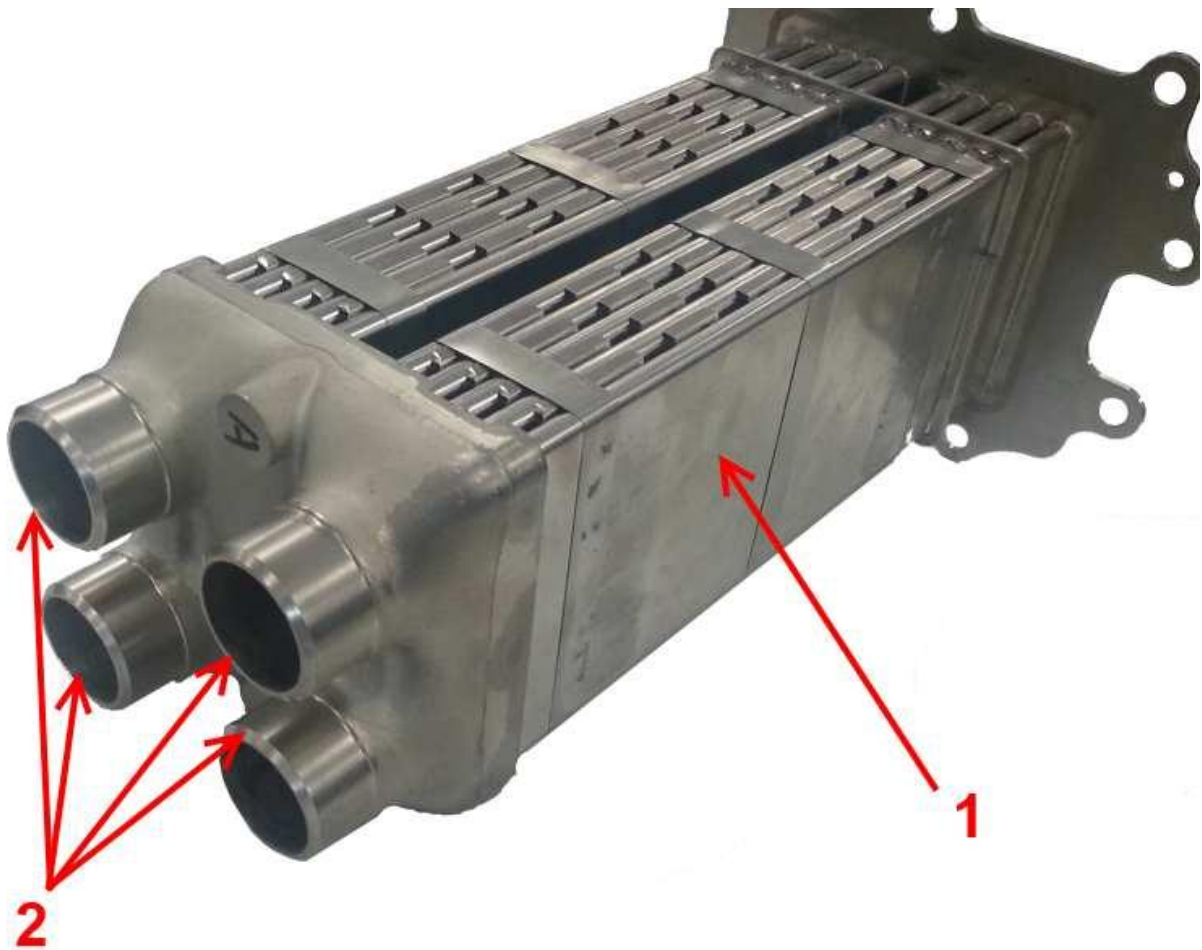
**Figure 16: Low Temp Cooler Inlet Manifold**

Item 1: Low Temp EGR Cooler Core

Item 2: Inlet Manifold Ports

3. Use P-80 to lubricate the LT core inlet manifold and the four o-rings in the LT housing.
4. Insert the core into the housing and maneuver it into the o-rings.

The core header plate must be less than a 1/2" from the housing face (core resting in o-rings) before driving the core in. Failure to comply will result in damage to the core, housing and tool.

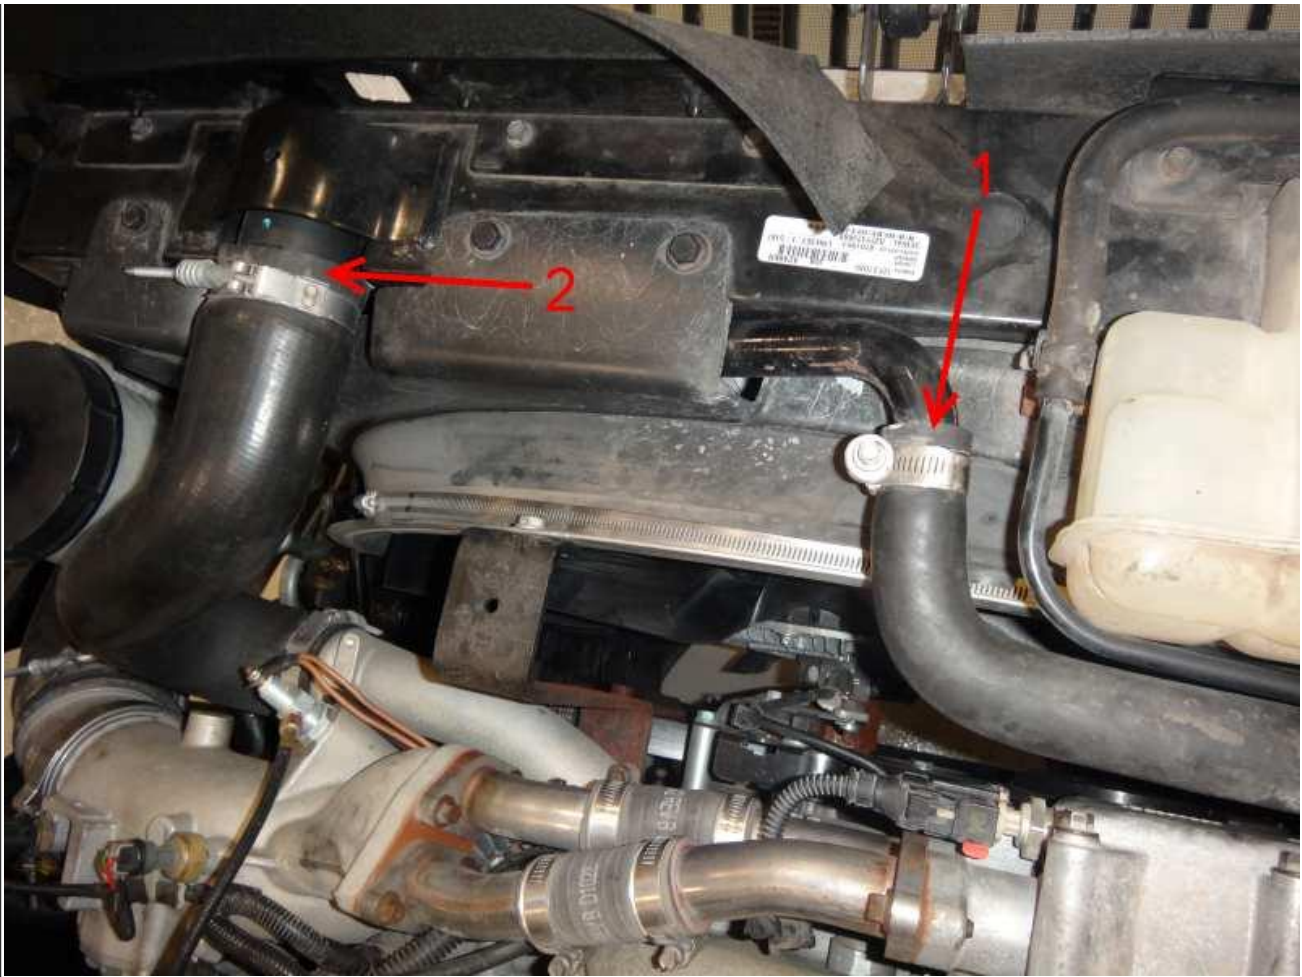
**Figure 27: Dearation Tank Assembly**

Item 1: Low Temp Radiator Hose

Item 2: Radiator Hose

24. Attach the radiator hose and tighten the clamp.
25. Attach the LTR hose and tighten the clamp.
