Spare Parts Requirements for Rear Cardan Shaft: Checking Heat Shield (14/15)

Model Line: **Panamera**

Model Year: **As of 2010 up to 2013**

Concerns: **Heat shield** (also referred to as tunnel heat shield)

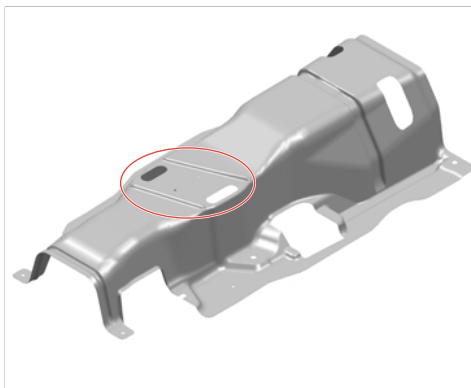
Figure 1

- old type: **without** cover on assembly bores (⇒ *Figure 1*)

Replace heat shield, see ⇒ *Workshop Manual '393519 Removing and installing rear cardan shaft'*

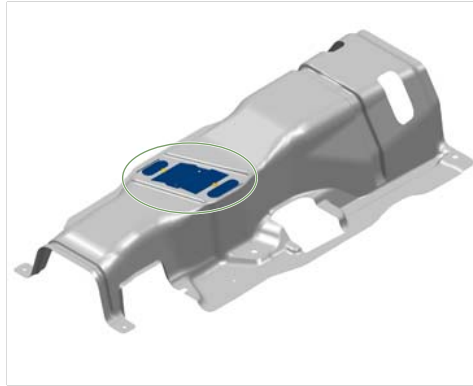
Figure 2

- new type: **with** cover on assembly bores (⇒ *Figure 2*)
