# Technical Service Bulletin

## 46 Q5 squealing from front brakes, 2.0T, & 3.2L (PR-1LA)

46 15 12 2033102/5 June 29, 2015. Supersedes Technical Service Bulletin Group 46 number 14-90 dated July 21, 2014 for reasons listed below.

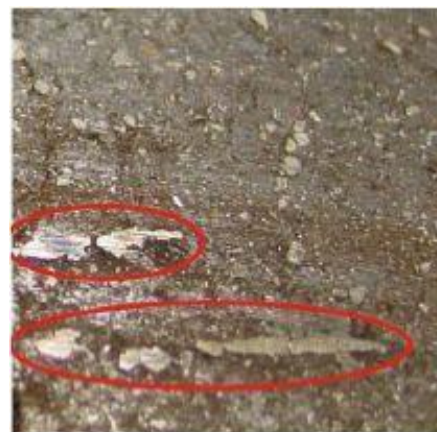
Figure 1. Metallic deposits.

1. Front brake discs or brake pads are close to their wear limit (disc wear limit: 28 mm and pads wear limit with backing plate and dampening late: 10 mm).
2. Foreign objects between brake disc and brake pad, such as small stones, grit, rust build-up, or sand.
3. Un-ground or corroded friction materials.
4. Metallic deposits from disc material in brake pad (Figure 1).

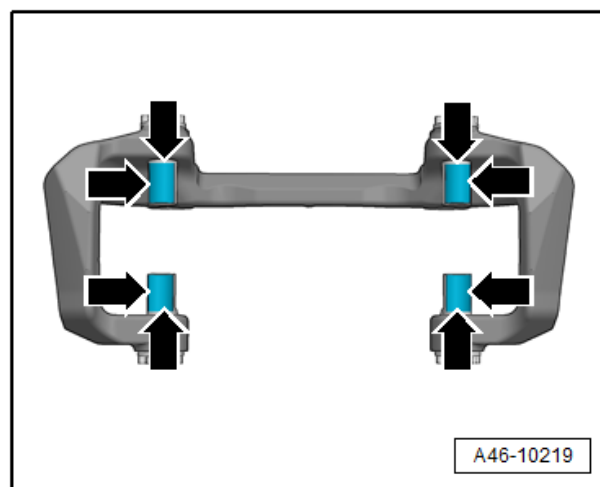
**Figure 2.** Caliper carrier guide pins with anti-seize (G 052560A2) lubricant applied where the pads make contact.

1. Apply a thin coat of anti-seize (G 052560A2) lubricant to the guide pins of the caliper carrier prior to installing the brake pads (Figure 2).
