Tech Tips

TT 27-13-01

2005-2015 Beetle, Beetle Convertible, CC, Eos, Golf/GTI, Jetta, Jetta Sportwagen, Passat, Tiguan – Generator Charging Concern Diagnosis Tip - One Way Clutch Pulley Testing

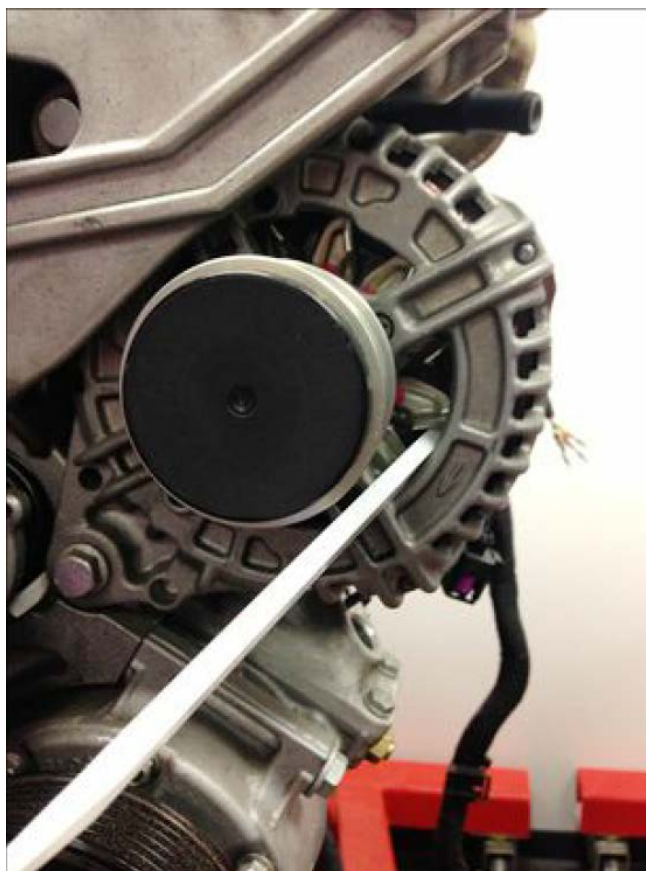
When diagnosing a generator charging concern, it is recommended to verify operation of the one way clutch located in the generator pulley (if equipped) before replacing generator assembly. To check the one way clutch, remove the belt from the generator pulley and use a trim removal tool to hold fan blades inside generator, as shown below. When attempting to turn pulley by hand with fan blades held, pulley should spin freely in only one direction. If pulley spins freely in both directions, the one way clutch has failed and should be replaced before continuing diagnosis.
