Technical Bulletin

53 15 01 April 29, 2015 2040536

Rear Quarter Panel Corrosion (U.S. Only)

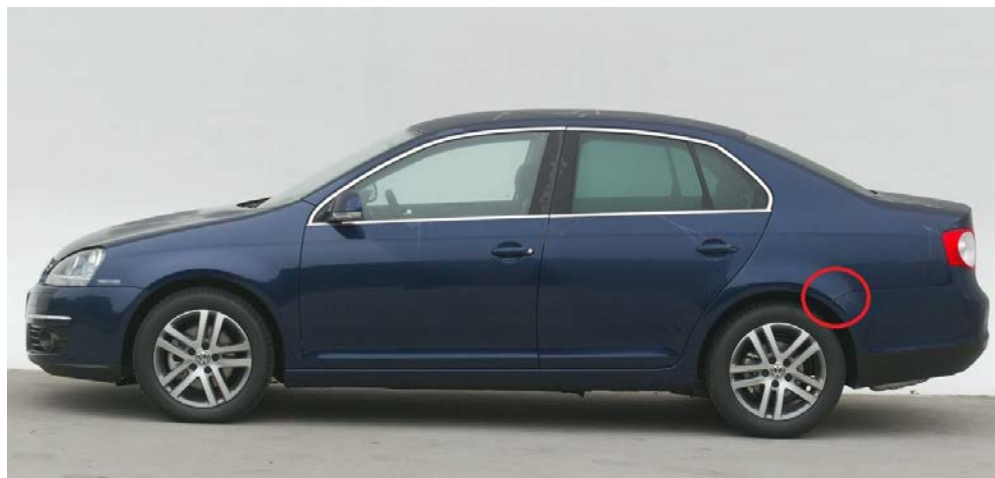
Figure 1

Corrosion is found where the rear bumper cover meets the quarter panel.

1a. Repair rear quarter panel.

1b. Replace rear quarter panel (Only if through-corrosion is present or if the repair cost is 80% or more of the replacement cost).

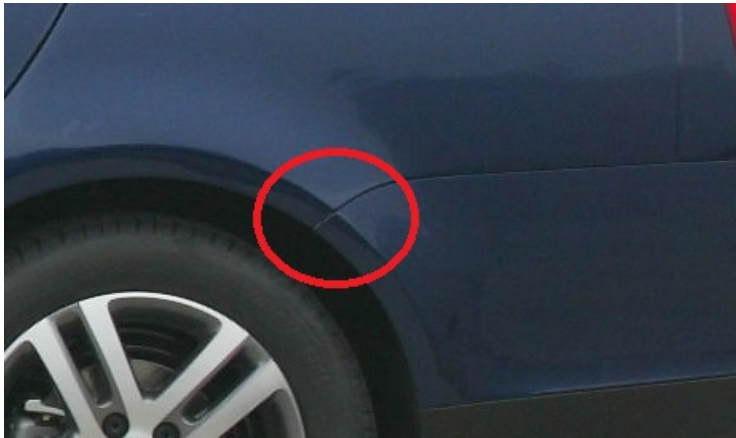
Figure 2

A Speed nut is used to assemble the rear bumper cover to the rear quarter panel. Relative movement between this metal speed nut and the quarter panel scratches away the paint and/or the corrosion protection (Figure 2).

2. Replace the speed nut (N 906 988 03) on the bumper cover (both sides).

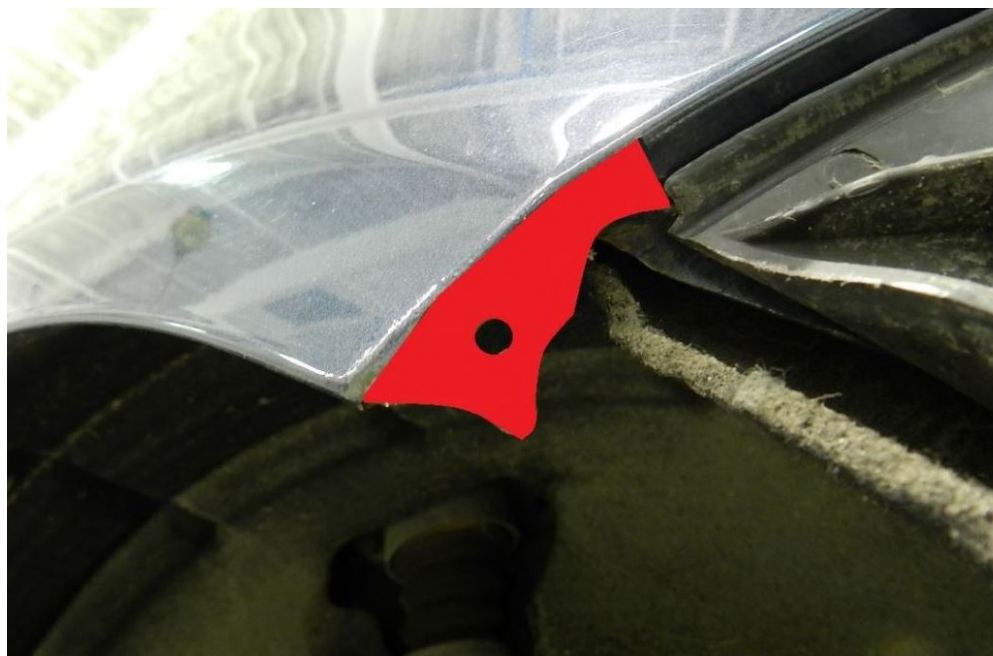
3. Apply the paint protection film (AKL 448 300 04) to the contact area of the quarter panel as shown in Figure 3 (both sides).
