Technical Bulletin

87 15 05 June 3, 2015 2040811

Vibration or Rattling Noise from Front End or Dash Panel while Driving (PR No.: 9M3)

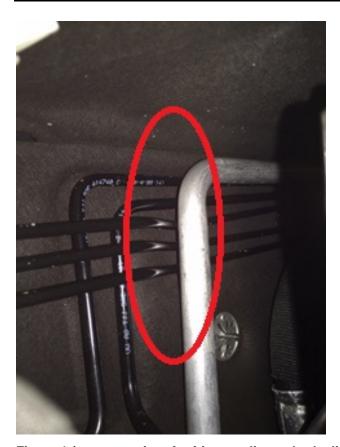
The refrigerant line from the compressor to the condenser of the heat pump has a contact point to the brake line in the area of the plenum chamber partition panel (Figure 1, red ellipse). As a result, the working noise of the air conditioning compressor is transmitted into the vehicle interior.

Figure 1 (contact point of refrigerant line to brake line)

• Install the vibration damper (part number 03L 130 118) on the lower brake line in the area of the contact point to the refrigerant line (Figure 2, red arrow).

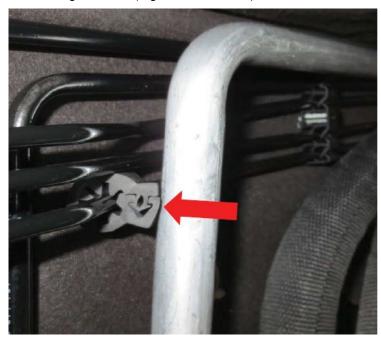
Figure 2 (example of brake line with vibration damper installed)
