Special Bulletin

SP15-335A

POWER STEERING HOSE REPLACEMENT

Prevost vehicles

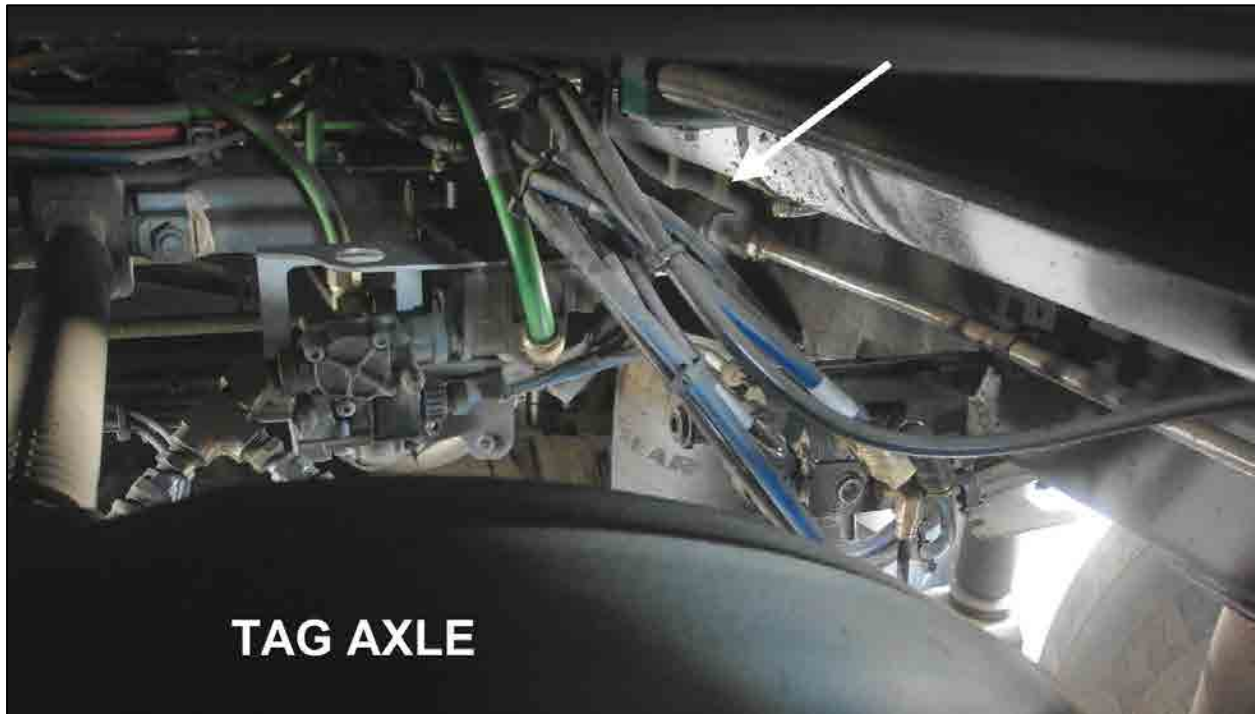
Figure 1

1. Prepare a suitable container and absorbent medium for hydraulic oil.
2. Locate the power steering hose above drive axle, curb side,. It is connected to a steel tube. (Fig. 1)
Loosen the hose fitting while supporting the steel line fitting with a wrench. Collect any oil dripping.

12. Connection above rear axles (Fig. 1).

- a. Inspect sealing surfaces. Clean and dry fitting threads.

- b. Hand-tighten.

- c. Tighten fitting with 7/8" open wrench to **1 1/2 FFWR or 42 lbf-ft (dry)** while holding the mating fitting with a wrench.

- d. Apply a torque seal mark across mating fittings.

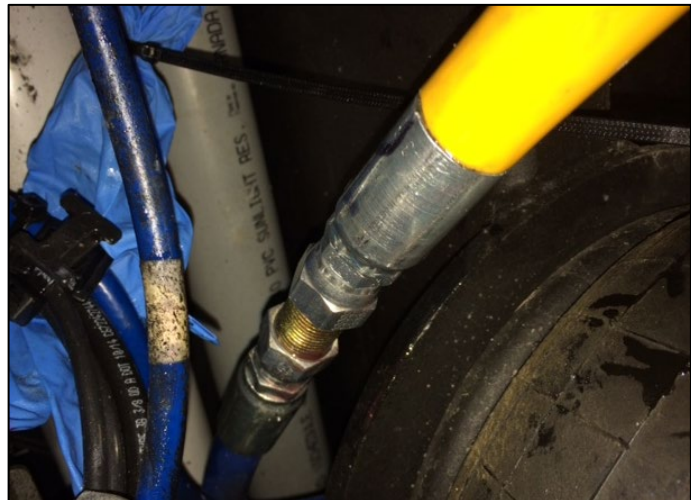
Figure 2

3. Join the old and new hose #161335P together with a #8 brass union fitting. (Fig. 2)

This will help guide the new hose into position while removing the old hose.

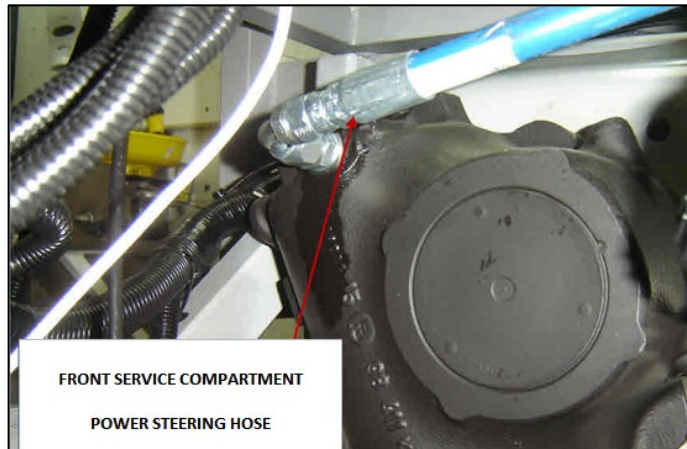
Figure 3

4. In front service compartment, locate the straight fitting on the upper hose. (Fig. 3)

Loosen the hose fitting while supporting the steering gear fitting with a wrench. Collect any oil dripping.

11. Steering gear connection.

- a. Inspect sealing surfaces. Clean and dry fitting threads.

- b. Hand-tighten.

- c. Tighten fitting with 7/8" open wrench to **1 1/2 Flats From Wrench Resistance FFWR¹ or 42 lbf-ft (dry)** while holding the mating fitting with a wrench.

- d. Apply a torque seal mark across mating fittings.

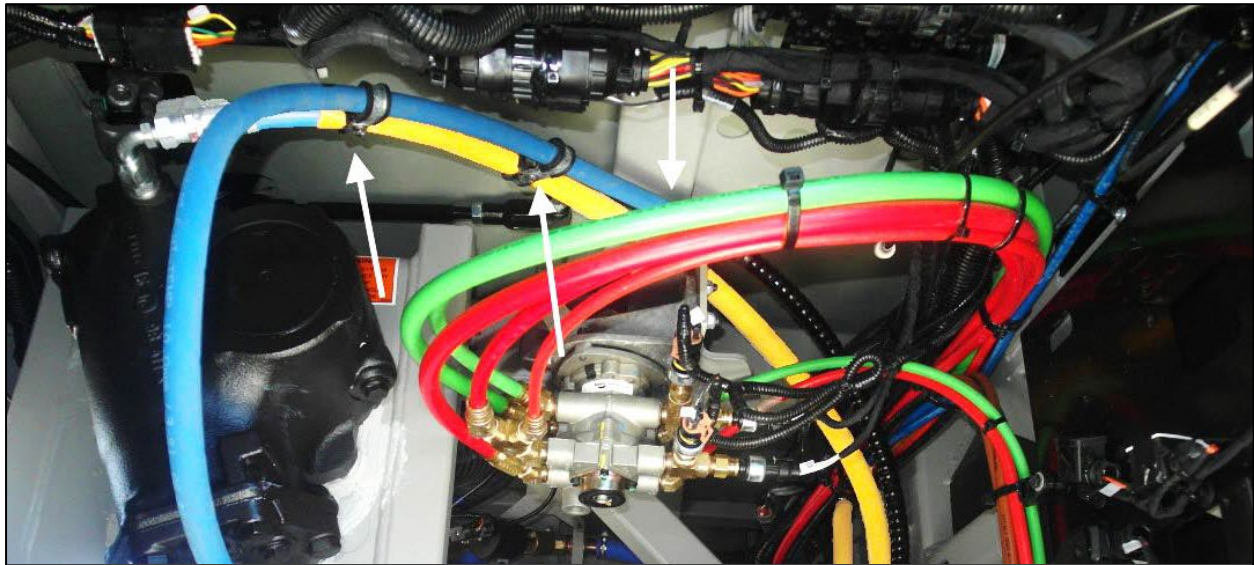
From the spare tire compartment, the following hose routing hardware is accessible: three (3) P-clamps (Fig 4), three (3) hose guides (Fig. 5) and one (1) block clamp (Fig. 6)

Figure 4: P-clamps in front service compartment.

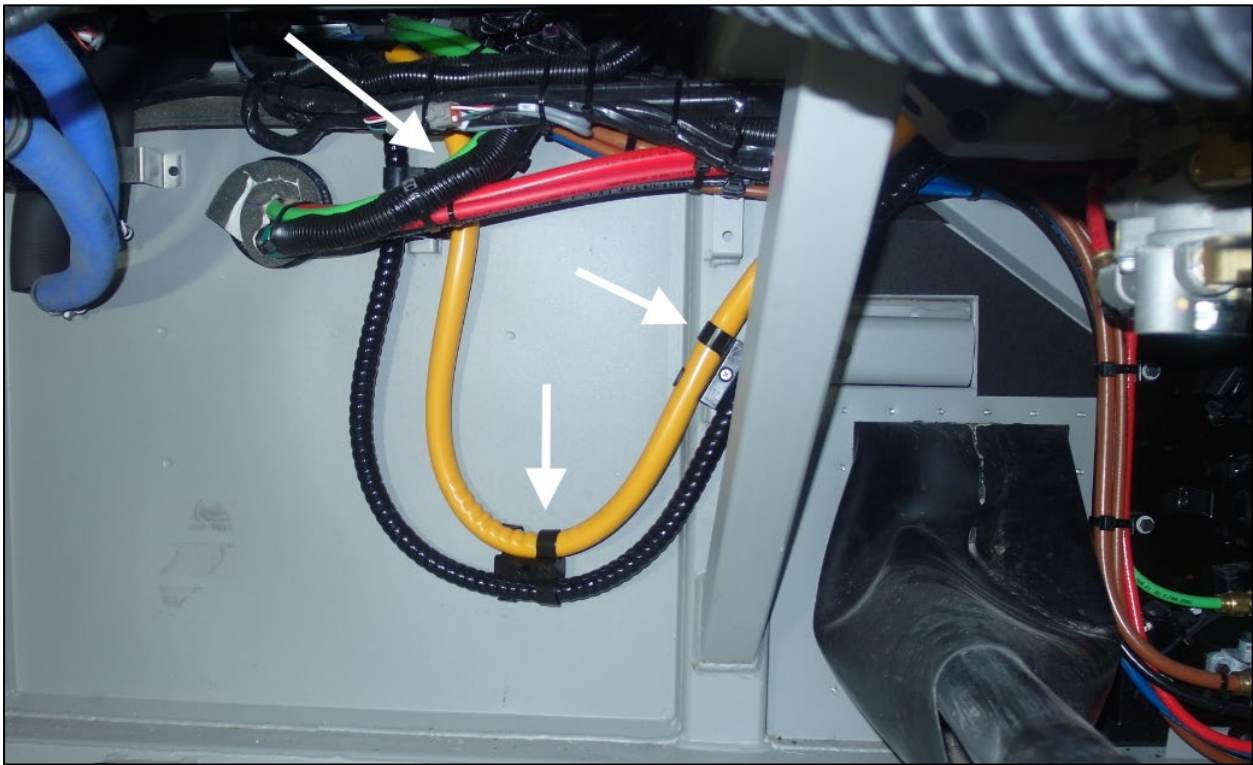
Figure 5: Hose guides on fore wall of front axle well

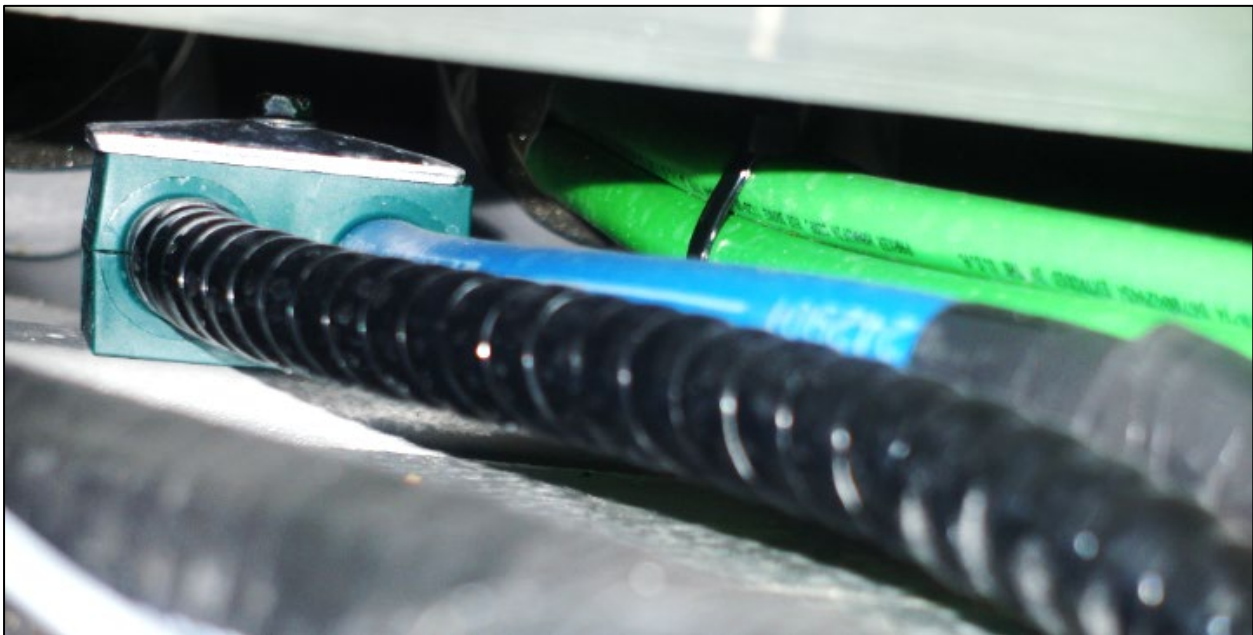
Figure 6: Block clamp in the tunnel leading to the first luggage bay.

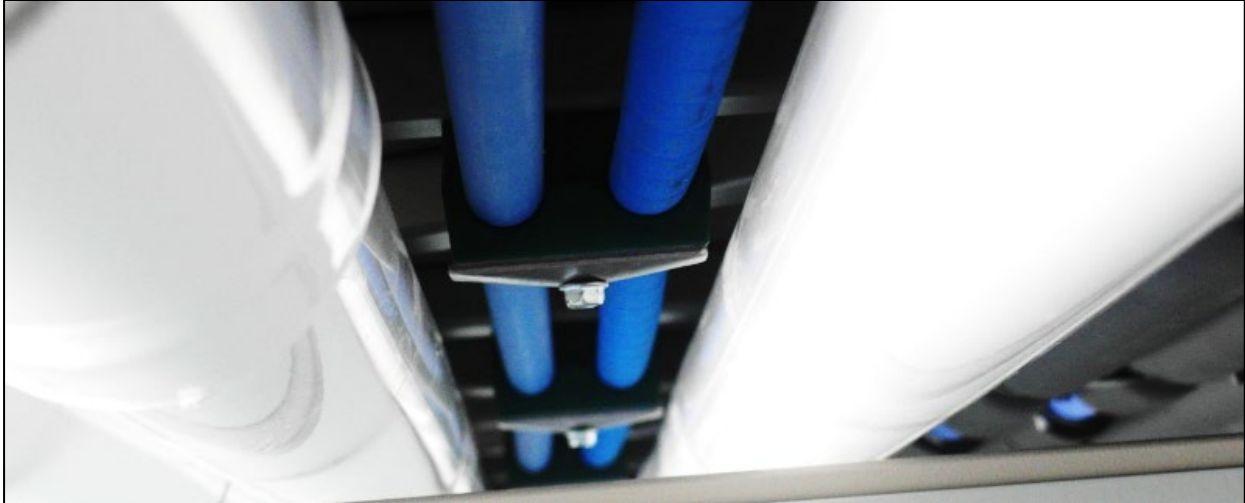
6. Remove the nine (9) block clamps on the luggage bay ceiling. (Fig. 7)

Figure 7: Inside Luggage bays

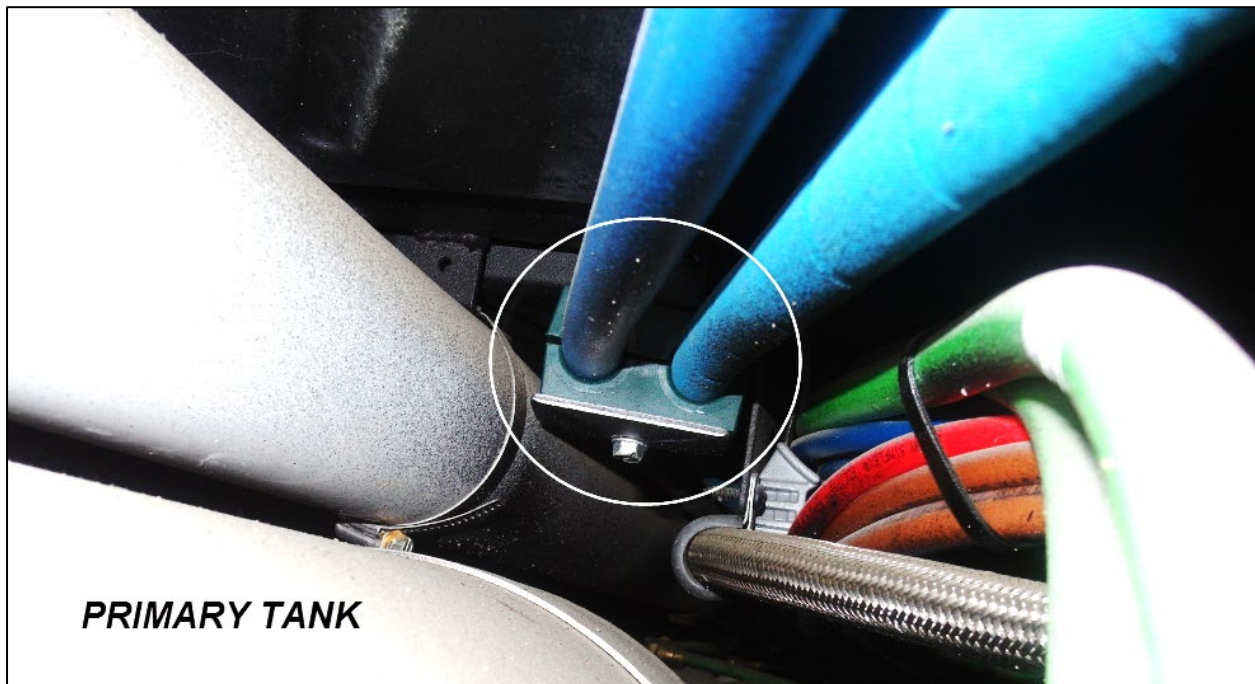
7. Remove three (3) block clamps accessed from above drive axle. (Fig. 8)

Figure 8: Above Primary Tank Looking Towards the Rear.

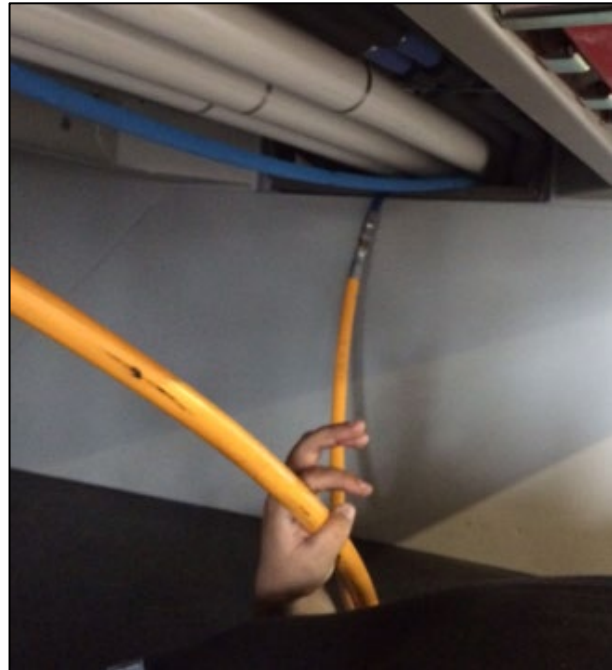
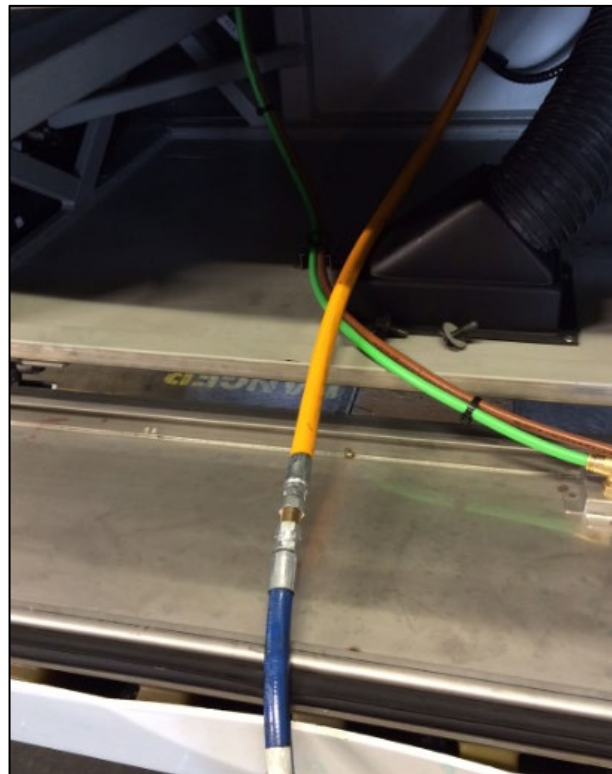
9. Still from the first luggage bay, assist a colleague by guiding the new hose into the spare tire compartment while he continues removing the existing hose. (Fig. 9, 10)
