Service Bulletin

Subject: Information Regarding the Modifying or Removing of Underbody Brace for Exhaust Modifications

Brand:	Model:	Model Year:		VIN:		Engine:	Transmission:
		from	to	from	to		
Chevrolet	SS	2014	2016			All	All

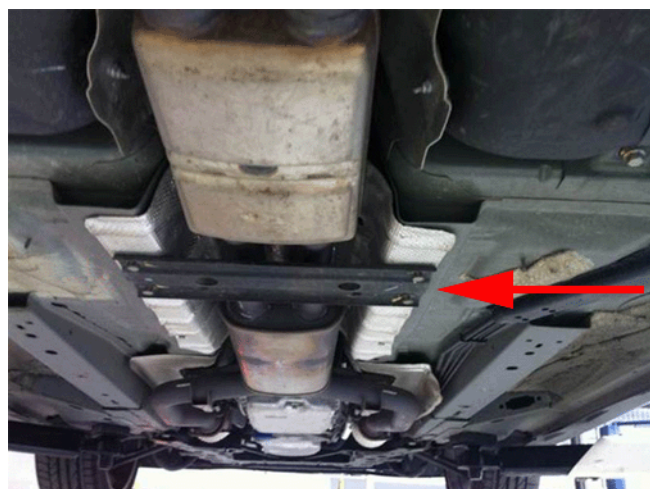
GM does not support permanent removal or modification of the brace as it would result in degradation of the side impact and N&V performances of the vehicle. The reason why the underbody brace cannot be permanently removed is because it is a critical part of the vehicle structure. It has been designed primarily as a main load path for side impact scenarios. In addition, this part improves the overall vehicle body torsional stiffness.
