**Front Hood Upper Latch Fine Adjustment**

Vehicle Type: **Macan**

Model Year: **2014 to present**

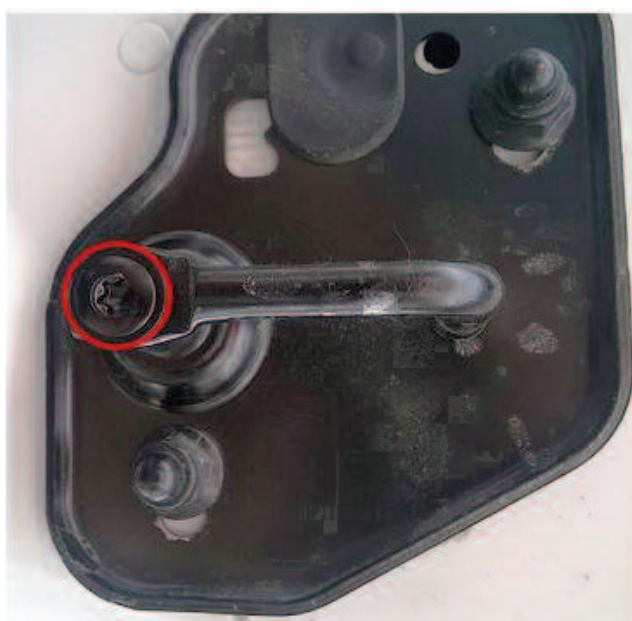
A fine adjustment to change the depth of the upper latch striker may be made at the bolt shown in the photo above.

This is a useful adjustment for front latch issues that cause a warning in the instrument cluster for the front hood being open as well as fine tuning the closed height of the hood.

Information: The upper front hood latches have a fine adjustment not mentioned in the workshop manual.
