Service Information Bulletin

SUBJECT	DATE
Oil Breather Vent	September 2015

2 Oil Breather Vent

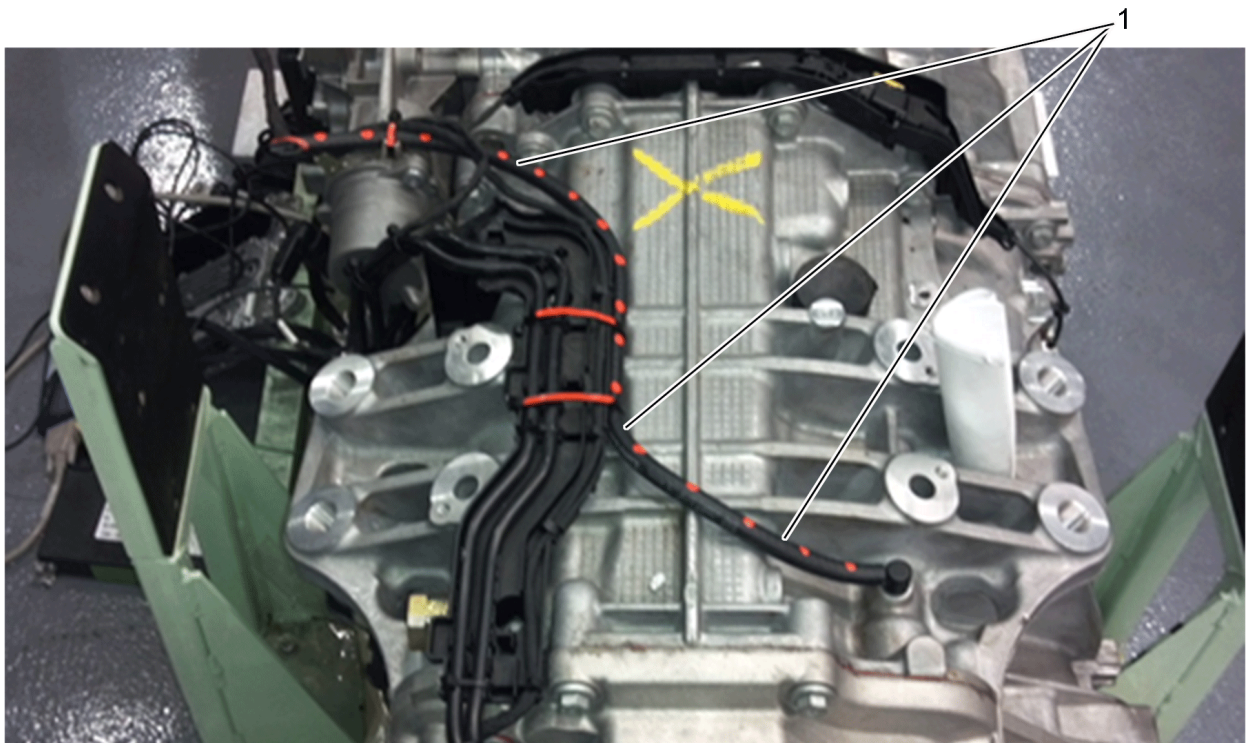
d260072

On DT12 DA/OA (large box) transmissions, oil may push out of the breather vent on top of the transmission and run around the outside of the housing to the rear bottom of the transmission. A plastic hose was added to the oil breather vent with approximate transmission serial number 1402497 (last seven digits). However, it is still possible for the plastic hose to leak if the seal to the breather vent fitting is not tight. The oil breather vent and hose were relocated to the left side of the transmission to further reduce the chance of oil leaks with approximate transmission serial number 1614270 (last seven digits).

To repair units with no oil breather vent hose, or a plastic hose on the right side of the transmission, install a ¼" ID hose of a suitable rubber material that is approximately 368 mm (14.5 in.) in length. Run the hose over the top of the transmission to left side front. The hose should end on the left side of the transmission at the AMT module. Secure with zip ties at the three indicated positions (1).
