# VW Elsa Newsletter

Edition 139: June 8, 2015

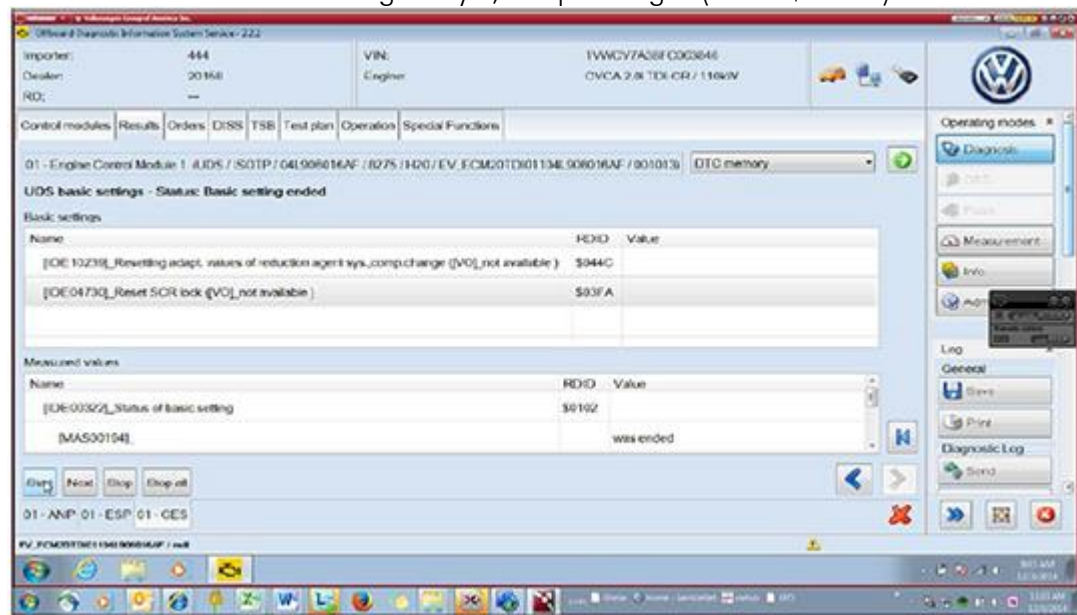
### 26-15-04 Selective Catalytic Reduction (SCR) System Repairs and AdBlue® Light Reset Procedure

The adaptation value in the Engine Control Module (ECM), must be adapted with the Vehicle Diagnostic Tester whenever the reducing agent is drained or one of the following components listed below is replaced:

- Reducing agent tank
- Reducing agent pump
- Reducing agent injector
  - Reducing agent line
- Engine control module

Go to control module OBD / Select basic settings / Select Resetting adapt. Values of reduction agent sys.,comp.change. (RDID \$044C).
