# Technical Service Bulletin

## 01 MIL on and/or oil pressure warning on (DTC P164D00)

01 15 30 2041093/2 July 10, 2015. Supersedes Technical Service Bulletin Group 01 number 15-27 dated June 30, 2015 for reasons listed below.

Model(s)	Year	VIN Range	Vehicle-Specific Equipment
A6, A7	2016	All	3.0 TFSI EVO
A8	2015 - 2016	All	3.0 TFSI EVO

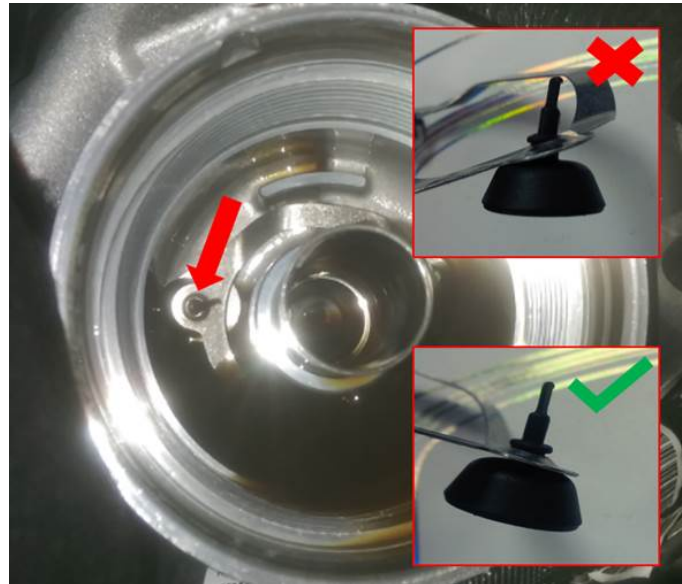
Rubber oil drain plug within the oil filter housing is out of position.

**Figure 1.** Correct and incorrect position of the oil drain plug.

- **If oil pressure is below 1.3 bar:**  
Open the oil filter housing to check the rubber oil drain plug. If the plug is not positioned correctly in the spring (Figure 1), replace the plug.
- **If oil pressure is above 1.3 bar:**  
Replace the low pressure oil pressure sensor F378 (Figure 2).

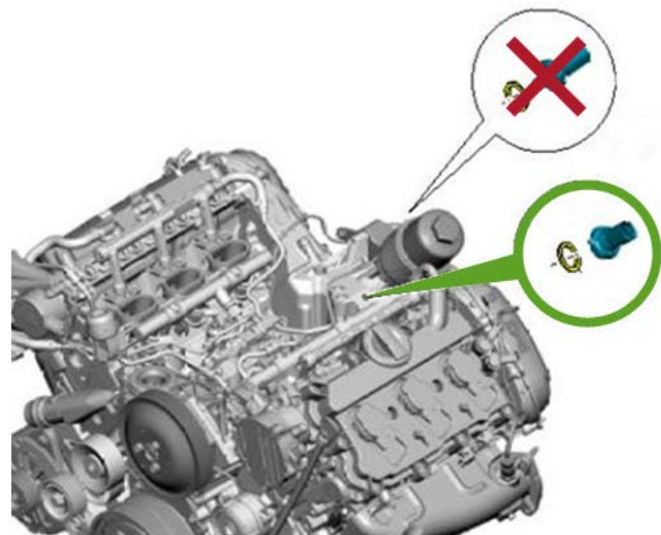
**Figure 2.** The low pressure oil pressure sensor F378 (circled in green) is located underneath the supercharger.
