Technical Service Bulletin

57 Trunk cannot be unlocked

57 15 12 2028207/2 August 13, 2015. Supersedes Technical Service Bulletin Group 57 number 12-62 dated January 9, 2012 for reasons listed below.

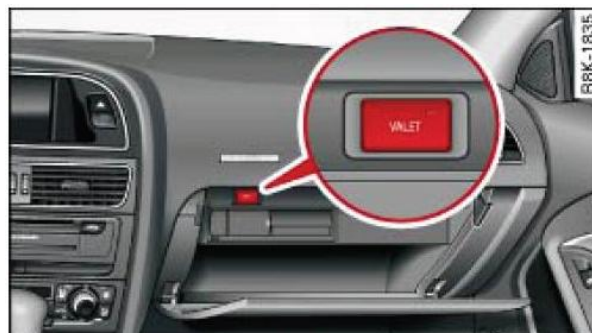
The trunk cannot be unlocked with the button on the remote, with the button in the driver's door panel, or with the handle on the lid of the trunk.

Vehicles have a "VALET" button in the glove box (Figure 1) that activates the valet parking feature, which prevents unauthorized access to the trunk. When the valet parking feature is activated, the trunk can only be opened mechanically with the key.

Figure 1. Valet button in glove box.

Check whether the “VALET” button in the glove box has been activated, and deactivate it if necessary.
