Release 0: Original release

HALDEX CONSEP VOLTAGE  
Prevost vehicles

## DESCRIPTION

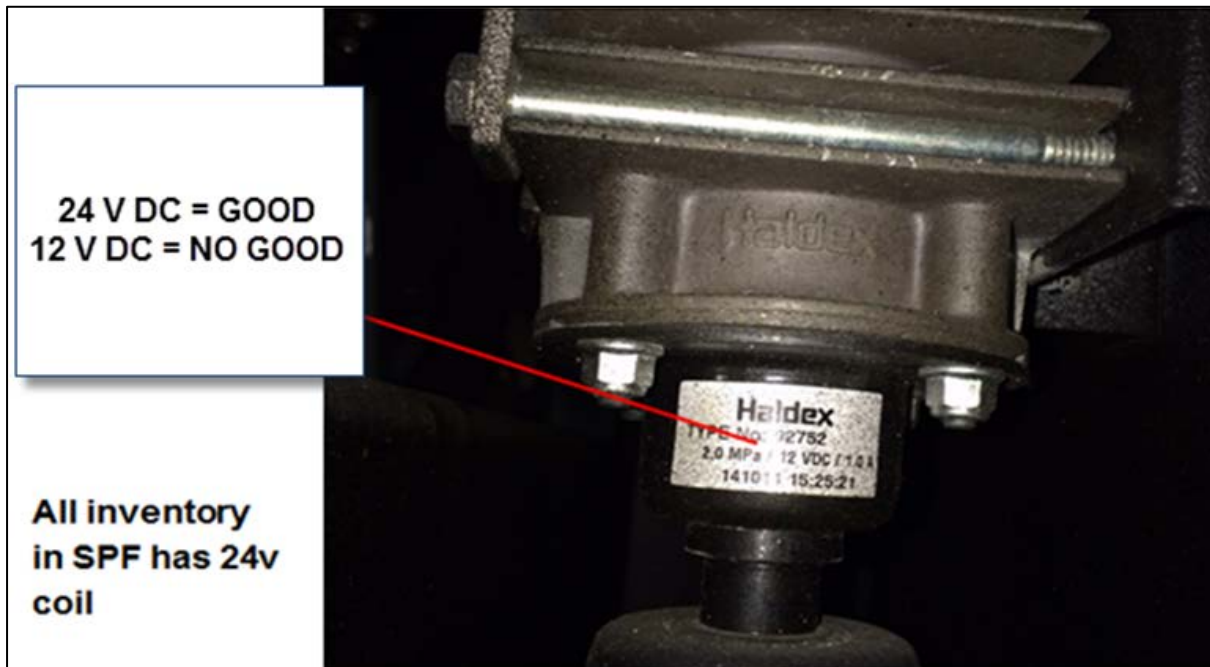
On the vehicles affected by this bulletin, the voltage rating of the condenser / separator coil may be inappropriate for our application. Our application is 24V.

- 1) Inspect the identification plate on the Haldex condenser – separator.
- 2) If the ID plate indicates 12 VDC, replace with a new part #649940. Make sure the new part is rated 24 VDC.
