## Panoramic roof roller blind noisy or tangled

| Topic number | LI77.21-P-061134 |
| Design group | 77.21 Panoramic roof |
| Validity | MODEL 117 up to VIN end no. N 115 718 with code 413 (Panoramic roof) |

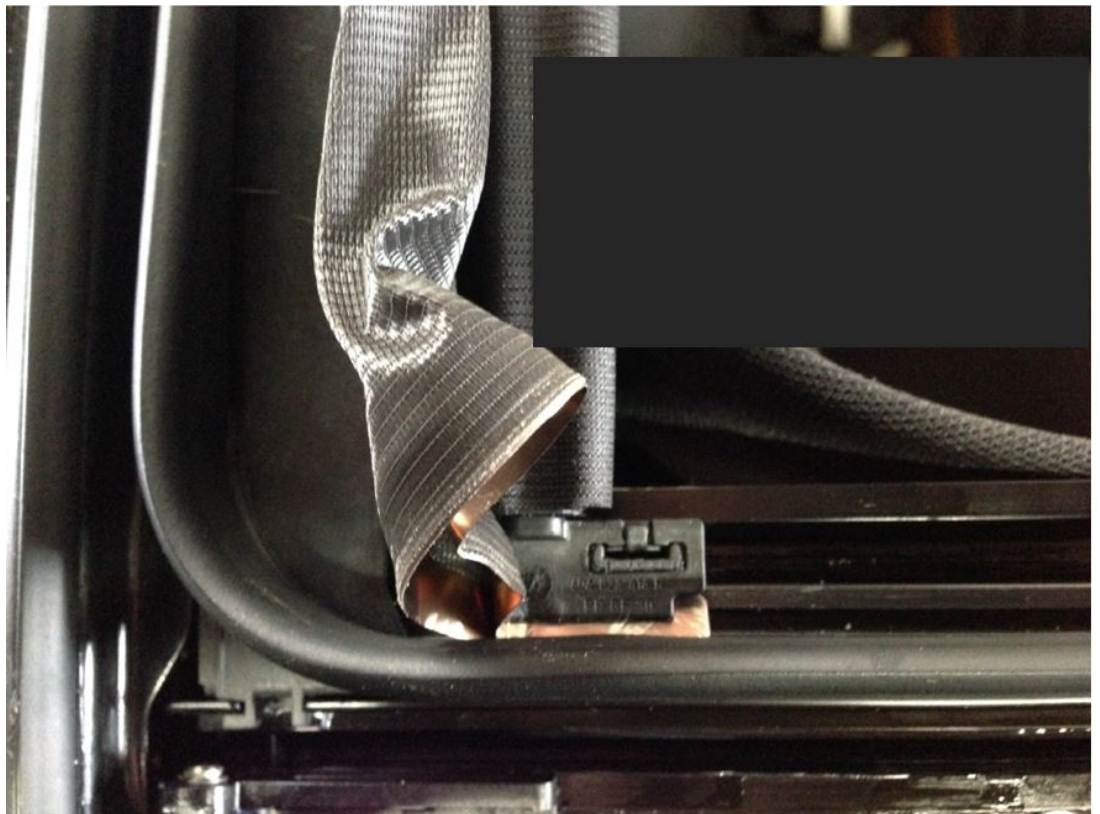
Bild 1.JPG:

- 1) Roller blind of panoramic roof tangled, see Figure 1.
- 2) Roller blind makes noises when extending and retracting.

1) Due to incorrect installation of the steel strip or unfavorable tolerances (crooked bows, roller blind rail creeping forwards, etc.), the steel strip is not guided correctly into the roller blind rail when the roller blind is closed. The steel strip rides over the roller blind rail instead of into it. As a result, the steel strip of the roller blind cannot be rolled up when opening.

- 1) Replace panoramic roof roller blind.
- 2) Replace roller sun blind trim
- 3) Important: Also for vehicles up to VIN end no. N 055 574

Perform initial startup of roof control unit A98 in Xentry.

- To do this, select menu item "Diagnosis - Control unit - PSD - Panoramic roof control module - Sliding roof (A98)
- Adaptations - Initial startup".
