## Noises from rear-end door

Topic number	LI72.20-P-061209
Version	1
Design group	72.20 Rear door, tailgate
Date	04-01-2015
Validity	MODEL 463
Reason for change	
Reason for block

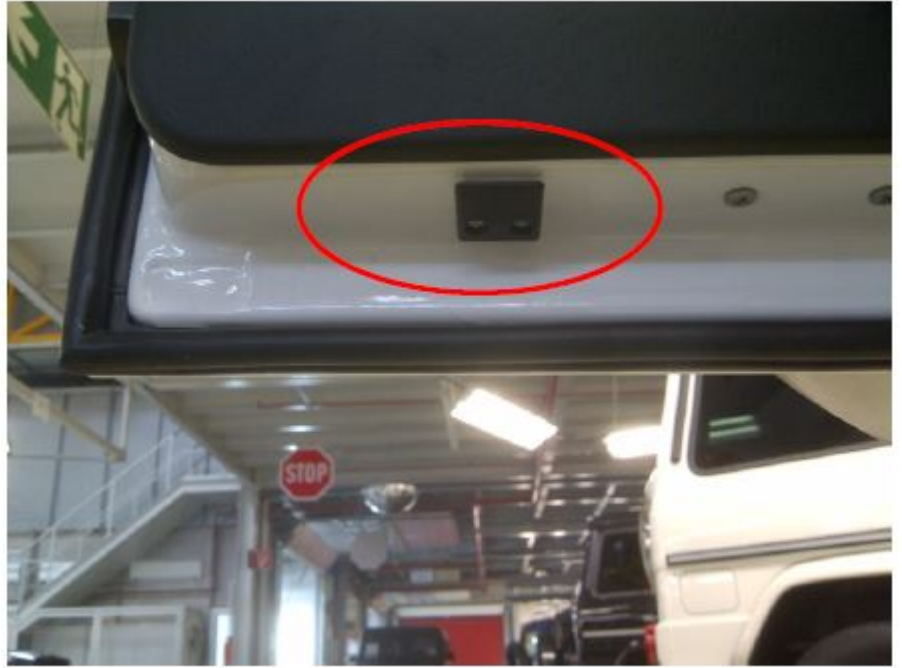
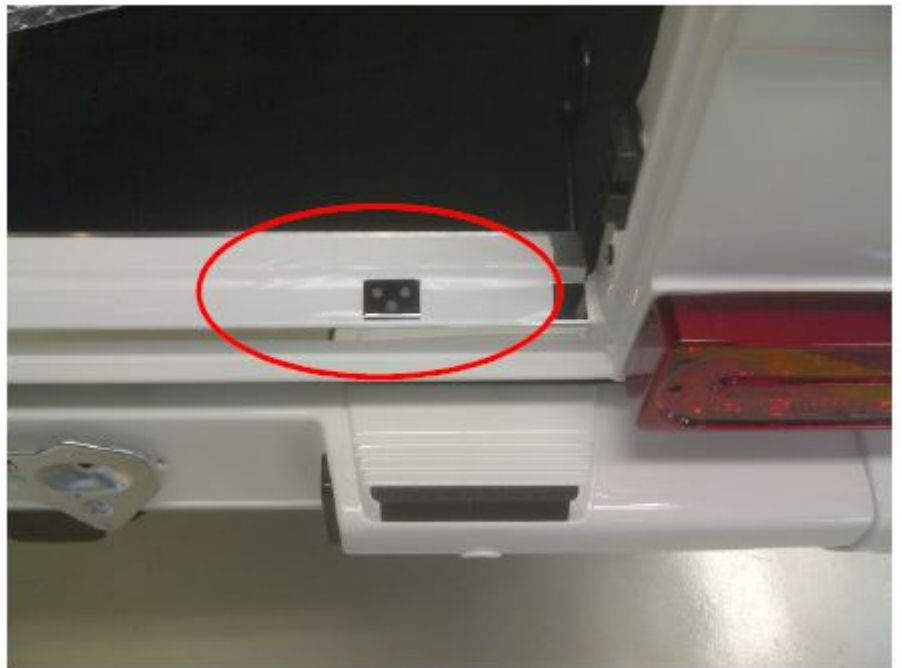
Auflaufkeil AMG.JPG:

Attachments	
File	Description
Auflaufkeil AMG.JPG	AMG retrofit solution: Rear-end door stop wedge

Correct door adjustment and retighten bolted connections.

As of VIN 223493 the AMG models also have a door stop wedge on the rear-end door. This can be retrofitted using the parts listed below.
