Service Bulletin

Subject: Information on Inside Rear View Mirror Loose

Models: 2013-2016 Buick Enclave
2014-2016 Buick LaCrosse, Regal
2013-2016 Cadillac SRX
2014-2016 Cadillac ATS, CTS (VIN Code A), XTS
2013-2016 Chevrolet Traverse
2014 Chevrolet Silverado 1500
2014-2016 Chevrolet Impala (VIN Code 1)
2015-2016 Chevrolet Silverado, Suburban, Tahoe
2013-2016 GMC Acadia
2014 GMC Sierra 1500
2015-2016 GMC Sierra, Yukon, Yukon XL

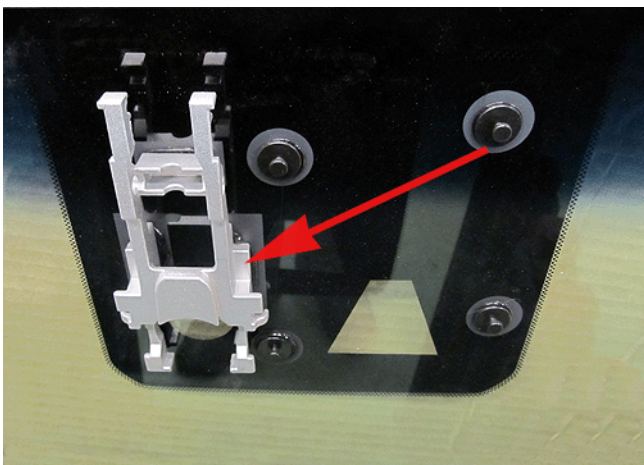
Some customers may comment that the inside rear view mirror is loose or that the mirror mounting bracket is loose or has fallen off.

If a vehicle is encountered with the above condition, **do not attempt to reinstall the bracket onto the windshield.** The above listed vehicles have a revised bracket design that is not serviceable. It is necessary to replace the windshield glass assembly. The bracket comes installed on the new glass assembly. Refer to Windshield Replacement in SI.
