# Service Bulletin

**Subject:** Transmitter/Fob Appearance After Integrated Blade Removed

**Models:** 2010-2015 Chevrolet Camaro

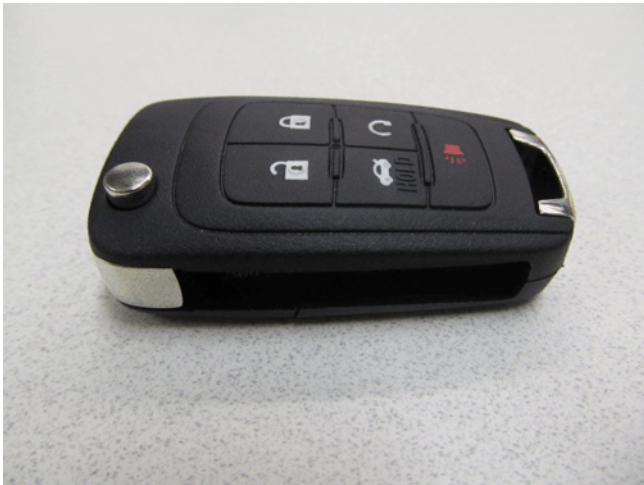
Some customers may comment on the appearance of the transmitter after the integrated blade has been removed.

2010-2014 Camaro

- This will occur after Recall #14294 has been performed.

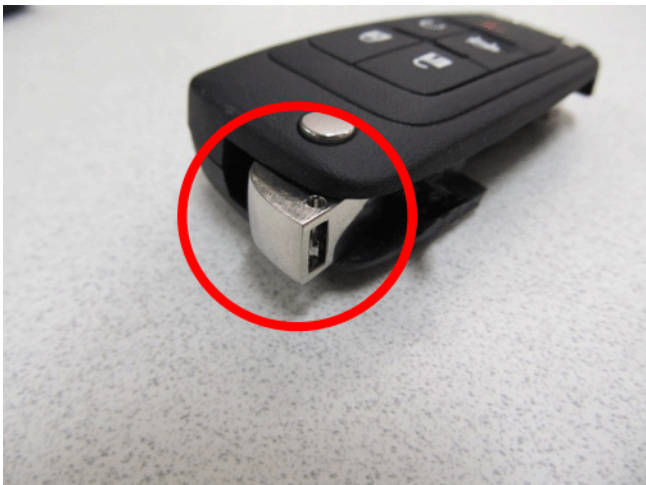
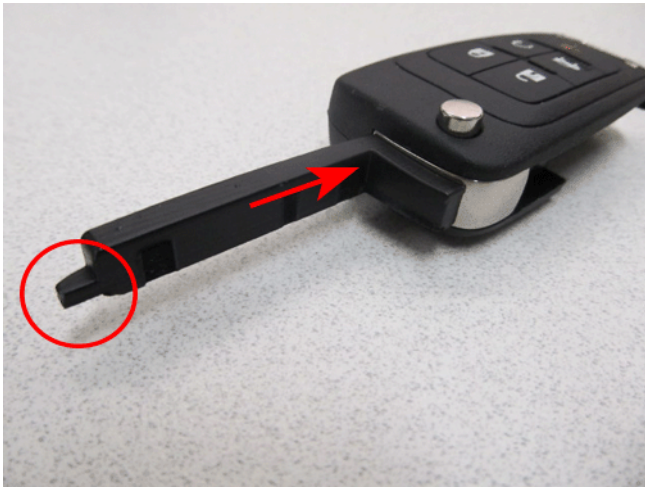
1. Locking Tab

**Note:** If the slot is not showing, press the release button to “flip” the chrome part over.

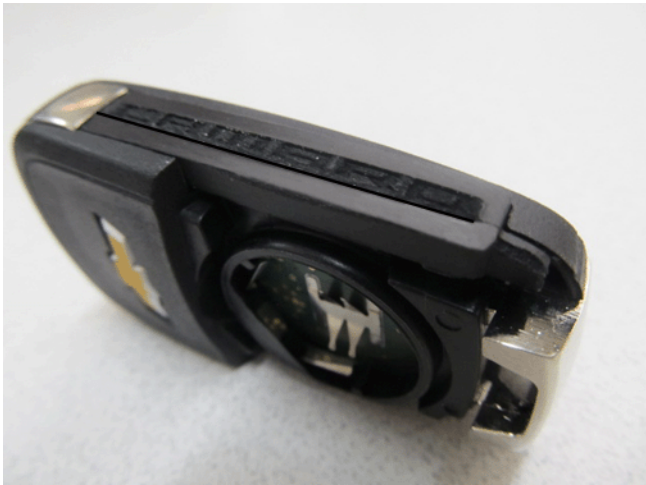
**Important:** Excessive force on the insert may crack the tab portion that is inserted into the slot.

3. Press and hold the button to “flip” the insert into the closed position and then release the button.

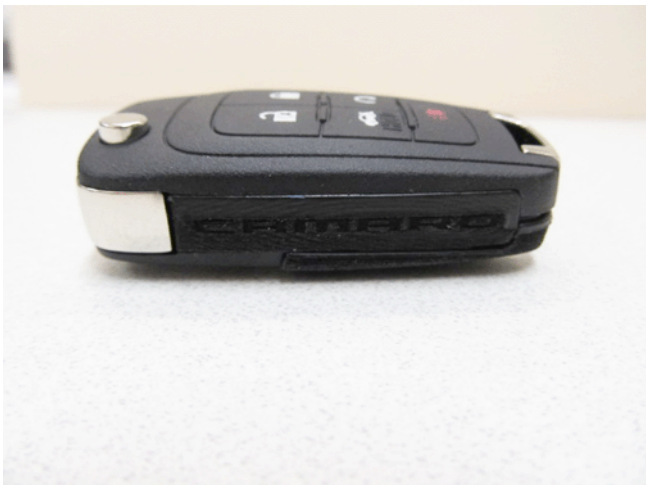
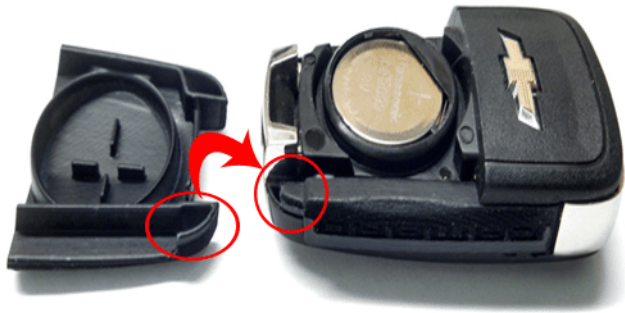
**Important:** Verify the positive “+” side of the battery is facing up.

4. Install the battery and new battery cover. Be sure the retention tab on the insert engages with the underside of the battery cover.
