Service Bulletin

Bulletin No.: PIT5363B

Subject: Click or Tick Noise Heard Inside Cab With Engine Running

Models: 2015 Chevrolet Colorado

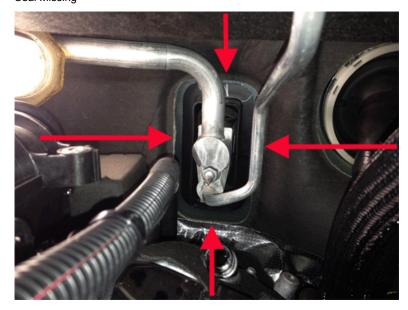
During vehicle build some my exists that an acoustic seal was knocked out of place during assembly. With this acoustic seal dislodged or missing the High Pressure Fuel pump tick / click noise can be heard easily inside the cab of the truck.

Seal Missing

If the seal is missing replace it with one from Kit Part Number 23135690. Reference the Blower Upper Case Replacement section of SI to assist with seal replacement.

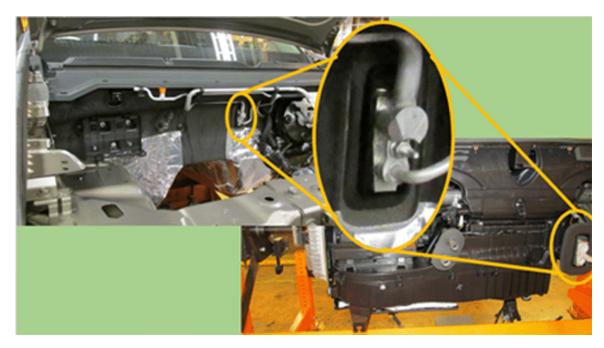
Seal Present
