Bulletin No.: PIT5313B

**Subject:** Paint Peeling Above Anti-Chip Area

Models: 2014 Chevrolet Silverado 1500

2014 GMC Sierra 1500

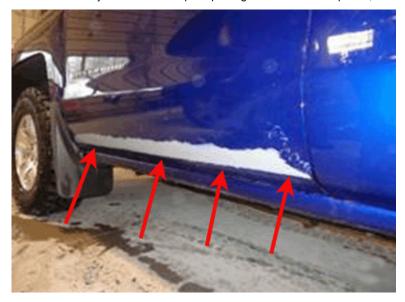
Some owners may comment of the paint peeling above the Anti-chip area, as shown below:

This test should only be conducted on a vehicle exhibiting this condition and performed above the Anti-Chip area. On a clean surface, at or above room temperature, firmly apply a 2" wide piece of masking tape to the body, and pull upward quickly. Do not use duct tape, cloth backed tape, or other aggressive tapes. If the paint flakes or peels away, the panel in question should be repaired.

Refinish the affected areas using the appropriate material supplied by the refinish material supplier being used by the repair facility for finish repairs.

Note: Only repaint the affected areas. Panels that pass the test described above should not be repaired.
