**Description of Revisions:** *This bulletin replaces the version dated March 2015. **Table 5** is added to provide part numbers for polyester tape.*

# 54-290 Guidelines for Repairing or Replacing an Electrical Harness

## Freightliner Service Bulletin

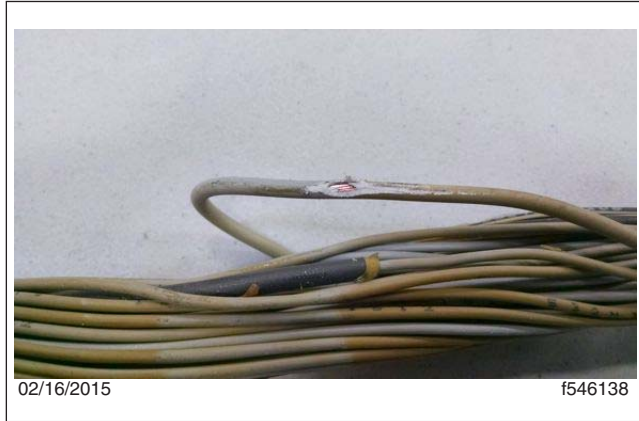
**Fig. 1, Worn Insulation, Major**

Wire Damage Quick Reference	
Description	Remedy
Kinked Wire	Repair
Melted Insulation, Major.	Replace
Melted Insulation, Minor	Repair
Worn or Missing Insulation. See <a href="#">Fig. 1</a> .	Repair
Discolored or Cracked Insulation, Major. See <a href="#">Fig. 2</a> .	Replace
Discolored or Cracked Insulation, Minor.	Repair
Datalink, Twisted Wire	Replace
NOTE: If only the terminals are damaged, the terminals can be replaced without replacing the twisted pair.	
Corrosion in the Wire*	Repair
Corrosion in the Connector	Repair
Failed Terminal Pair Drag Test	Replace Terminal
Molded Cable†	Replace

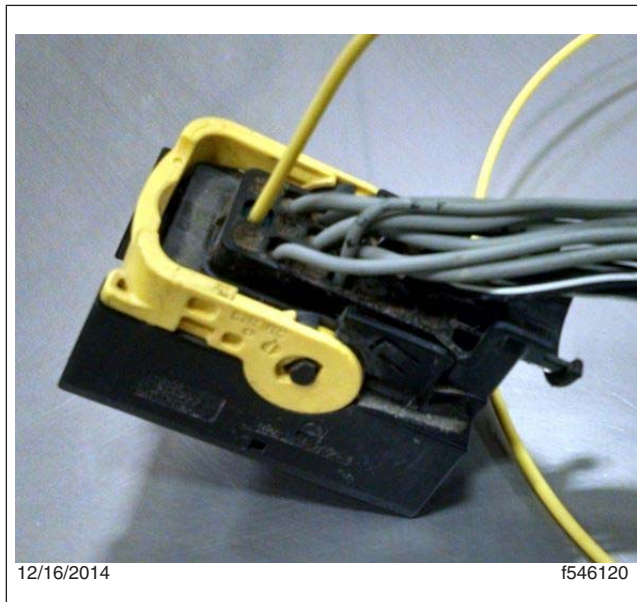
**Fig. 3, Terminal Inserted Into the Connector**

4. Insert the terminal into the connector. See [Fig. 3](#).

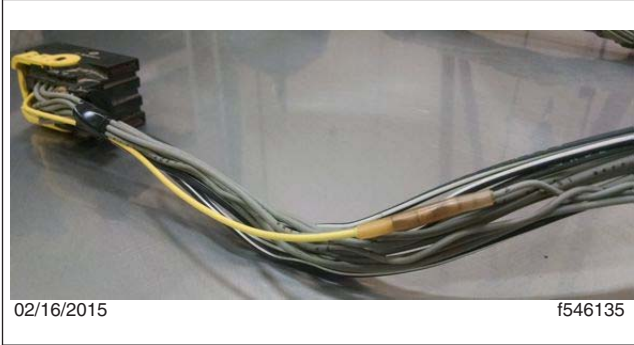
Fig. 5, Splicing the Wires

6. Splice the wires using a Daimler splice kit ESY E66 404, or Phillips STA-DRY® Crimp and Solder connector parts. See [Fig. 5](#). Refer to [Table 4](#) for a list of connector parts.

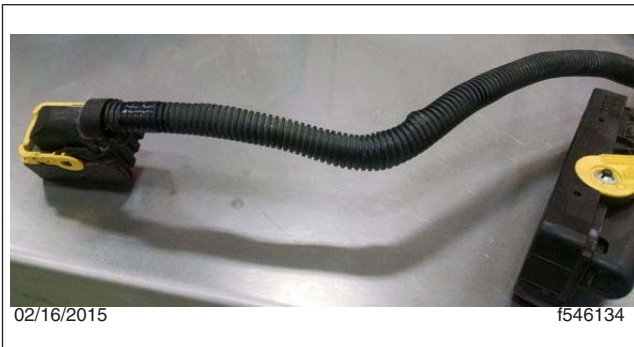
Fig. 7, Harness Wrapped with Convolute

8. Wrap the harness with convolute tubing. See [Fig. 7](#).

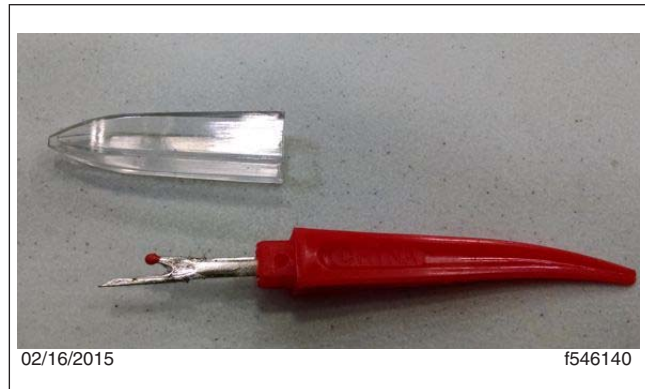
Fig. 8, Sewing Seam Ripper

**IMPORTANT:** Do not use a hook razor blade to cut fiber wrap. Use a sewing seam ripper to cut the fiber tape ( [Fig. 8](#) ), taking care not to cut the harness wires.

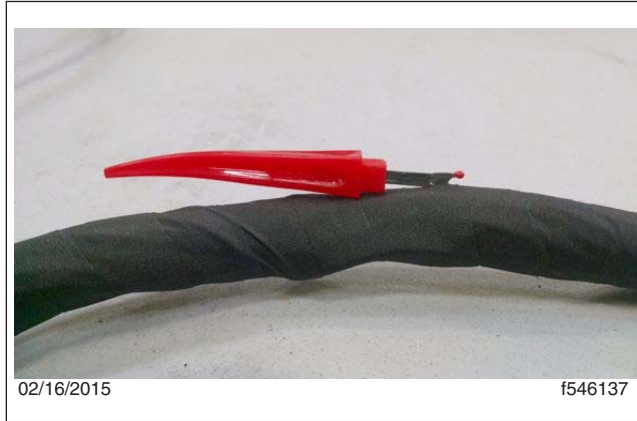
**Fig. 9, Cutting an Opening into the Fiber Wrap**

1. Locate damaged area and carefully make an opening in the fiber wrap using a sewing seam ripper. See [Fig. 9](#).
2. Flip the tool over so the blunt end is facing wiring, then cut enough length to allow the fiber to be unwrapped. See [Fig. 10](#).
3. Unwrap the fiber until a sufficient area is exposed to make the repair. See [Fig. 11](#).
4. If an overlay is necessary, remove just enough fiber to allow for a splice into the damaged wire. See [Fig. 12](#).
5. Overlay the wire, then wrap the entire length to cover the overlay and integrate it with the harness.
6. Repair the wire as necessary. See [Fig. 13](#).

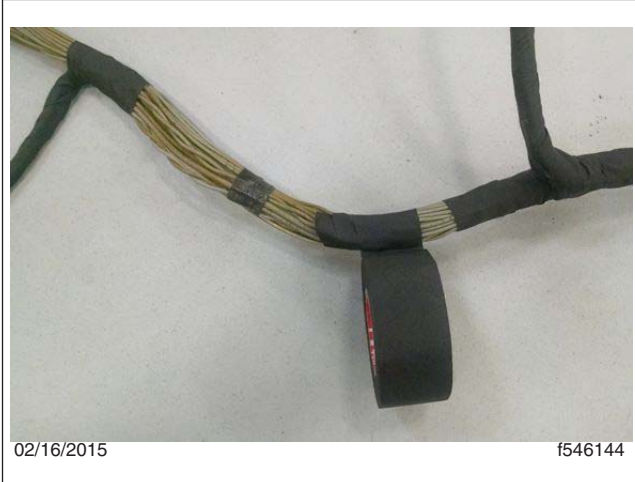
Fig. 14, Wrapping the Harness with Fiber Tape

7. Wrap the harness with fiber tape. Refer to 48-25910-000. Make sure enough tape is used to overlap the starting point. See [Fig. 14](#).
8. When the harness is completely wrapped, secure both ends of the fiber wrap with electrical tape. See [Fig. 15](#).

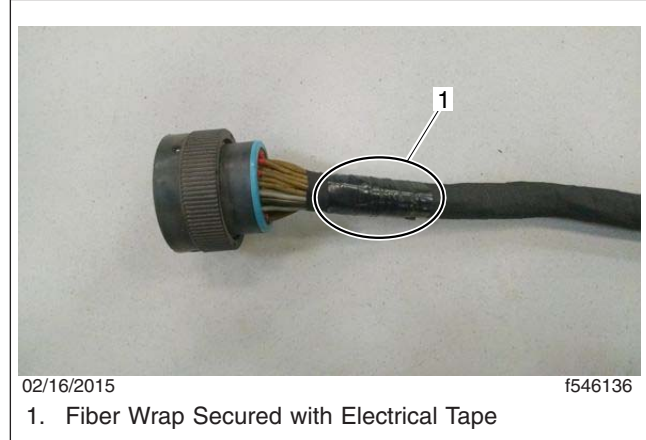
Fig. 15, Fiber Wrap Secured with Electrical Tape

1. Fiber Wrap Secured with Electrical Tape
