NUMBER: 23-008-15

Rattle Noise From The Right Or Left Rear Sliding Door While Driving Over Bumps

This bulletin involves modifying the rubber bumper located at the rear end of the rear sliding door upper track.

2013 - ****2015**** (RT)

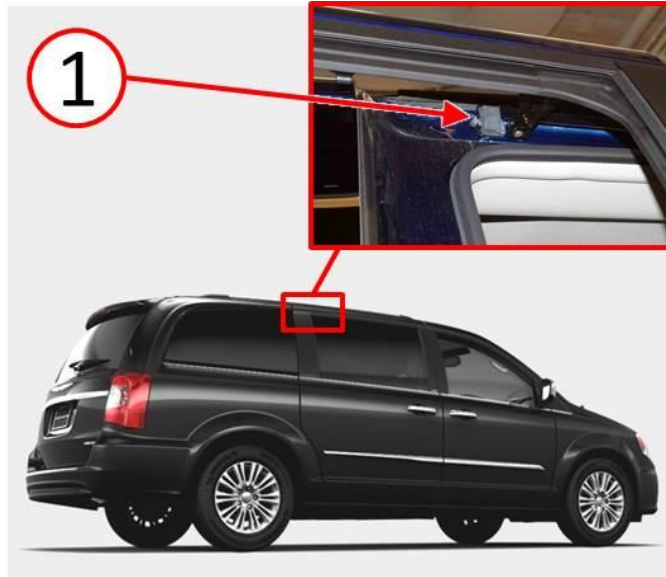
Fig. 1 Remove Bumper

Rattle noise that sounds like metal against metal coming from the right ****or left**** rear sliding door area while driving over bumps.

1 - Rubber Bumper

3. Open the rear sliding door and remove the rubber bumper (Fig. 1) from the rear end of the upper door track, then close the door.

-
4. Continue test driving the vehicle over the same road conditions to determine if removal of the rubber bumper eliminated the rattle noise.
 - a. YES>>> The rattle noise was eliminated. Continue to [Step #5](#).
 - b. NO>>> The rattle noise was NOT eliminated. Reinstall the rubber bumper. This Bulletin does not apply. Normal diagnostics should be performed.
 5. Using a coarse file (2), remove 1 mm of material from the rubber bumper surface (1) indicated in ([Fig. 2](#)).

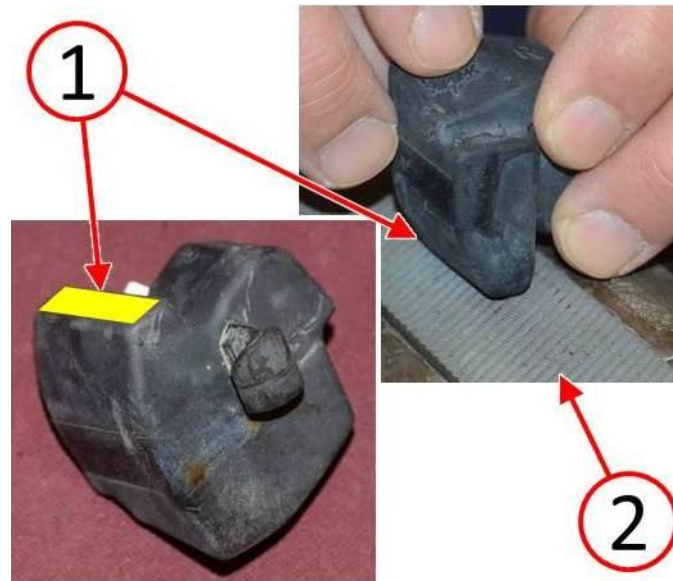
Fig. 2 Modify Bumper

1 - Rubber Bumper Surface

2 - Coarse File

6. Install the modified rubber bumper to the vehicle.
