This Service Information bulletin supersedes SI B13 02 15 **dated May 2015**.

SUBJECT

Service Action: N63 Replace High-Pressure Fuel Pumps

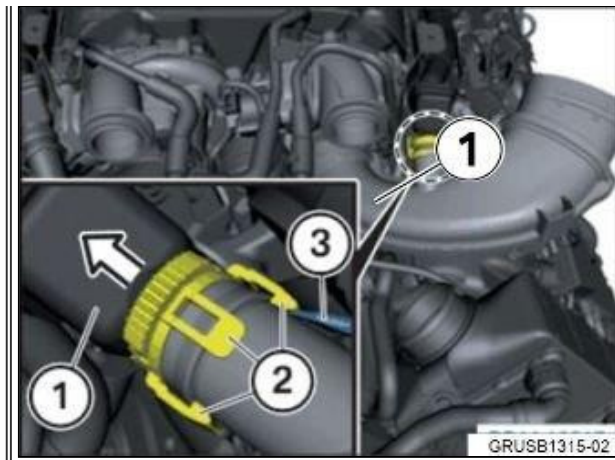
Important Note: Below, find the removal and installation of the crankcase ventilation lines (hoses) if the vehicle has had the procedures described in [B11 06 14](#) and [B11 16 14](#) already performed.

pick or suitable tool.
Disconnect connecting line 3.

Replace both high-pressure pumps. Refer to the following Repair Instruction 13 51 065, "Remove and installing/replacing the left high-pressure pump (N63)," and 13 51 070, "Remove and installing/replacing the right high-pressure pump (N63)."
