This Service Information bulletin supersedes SI 26 01 15 **dated November 2015**.

Service Action: Replace the NVLD Temperature Sensor

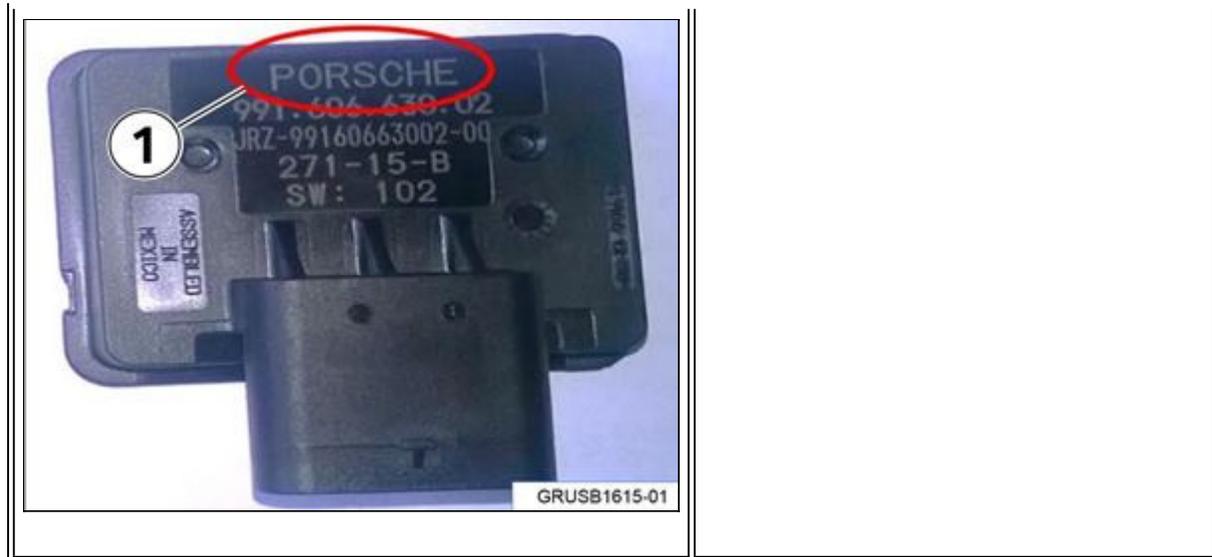
The wrong temperature sensor for the Natural Vacuum Leak Detection (NVLD) may have been installed.

<p>If the temperature sensor is labeled "PORSCHE" (1), it needs to be replaced.</p>
--	---

Access the temperature sensor for the NVLD following repair instruction RA 16 13 522 Removing and installing/replacing temperature sensor for Natural Vacuum Leak Detection (NVLD).

Part Number	Description	Quantity
16 13 7 333 588	NVLD temperature sensor	1
