**NUMBER:** 08-089-15

Security System Nuisance Alarms

This bulletin involves replacing the five alarm sensor transmitters.

2011 - 2015 (JK)

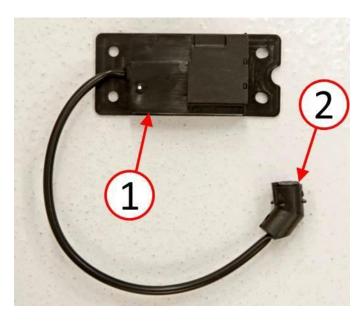
Fig. 1 Ultrasonic Sensor

- 1 Alarm Sensor
- 2 Alarm Sensor Microphone

1. Replace all five alarm sensor transmitters per the following procedure (Fig. 1). Two are located in the instrument panel, two in the center console, and one behind the left rear quarter interior trim panel.

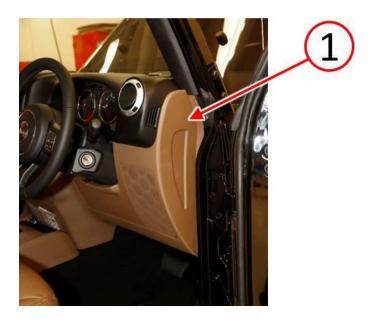
Fig. 2 Instrument Panel Right Side End Cap

1 - Instrument Panel End Cap

3. Using a trim stick, remove the instrument panel right side end cap (Fig. 2).

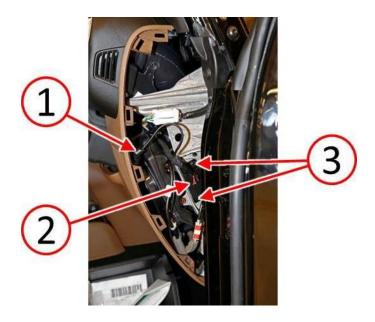
Fig. 3 Instrument Panel Right Side Alarm Sensor

- 1 Alarm Sensor Microphone
- 2 Electrical Connector
- 3 Fasteners

- 4. Remove the alarm sensor microphone (1) from the reflector cone, located on the back side of the speaker grille (Fig. 3).
- 5. Disconnect the electrical connector (2) from the alarm sensor (Fig. 3).
- 6. Remove the two fasteners (3) securing the alarm sensor (Fig. 3).
- 7. Remove the alarm sensor and replace with a NEW alarm sensor from the Parts Required table.
- 8. Install the two fasteners (3) securing the alarm sensor (Fig. 3).
- 9. Connect the electrical connector (2) to the alarm sensor (Fig. 3).

# NOTE: Ensure the correct direction orientation of the alarm sensor microphone for proper functionality.

- 10. Install the alarm sensor microphone (1) to the reflector cone, located on the back side of the speaker grille (Fig. 3).
- 11. Install the instrument panel right side end cap (Fig. 2).

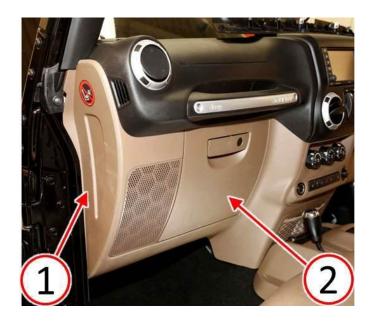
Fig. 4 Instrument Panel Left Side End Cap And Glove Box

- 1 Instrument Panel End Cap
- 2 Glove Box

- 12. Using a trim stick, remove the instrument panel left side end cap (Fig. 4).
- 13. Remove the glove box (2) (Fig. 4). Refer to the detailed service procedures available in DealerCONNECT> TechCONNECT under: Service Info> 23 Body> Instrument Panel> GLOVE BOX, Instrument Panel> Removal.

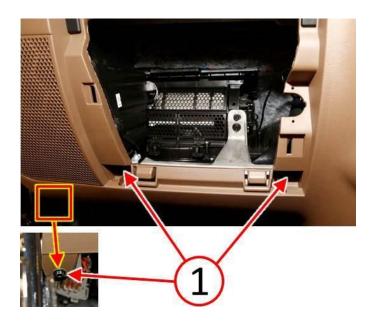
Fig. 5 Instrument Panel Left Side Fasteners

1 - Fasteners

14. Remove the three fasteners (1) attaching the lower left side of the instrument panel cover (Fig. 5).

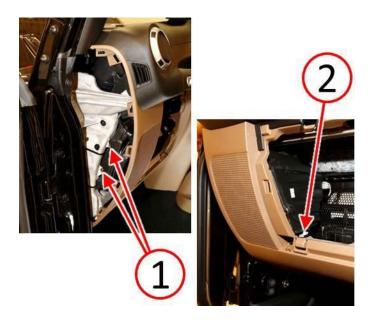
Fig. 6 Instrument Panel Left Side Speaker Fasteners

- 1 Speaker Fasteners
- 2 Speaker Fastener

15. Remove the left speaker mounting fasteners. Two fasteners (1) are located at the left side of the instrument panel and one fastener (2) is located at the lower left corner of the glove box opening (Fig. 6).

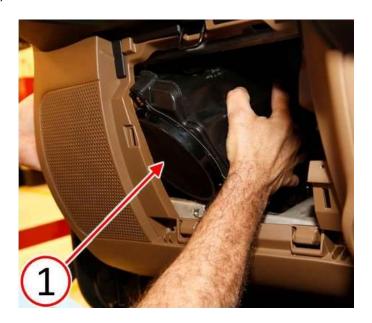
Fig. 7 Instrument Panel Left Side Speaker

1 - Speaker

16. Remove the left speaker by carefully pulling the left side of the instrument panel cover outward until there is sufficient room to remove the speaker (1) through the glove box opening (Fig. 7).

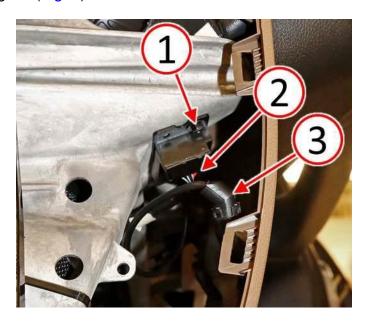
Fig. 8 Instrument Panel Left Side Alarm Sensor

- 1 Fasteners
- 2 Electrical Connector
- 3 Alarm Sensor Microphone

- 17. Remove the alarm sensor microphone (3) from the reflector cone, located on the back side of the speaker grille (Fig. 8).
- 18. Disconnect the electrical connector (2) from the alarm sensor (Fig. 8).
- 19. Remove the two fasteners (1) securing the alarm sensor (Fig. 8).
- 20. Remove the alarm sensor and replace with a NEW alarm sensor from the Parts Required table.
- 21. Install the two fasteners (1) securing the alarm sensor (Fig. 8).
- 22. Connect the electrical connector (2) to the alarm sensor (Fig. 8).

## NOTE: Ensure the correct direction orientation of the alarm sensor microphone for proper functionality.

23. Install the alarm sensor microphone (3) to the reflector cone, located on the back side of the speaker grille (Fig. 8).

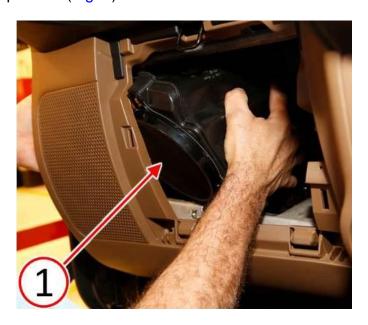
Fig. 9 Instrument Panel Left Side Speaker

1 - Speaker

24. Install the left speaker through the glove box opening while carefully pulling the left side of the instrument panel cover outward, until there is sufficient room to insert the speaker (1) into position (Fig. 9).

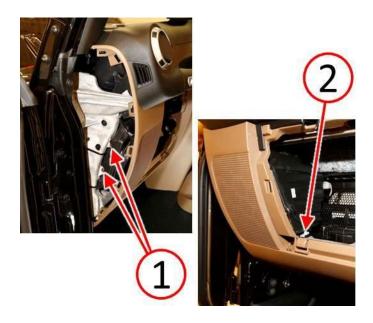
Fig. 10 Instrument Panel Left Side Speaker Fasteners

- 1 Speaker Fasteners
- 2 Speaker Fastener

25. Install the left speaker mounting fasteners. Two fasteners (1) are located at the left side of the instrument panel and one fastener (2) is located at the lower left corner of the glove box opening (Fig. 10).

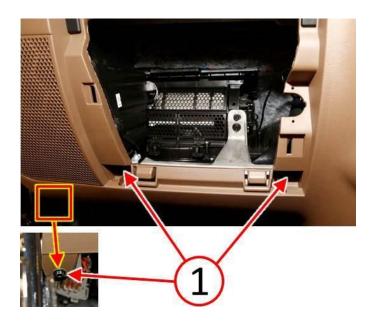
Fig. 11 Instrument Panel Left Side Fasteners

1 - Fasteners

26. Install the three fasteners (1) attaching the lower left side of the instrument panel cover (Fig. 11).

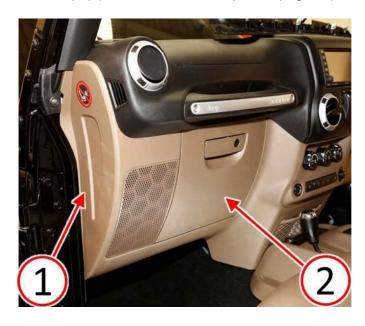
Fig. 12 Instrument Panel Left Side End Cap And Glove Box

- 1 Instrument Panel End Cap
- 2 Glove Box

- 27. Install the glove box (2) to the instrument panel (Fig. 12). Refer to the detailed service procedures available in DealerCONNECT> TechCONNECT under: Service Info> 23 Body> Instrument Panel> GLOVE BOX, Instrument Panel> Removal.
- 28. Install the left side end cap (1) to the instrument panel (Fig. 12).

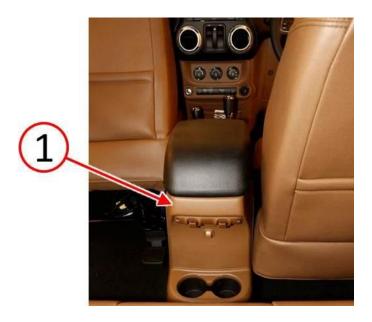
Fig. 13 Center Console End Cap

1 - Center Console Bezel

29. Using a trim stick, release the rear center console bezel (1) and tilt the bezel downward (Fig. 13).

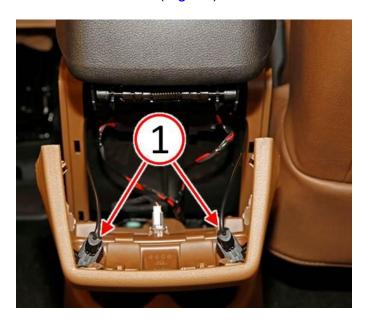
Fig. 14 Center Console Alarm Sensor Microphone

1 - Alarm Sensor Microphone

30. Remove the alarm sensor microphones (1) from the reflector cones, located on the back side of the center console bezel (Fig. 14).

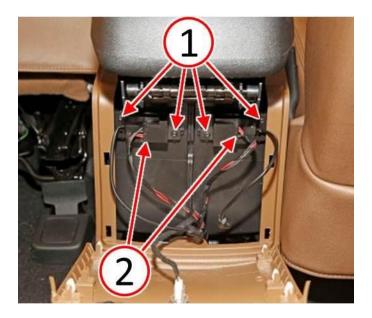
Fig. 15 Center Console Alarm Sensor

- 1 Fasteners
- 2 Electrical Connectors
- 36. Install the alarm sensor microphones to the reflector cones, located on the back side of the center console bezel (Fig. 14).
- 37. Install the rear center console bezel to the rear center console (Fig. 13).

- 31. Disconnect the electrical connectors (2) from the alarm sensors (Fig. 15).
- 32. Remove the four fasteners (1) securing the alarm sensors (Fig. 15).
- 33. Remove the alarm sensors and replace with a NEW alarm sensors from the Parts Required table.
- 34. Install the four fasteners (1) securing the alarm sensors (Fig. 15).
- 35. Connect the electrical connectors (2) to the alarm sensors (Fig. 15).

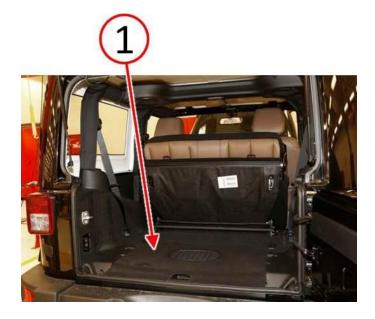
Fig. 16 Rear Compartment Load Floor Panel

1 - Load Floor Panel

38. Remove the load floor panel (1) from the rear compartment (Fig. 16).

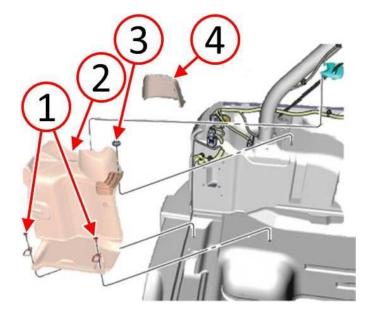
Fig. 17 Interior Trim Panel Left Rear Corner

- 1 Fasteners
- 2 Trim Cover
- 3 Fastener
- 4 Quarter Trim Panel

- 39. Remove the fasteners (1) and tie-down clips from the left rear quarter trim panel (Fig. 17).
- 40. Remove the trim cover (4) from the left rear quarter trim panel (Fig. 17).
- 41. Remove the fastener (3) from the left rear quarter trim panel (Fig. 17).
- 42. Remove the left rear quarter trim panel (2) and disconnect the electrical connector from the alarm sensor attached to the back side of the quarter trim panel (Fig. 17).

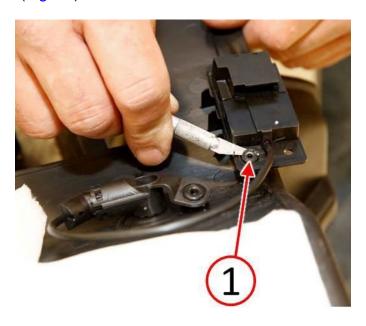
Fig. 18 Cut Heat Stakes And Remove Alarm Sensor

1 - Heat Stakes

43. Using a suitable tool, remove the heat stakes (1) securing the alarm sensor to the quarter trim panel (Fig. 18).

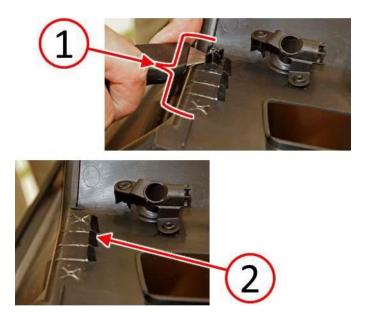
Fig. 19 Remove Alarm Sensor Spacer Ribs And Heat Stake Studs

1 - Heat Stake Studs And Support Ribs

2 - Shark Fins

44. Trim away the part of the two heat stake studs and three plastic alarm sensor support ribs (1) leaving only the tall shark fin portion (2) of the three ribs (Fig. 19).

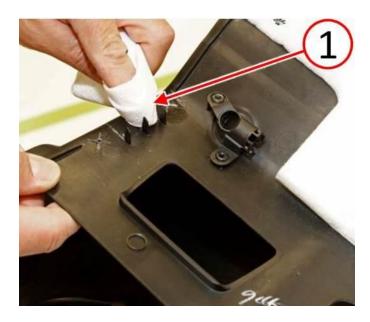
Fig. 20 Clean Alarm Sensor Mounting Surface

1 - Clean Cloth

45. Using a clean cloth (2), clean the trimmed area with isopropyl alcohol, then apply 3M<sup>™</sup> adhesion promoter or equivalent to the trimmed area (Fig. 20).

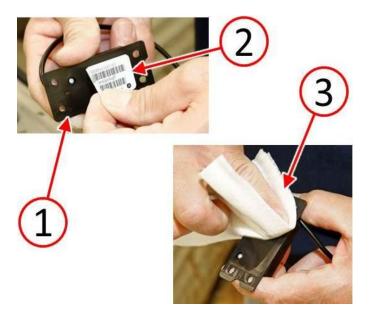
Fig. 21 Remove Label And Clean Alarm Sensor

- 1 Alarm Sensor
- 2 Label
- 3 Clean Cloth

- 46. Remove the label (2) from the back side of the alarm sensor (1) in order to improve adhesion of the sensor to the trim panel (Fig. 21).
- 47. Using a clean cloth (3), clean the back side of the alarm sensor with isopropyl alcohol, then apply 3M<sup>™</sup> adhesion promoter or equivalent to the back side of the alarm sensor (Fig. 21).

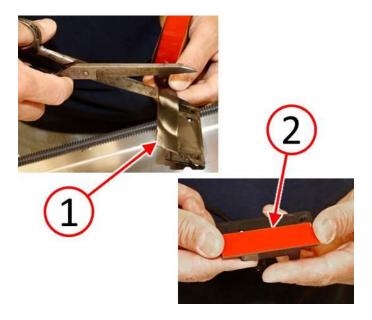
Fig. 22 Apply Attachment Tape To Alarm Sensor

- 1 Attachment Tape
- 2 Tape Piece

- 48. Using scissors or equivalent cutting tool, cut one piece of 3M™ automotive acrylic plus attachment tape (1) the full length of the alarm sensor (Fig. 22).
  49. Apply the piece of 3M™ automotive acrylic plus attachment tape (2) to the top edge of
- the alarm sensor (Fig. 22).

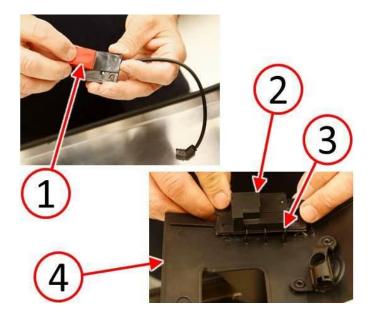
Fig. 23 Remove Tape Backing And Align Alarm Sensor

- 1 Backing Film
- 2 Alarm Sensor
- 3 Shark Fins
- 4 Quarter Trim Panel

- 50. Remove the backing film (1) from the attachment tape (Fig. 23).51. Align the alarm sensor (2) in its original location on the quarter trim panel (4) against the shark fins (3) (Fig. 23).

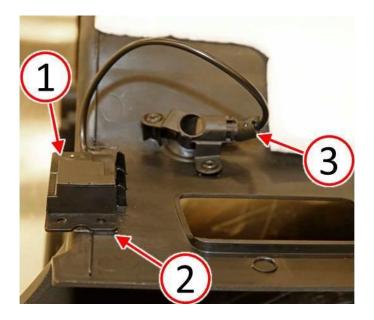
Fig. 24 Install Alarm Sensor And Microphone

- 1 Alarm Sensor
- 2 Attachment Tape
- 3 Alarm Sensor Microphone

- 52. Press the alarm sensor (1) firmly to the quarter trim panel ensuring complete contact of the attachment tape (2) (Fig. 24).
- 53. Install the alarm sensor microphone (3) to the reflector cone (Fig. 24).

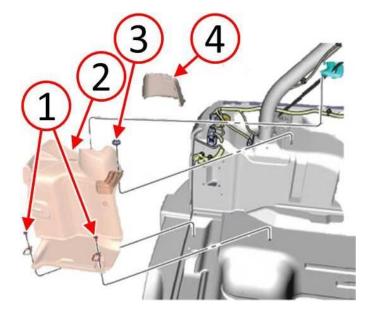
Fig. 25 Interior Trim Panel Left Rear Corner

- 1 Fasteners
- 2 Trim Cover
- 3 Fastener
- 4 Quarter Trim Panel

- 54. Connect the electrical connector to the alarm sensor attached to the back side of the quarter trim panel, then install the left rear quarter trim panel (2) to the vehicle (Fig. 25).
- 55. Install the fastener (3) to the left rear quarter trim panel (Fig. 25).
- 56. Install the trim cover (4) to the left rear quarter trim panel (Fig. 25).
- 57. Install the fasteners (1) and tie-down clips to the left rear quarter trim panel (Fig. 25).

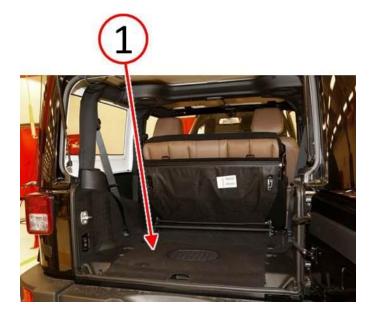
Fig. 26 Rear Compartment Load Floor Panel

1 - Load Floor Panel

58. Install the load floor panel (1) to the rear compartment (Fig. 26).
