Quality Inspection Request 68188899AA – Brake Rotor Correct and Suspect Part Identification

Wrong Part in the package – PN: 68188899AA

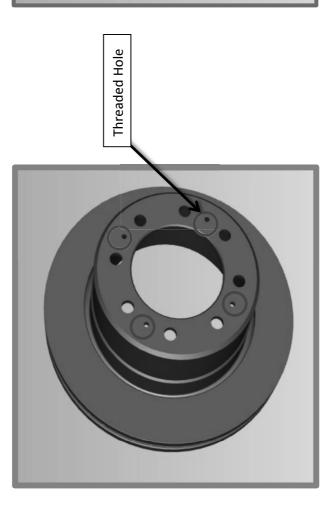
Correct Part Identification

Correct part has 4 threaded holes on hub to hold tone ring.

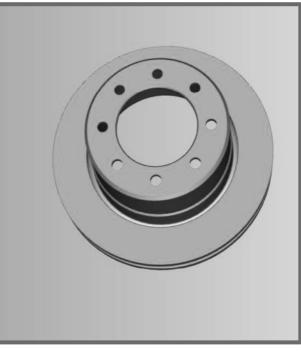
Suspect Part Identification

Suspect part does not have threaded holes.
