## Technical Service Bulletin

**Tech Service Bulletin #: 15-01**

**Date: 1/21/2015**

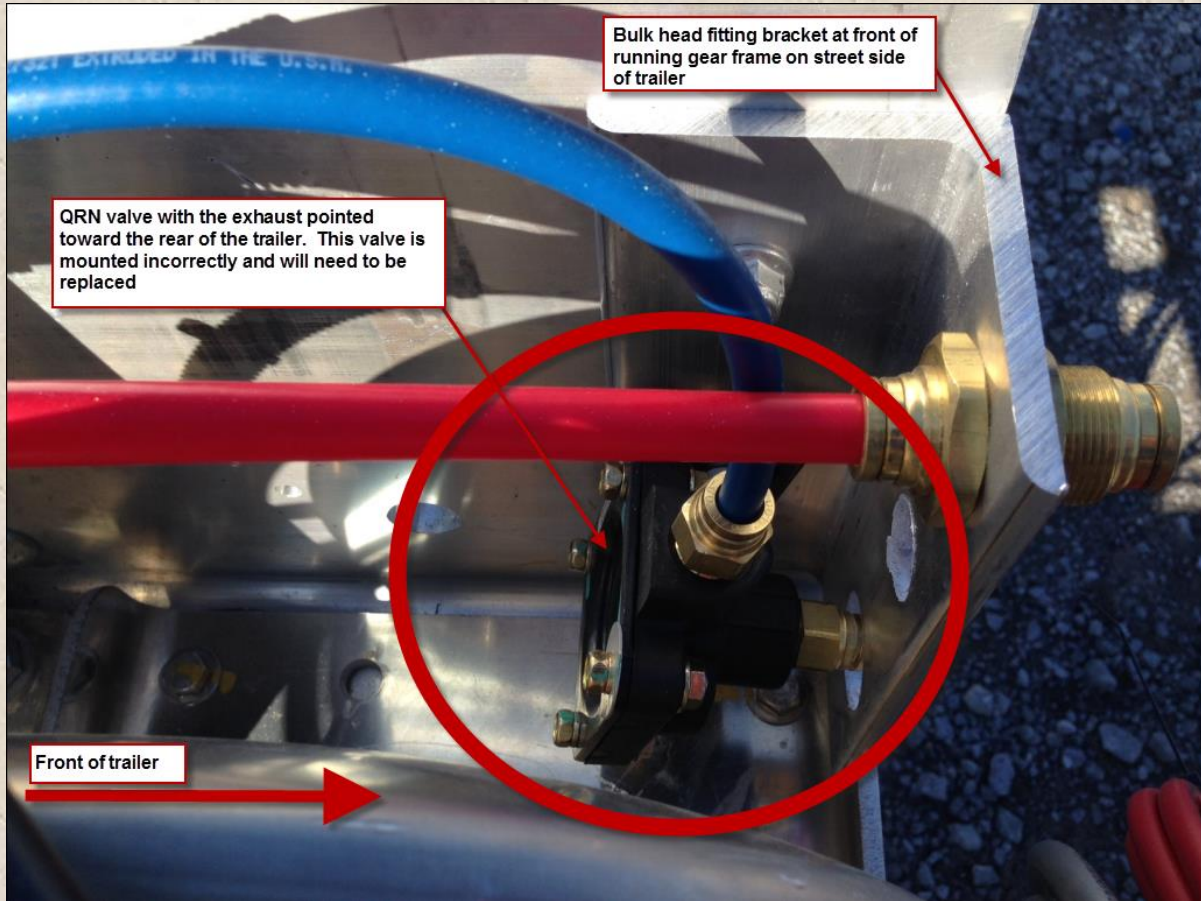
The QRN valve is located at the front of the running gear frame on the left hand/street side behind the bulk head fitting bracket (as shown in the picture on the second page of this bulletin). If the valve is mounted to where the exhaust port is pointed in any direction but downward, the valve is installed incorrectly and needs to be replaced.

Heil Trailer requests that each trailer you possess listed on the original email, be inspected and Technical Service informed (800-400-6913 or [service@heiltrailer.com](mailto:service@heiltrailer.com)) as to the orientation of the part. If the valve is mounted incorrectly, Heil Trailer will send you a replacement valve and pay labor to have the valve replaced at a repair facility of your choice.

Please inspect the valve and contact Heil Trailer Technical Service to proceed with either eliminating the trailer from the list or obtaining a plan for part replacement.
