# Field campaign

| Topic | Boot lid parameter change - software update (SC15/10) |
| Campaign number | EA31 |

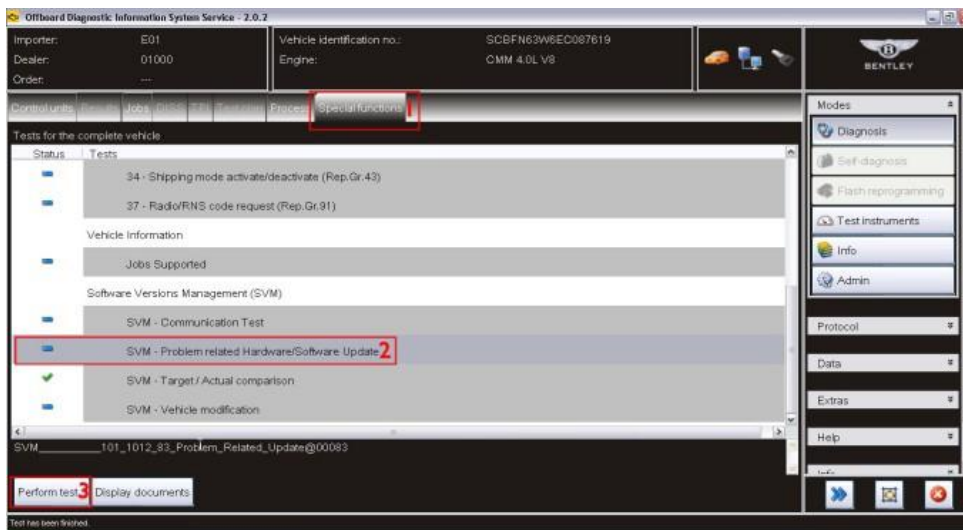
Figure 1

8. Select Special functions (1), Select SVM – Problem related Hardware/Software Update (2), Select Perform test (3) (see Figure 1)

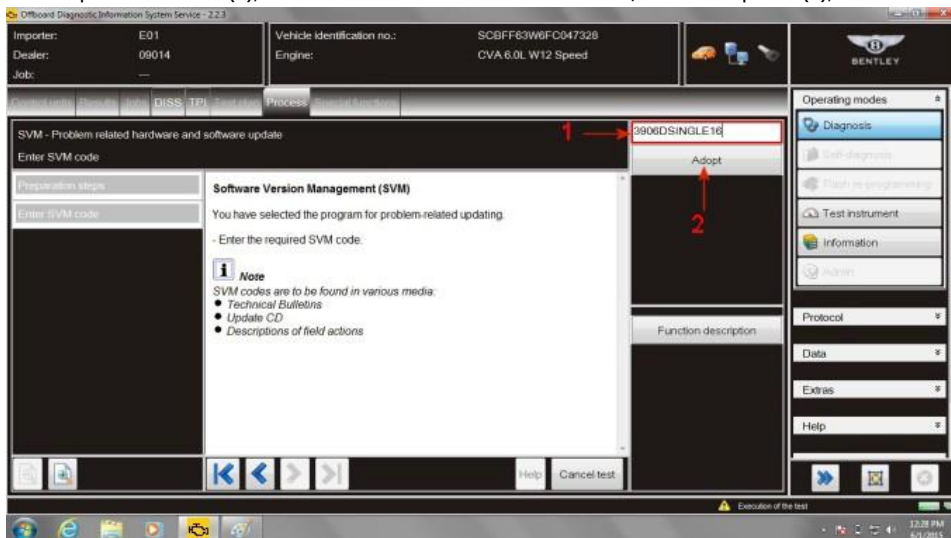
Figure 2

9. For **Continental GT and GT Convertible** at SVM process screen enter (1) the specific SVM code **3906DSINGLE16** and then Adopt (2)
10. For **Flying Spur** at SVM process screen enter (1) the specific SVM code **4W06DSINGLE16** and then Adopt (2)

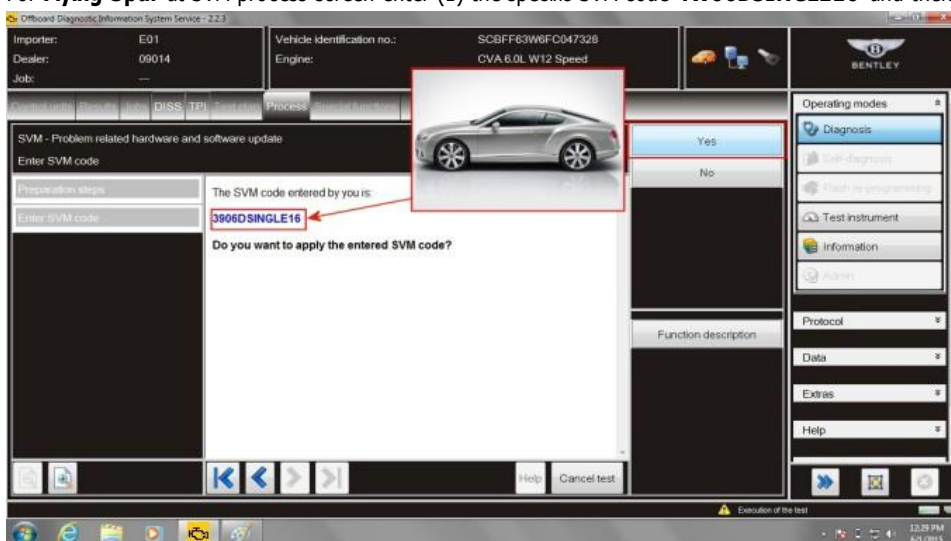
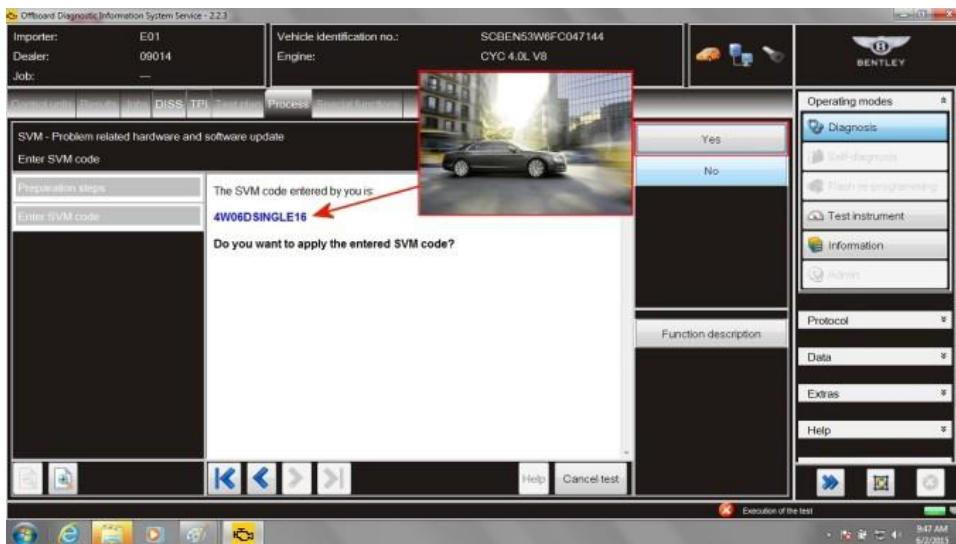
11. Check you have entered the correct SVM code for the vehicle type and select Yes (see Figure 3 & 3a)
12. If prompted enter your global user ID and password

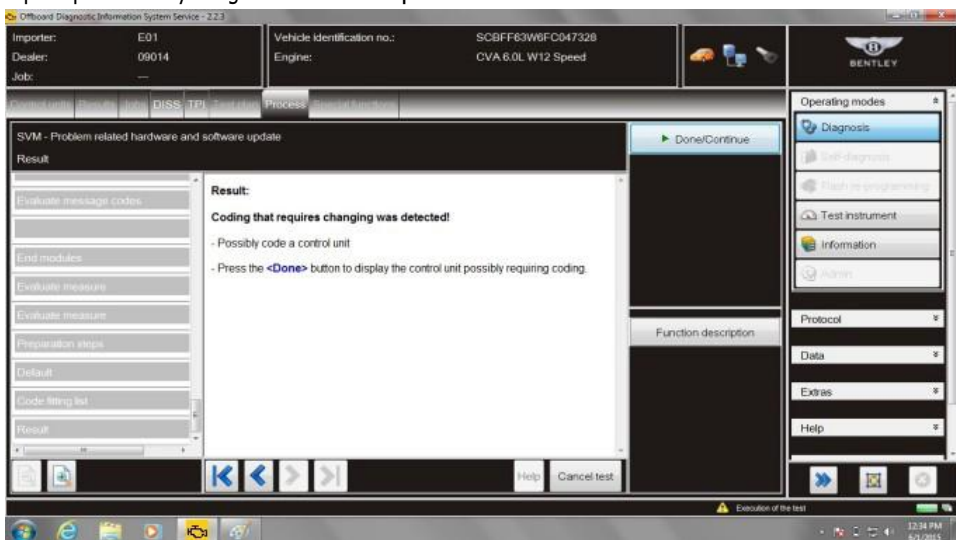
Figure 4

13. Coding that requires changing will be detected select Continue (see Figure 4)

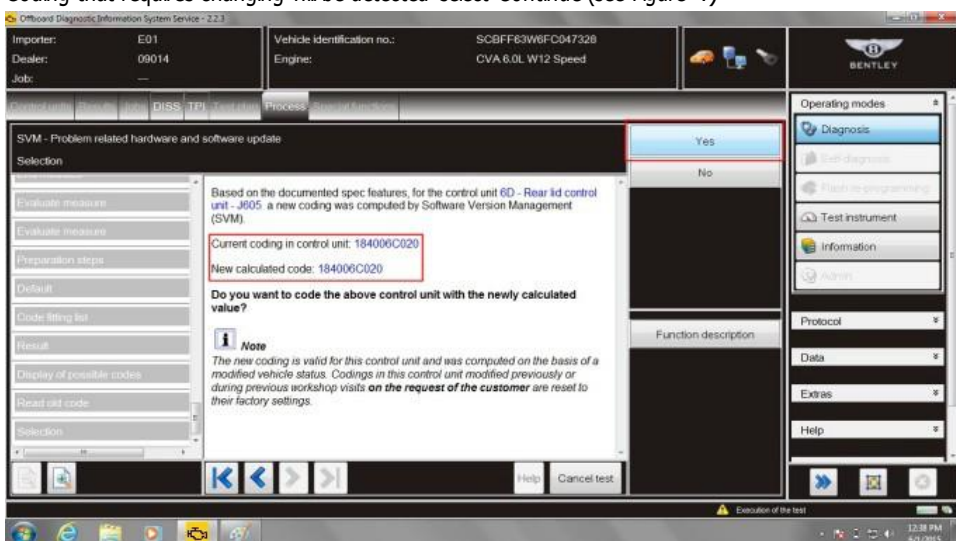
Figure 5

14. Like for like coding will be identified select Yes to progress through the procedure (see Figure 5)
15. Once Done/Continue is selected at the successful coding screen then you are prompted to perform an ignition off/on cycle, to do this: FIRST press Done/Continue then at prompt turn ignition OFF, press Done/Continue then at prompt turn ignition ON

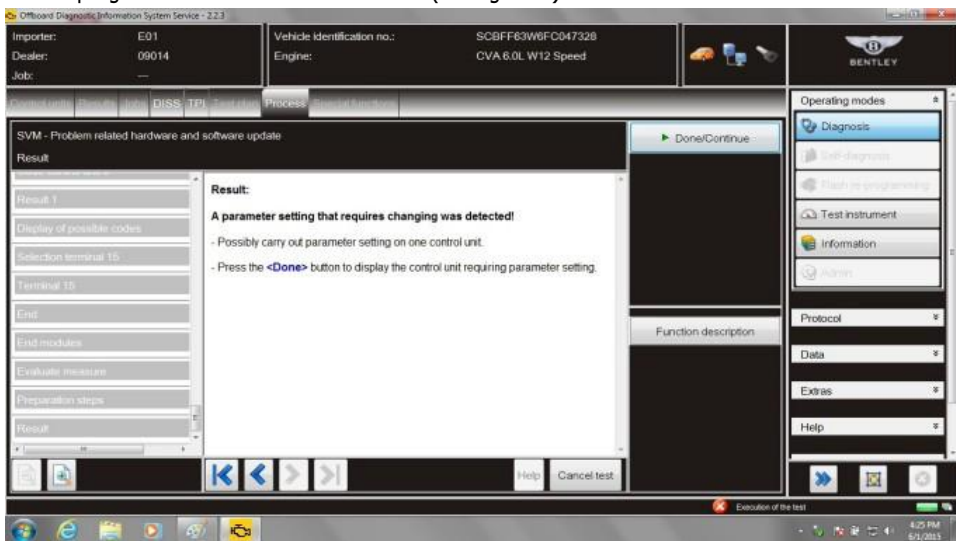
Figure 7

17. At Result screen for parameter settings detected select Continue (see Figure 7) follow screen prompts to allow automatic run of SVM

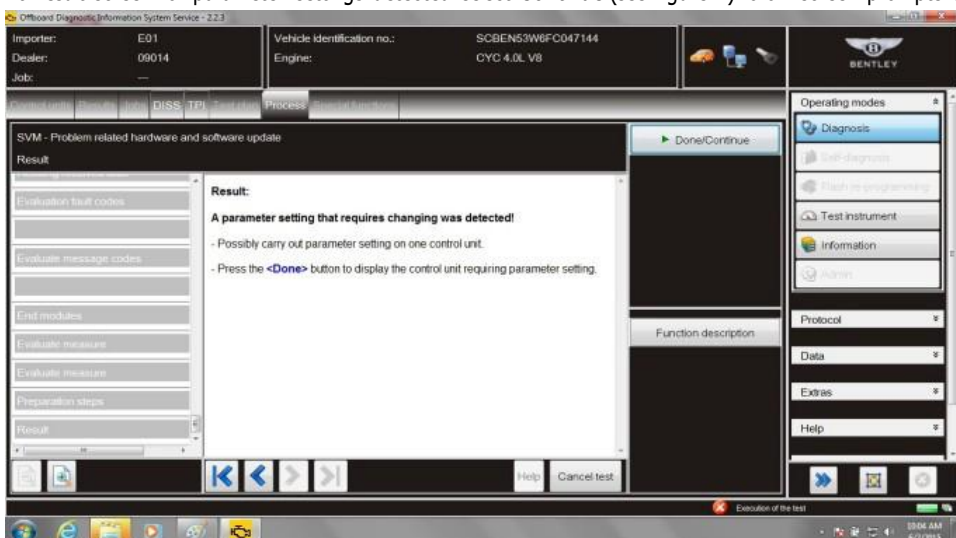
Figure 8

18. Once parameter that requires changing is detected select Done/Continue (see Figure 8)

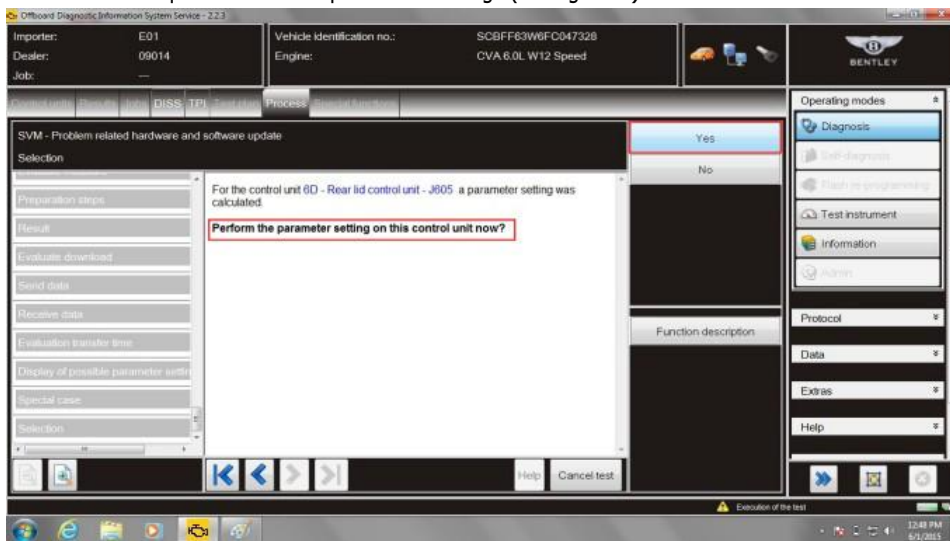
Figure 10

20. Select Yes to perform the parameter settings to the Rear lid control unit – J605 (see Figure 10)
21. Once Done/Continue is selected at the parameter setting screen then you are prompted to perform an ignition off/on cycle, to do this: FIRST press Done/Continue then at prompt turn ignition OFF, press Done/Continue then at prompt turn ignition ON
22. Follow the on screen prompts to continue through the automated SVM procedure
23. Select exit Offboard Diagnostic Information System Service to check and clear the vehicle of any fault codes generated as a result of performing this campaign.
24. On completion apply a yellow campaign completion mark (see Figure 11)

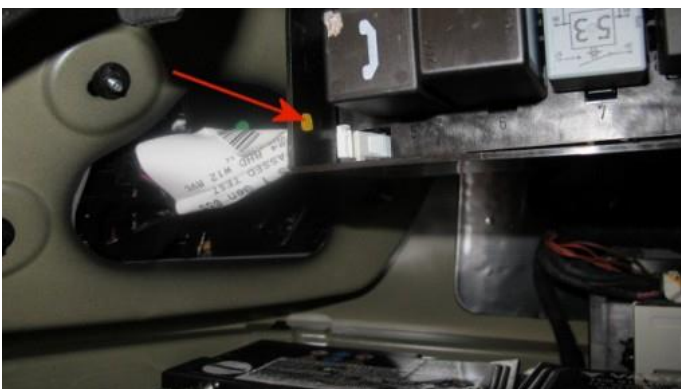
Figure 11

On completion apply a yellow campaign completion mark to the boot mounted fuse box adjacent to the main system battery negative post (see

If the vehicle is not already listed as repaired in the "Repair history" (ElsaPro), check for the campaign identification mark, to the boot mounted fuse box adjacent to the main system battery negative post (see Figure 11), should neither be evident carry out the required work in accordance with these instructions
