Field campaign

Topic	Incorrect fuel filler door and bowl assembly (SC15/11)				
Market area	United Kingdom E01 Bentley UK (6E01), Germany E02 Bentley rest Europe (6E02), United States E05 Bentley USA and rest America (6E05)				
Brand	Bentley				
Transaction No.	2041153/1				
Campaign number	EA32				
Note					
Туре					
US code

Continental GT

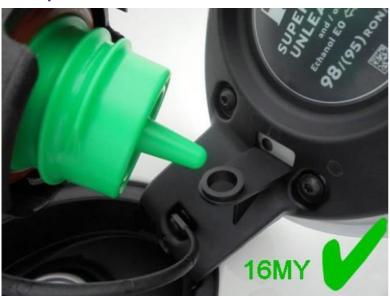
For 16MY the method of storing the fuel filler cap during refuel has changed. A small number of 16MY Continental GT cars have the incorrect fuel filler bowl assembly fitted

Fit the correct fuel filler flap and bowl assembly (part number 3W8809857M). Figure 1 shows the correct 16MY fuel filler flap and bowl assembly Figure 2 shows the incorrect assembly for 16MY Reference workshop manual, Rep. Gr.55 Fuel Filler Flap and Bowl – To Remove and Fit

If the vehicle is not already listed as repaired in the "Repair History" (in ElsaPro), check for the presence of the correct fuel filler bowl assembly (see Figure 1)

Fit the correct fuel filler flap and bowl assembly (part number 3W8809857M) Reference

workshop manual, Rep. Gr.55 Fuel Filler Flap and Bowl - To Remove and Fit
