**AFFECTED:** Certain 2015 Winnebago Aspect and Itasca Cambria model 730J coaches

**DATE:** May 4, 2015

**SUBJECT:** Removal of Satellite Cable Locating Label on Roof

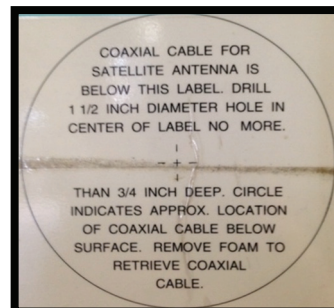
**Label to be removed**

Winnebago Industries is conducting a Field Service Campaign to remove the satellite cable locating label (pictured at right) from the roof of certain 2015 Aspect/Cambria coaches. The label was inadvertently installed in the wrong location and will need to be removed to prevent damage to the roof if someone were to attempt to install a satellite dish in this location.

Evaluate this issue on all subject vehicles currently in your inventory. Do not deliver any subject units to a customer until the label has been removed.

On stock vehicles, we request that you remove the label, then place the attached 'Instructions for Locating Satellite Wiring' document in the Entertainment section of the vehicles InfoCase (the black bag that contains the Operator's Manual, etc.).

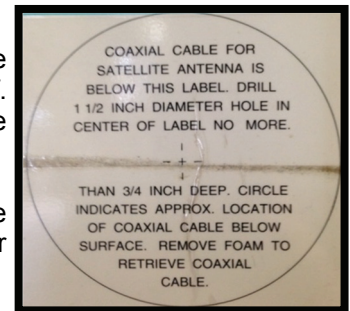
Winnebago Industries, Inc. has found that the 'Locating Label' (pictured at right) for the satellite dish wiring was inadvertently installed on the exterior, forward portion of the roof. The wires are actually located toward the middle center of the roof. To avoid confusion, we ask that the label be removed at your earliest convenience.

If you choose to remove the label, rather than returning to your dealer, we ask that you use all necessary caution when accessing and walking on the roof, this surface can be slick in certain conditions. If you are not comfortable removing the label, please present this letter to your dealer on your next visit and ask them to remove the label for you.
