# SERVICE BULLETIN

Classification: EC14-005a	Reference: NTB14-103a	Date: February 10, 2015
------------------------------	--------------------------	----------------------------

## 2013-2015 FRONTIER; FUEL TANK HARD TO FILL

**APPLIED VEHICLES:** 2013 – 2015 Frontier (D40)  
**APPLIED VIN AND DATE:** Built before 1N6AD0FV(\*)FN 728141 / Oct 1, 2014  
Shortbed Crew Cab vehicles **only**

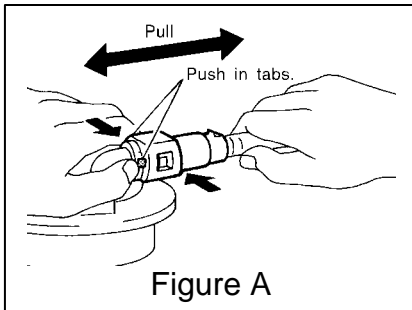
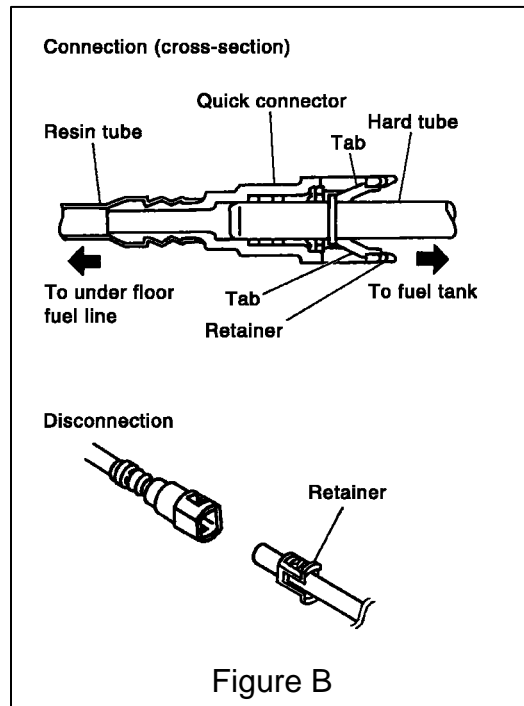
**NOTE:** See Figure A and Figure B for detail of "Quick connector" retainer release.

1. Disconnect vent hose at canister.

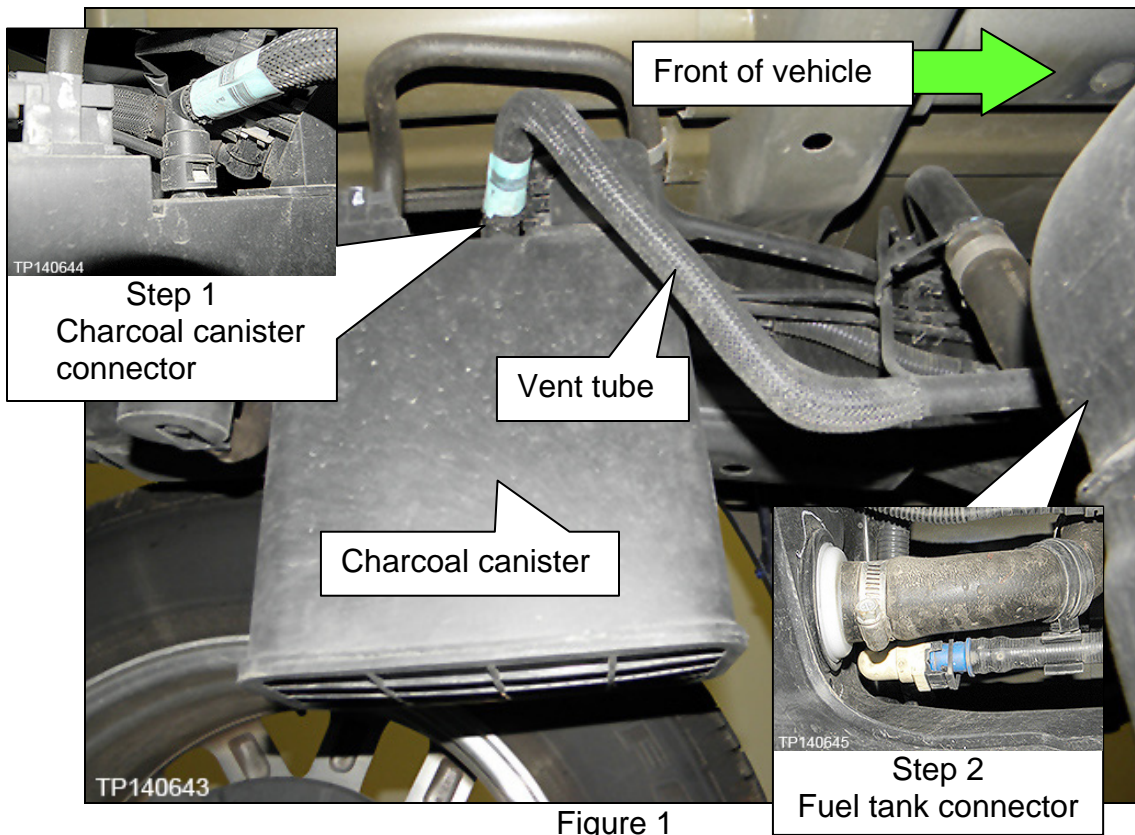
2. Disconnect vent hose from fuel tank.
3. Install new vent hose.

Replace the charcoal canister to fuel tank vent hose with the one from the Parts Information table.
