NISSAN BULLETIN

2015 NV Passenger Van Front Air Conditioning Control Assembly Dealer Service Action

Reference: PC355

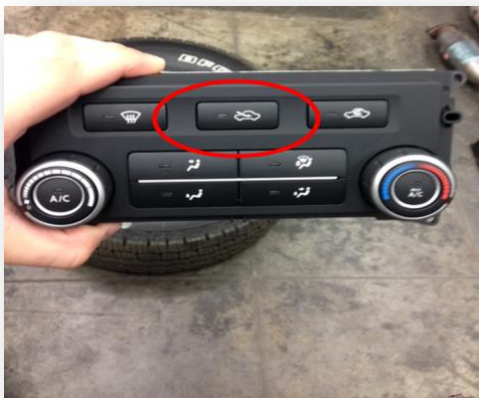
Nissan is conducting a dealer inventory service action to replace the front Air Conditioning Control Assembly on **17** specific 2015 NV passenger vans identified in SERVICE COMM. The heated mirror button on affected vehicles is missing due to incorrect front air conditioning control assembly installation in the vehicle.

**NG: Heated Mirror
Switch Missing**

1. Verify the subject vehicle is affected by this dealer inventory service action using Service Comm I.D. **PC355**.
2. Order the part and replace the front air conditioning control assembly using procedures available in the **HAC** section of the service manual.

Replacement parts are not restricted. Part number **27510-1PJ0B** is required for each vehicle and may be ordered via normal ordering process.

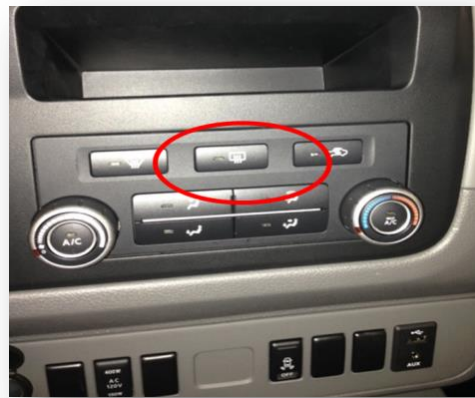
**OK: Heated Mirror
Switch Installed**
