# SERVICE BULLETIN

FA14-001b
 NTB14-088b
 April 1, 2015

# NOISE WHEN TURNING THE STEERING WHEEL

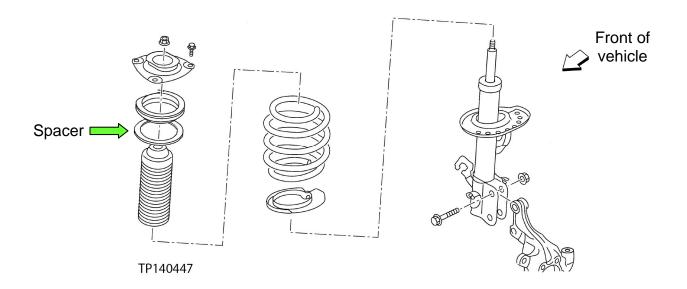
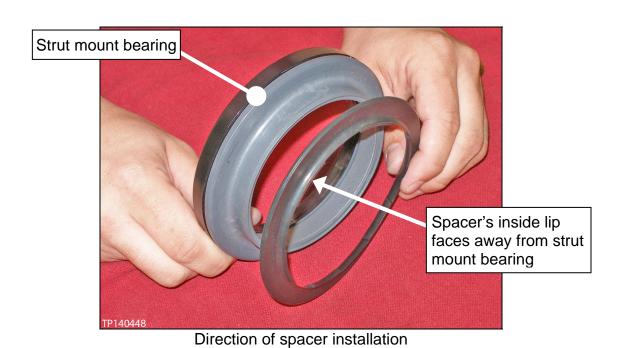
Install a spacer in both the left front and right front strut assemblies where shown in this bulletin.

Refer to the appropriate Electronic Service Manual (ESM), section FSU- Front Suspension, for removal and installation instructions.
